How clean do **sterile** implants have to be?

Analysis and clinical relevance of **factory-related** contaminations

Dr Dirk U. Duddeck, Germany

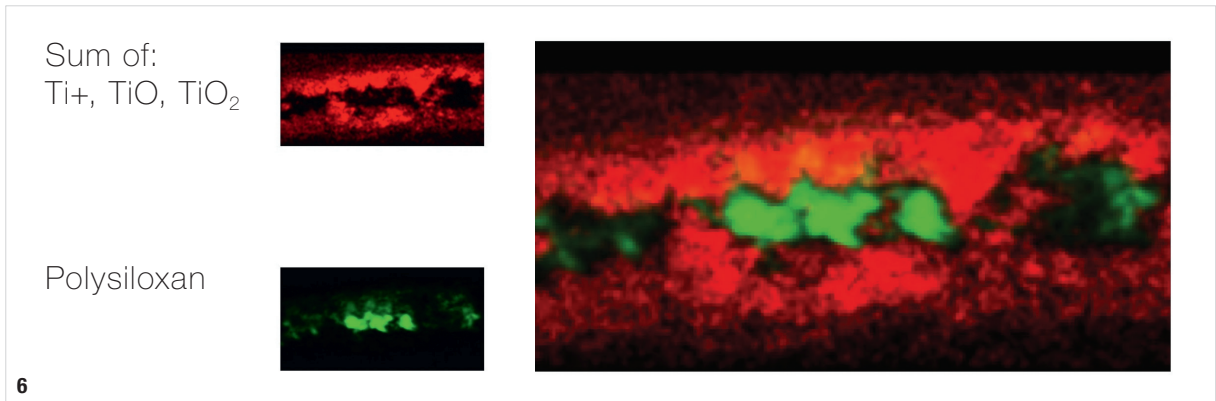
Fig. 6: Time-of-flight secondary ion mass spectrometry detection of polysiloxane on a titanium implant.

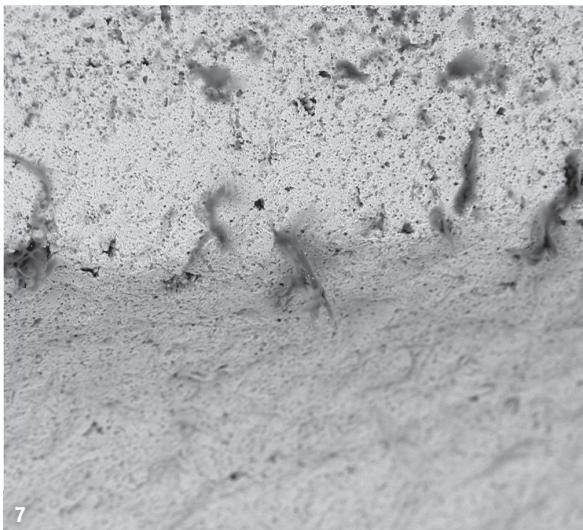
Fig. 7: Significant plastic material (polyacetal) on the shoulder of a ceramic implant (vitaclinical, VITA Zahnfabrik) from abrasion from the packaging.

Unfortunately, implant systems do not have consistent, comparable quality, as summarised in 2020 by Dr Norton, a past president of the Academy of Osseointegration, in an opinion piece in the *British Dental Journal* that is well worth reading.¹¹ The use of factory-contaminated implants not only may lead to inferior clinical outcomes but also carries the risk of legal implications. The problem of possible factory-related contamination concerns not only implants made of titanium or titanium alloys but also ceramic implants, as scientists from the universities of Gothenburg, Malmö and Berlin impressively described in a study published in 2021.¹² The bottom line of the study is that just because the material of ceramic implants is white does not necessarily mean that they are clean (Fig. 7).
