How clean do **sterile** implants have to be?

Analysis and clinical relevance of **factory-related** contaminations

Dr Dirk U. Duddeck, Germany

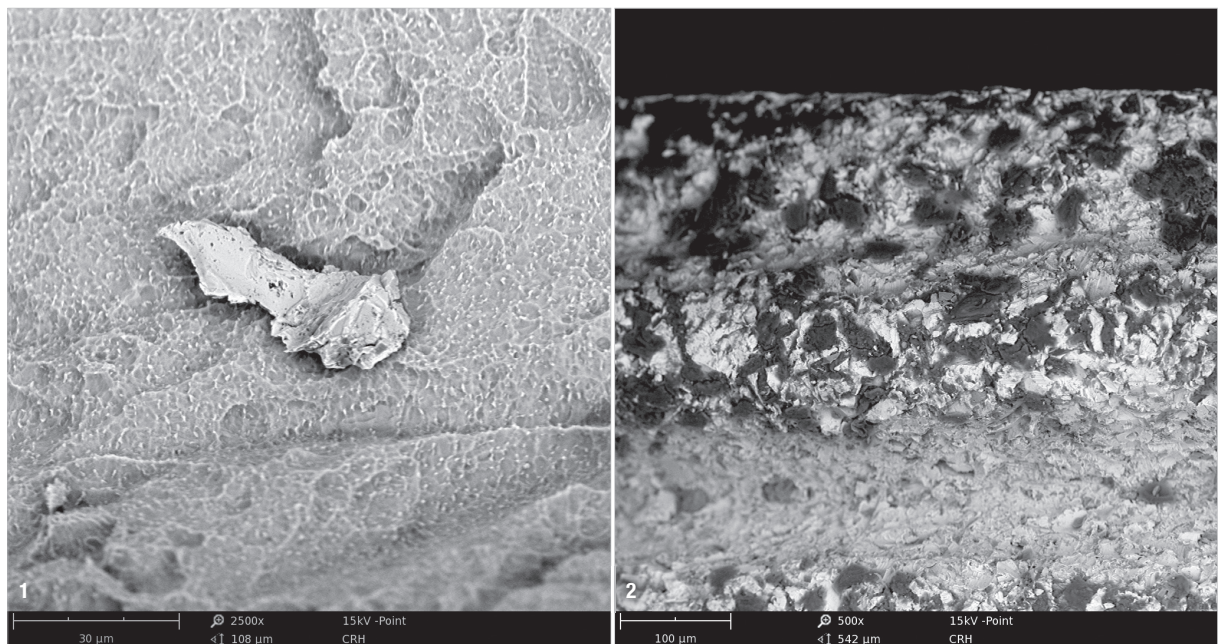
Fig. 1: Metal particle of iron, chromium and nickel on the surface of a titanium implant (Adin). SEM 2,500× magnification. **Fig. 2:** Numerous organic particles on the entire implant shoulder (OCO Biomedical). SEM 500× magnification.

for the analysis of particulate and film-like contaminants on sterile-packaged dental implants. Back-scattered electrons from the implant surface have typical energy of up to 10 keV. The intensity of these signals depends on the average atomic number of the sample material in focus. Compared with titanium or zirconium, heavier elements, such as iron or nickel, show more intense back scattering so that corresponding image areas appear bright (Fig. 1). In contrast, locations with lighter elements, such as carbonaceous plastic particles, are displayed darker than areas with titanium or zirconium (Fig. 2).

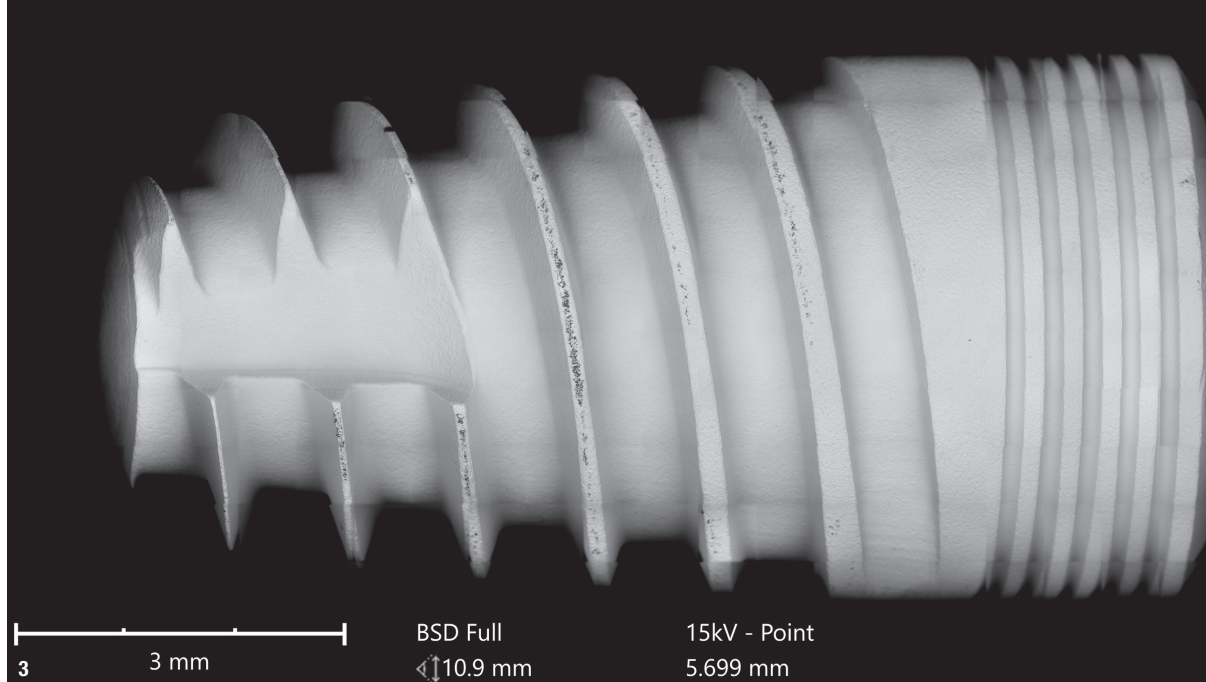
Fig. 3: Factory-related contamination of entire implant threads (Ritter Implants). Full-size SEM image of the implant electronically compiled from hundreds of single images at 500× magnification using the material contrast technique (back-scattered electron mode).

to depict details at high magnification without pixelation, up to 600 individual SEM images must be electronically stitched together in high resolution for these comprehensive overview images. The resulting SEM image in material contrast provides a detailed overview and allows the quantitative detection of individual particles (Fig. 3).

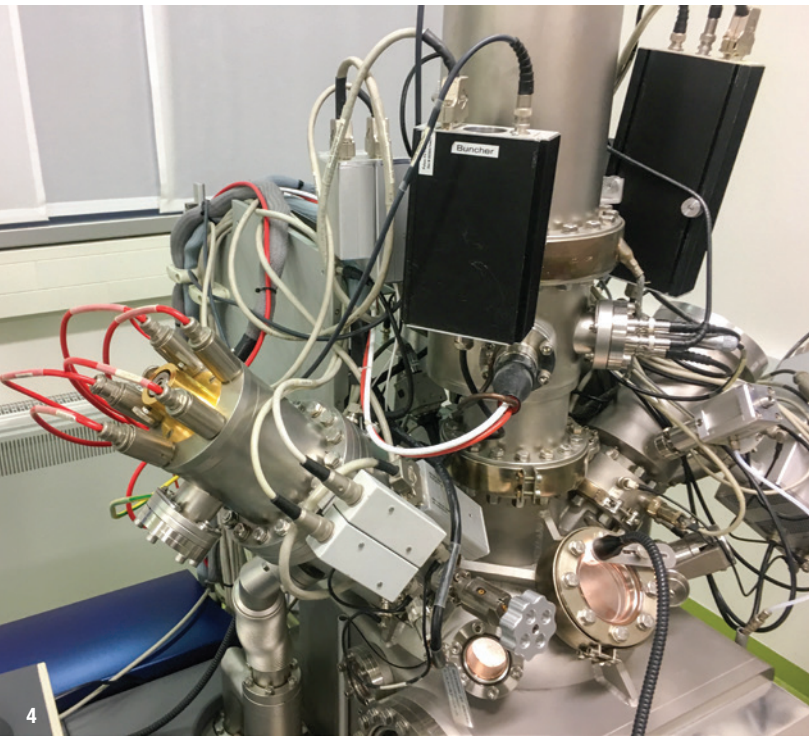
Fig. 4: Time-of-flight secondary ion mass spectrometry instrument (tascon).

Time-of-flight secondary ion mass spectrometry (ToF-SIMS) provides even more precise information about the chemical composition of an impurity. The method provides information on the atomic and molecular structure of the uppermost monolayers of a substrate on an analysis area of $500 \times 500 \mu\text{m}^2$ with sensitivity in the parts per million range and a lateral resolution of up to 100 nm. Comparison of the spectra with known substances allows precise material determination of the respective contamination (Fig. 4).

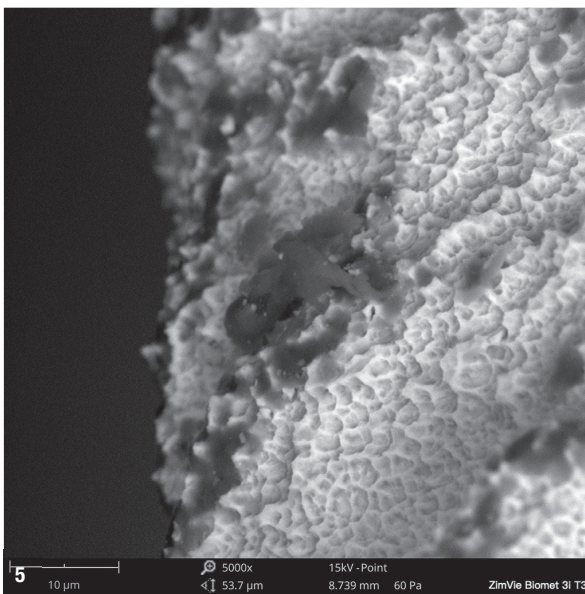
Fig. 5: Carbonaceous particles (polysiloxanes) on a titanium implant at the implant apex of a titanium implant (T3, ZimVie). SEM 500 \times magnification.

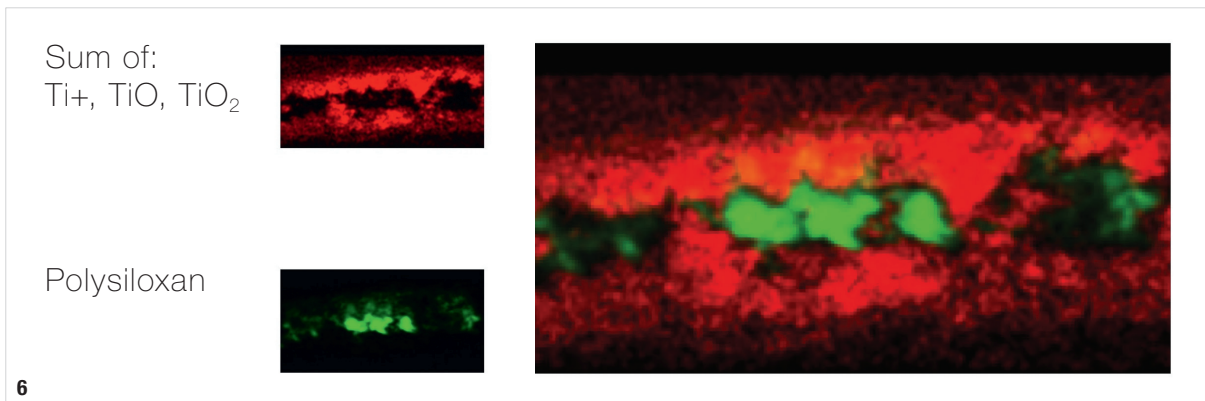
Fig. 6: Time-of-flight secondary ion mass spectrometry detection of polysiloxane on a titanium implant.
