How clean do **sterile** implants have to be?

Analysis and clinical relevance of **factory-related** contaminations

Dr Dirk U. Duddeck, Germany

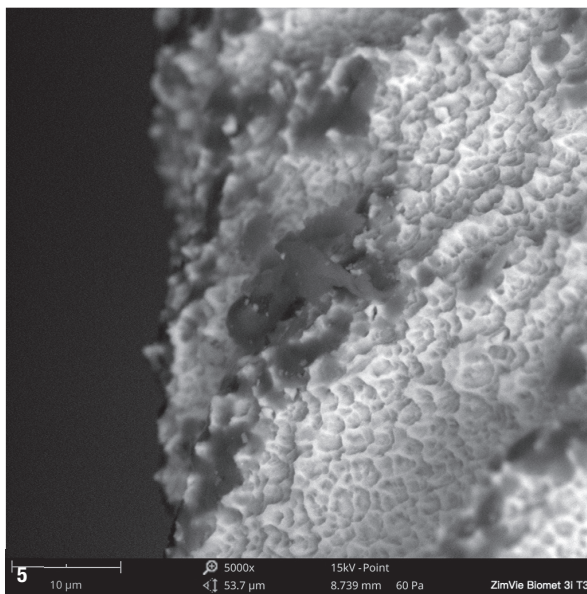
Fig. 5: Carbonaceous particles (polysiloxanes) on a titanium implant at the implant apex of a titanium implant (T3, ZimVie). SEM 500 \times magnification.

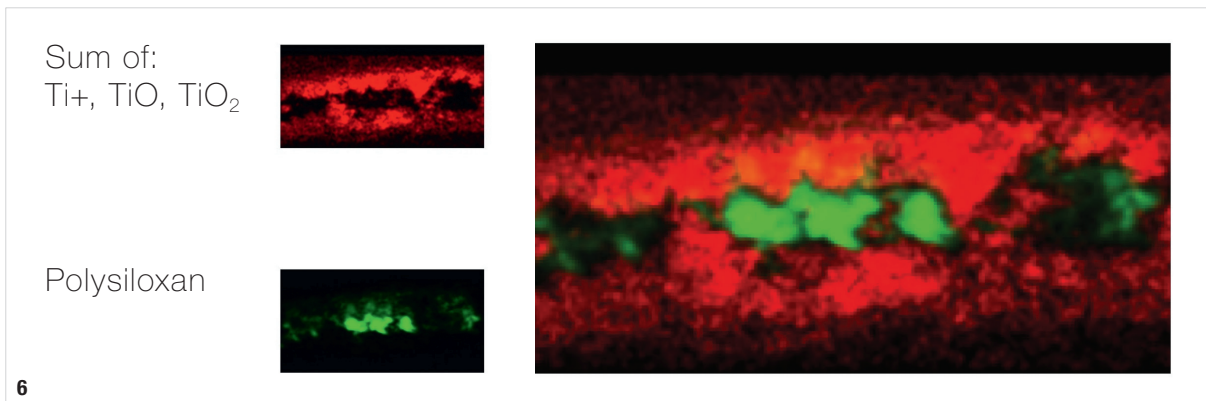
Fig. 6: Time-of-flight secondary ion mass spectrometry detection of polysiloxane on a titanium implant.
