A periodontal and restorative success formula

Rehabilitation of a failing central incisor

Dr Rita Singh, Nepal

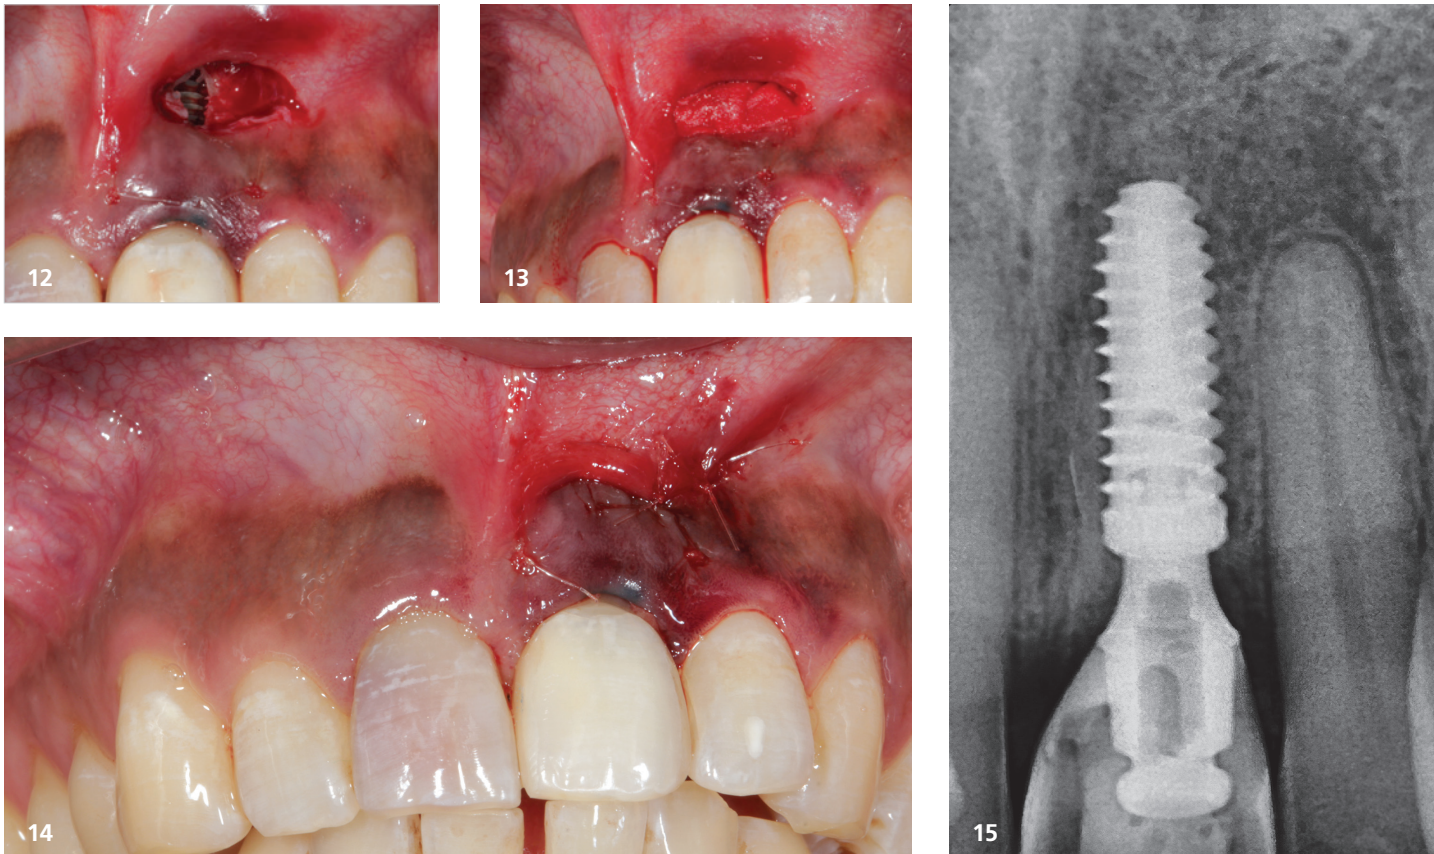
Fig. 12: Fenestration exposed with semilunar incision. **Fig. 13:** Guided bone regeneration done with bone grafting material and a membrane. **Fig. 14:** Tension-free closure. **Fig. 15:** Immediate post-op radiograph after seating of the provisional crowns.

Guided bone regeneration was done at the site of the fenestration to ensure bone filling of the defect. Guided bone regeneration provides an environment conducive to bone formation. A membrane is applied to exclude non-osteogenic tissue from interfering with bone regeneration. A semilunar incision was made on the mucogingival junction to expose the area of fenestration (Fig. 12). After debridement, 50/50 NonDemin mineralised cortical and cancellous human allograft (0.5cm³; Implants), along with autogenous bone, was mixed together with injectable platelet-rich fibrin to make sticky bone, which was then packed on the exposed implant side and later covered with a resorbable collagen bilayer membrane, and the flap was sutured with the same aforementioned suture thread (Figs. 13 & 14). An immediate postoperative radiograph was taken (Fig. 15).
