A periodontal and restorative success formula

Rehabilitation of a failing central incisor

Dr Rita Singh, Nepal

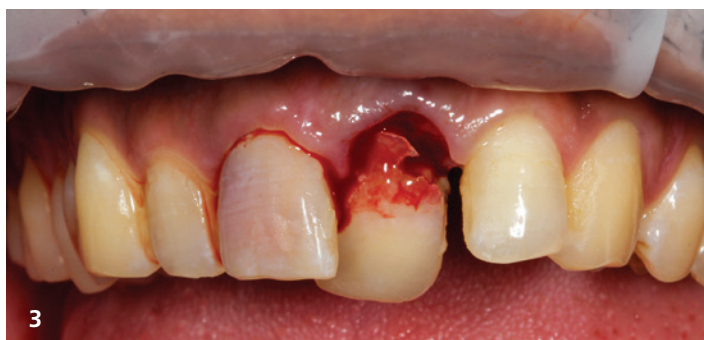
Fig. 3: Fractured cervical portion of tooth #21. **Fig. 4a:** Granulation tissue after extraction. **Fig. 4b:** Extraction socket after mechanical debridement. **Fig. 5:** HELBO antimicrobial photodynamic therapy. **Fig. 6:** Verifying implant position and angulation. **Fig. 7:** Implant placement 4 mm below the gingival margin, respecting biologic width.

The procedure was flapless in order to minimise hard- and soft-tissue trauma. The fractured portion of the tooth was gently removed with a tweezer and the remaining root was atraumatically luxated (Fig. 3). Thorough curettage was done to ensure the total removal of the granulation tissue (Figs. 4a & b). To ensure complete disinfection of the site, antimicrobial photodynamic therapy was done using the HELBO laser (bredent medical). Blue photosensitiser (methylene blue) was applied inside the socket and left *in situ* for 60 seconds to stain the bac-

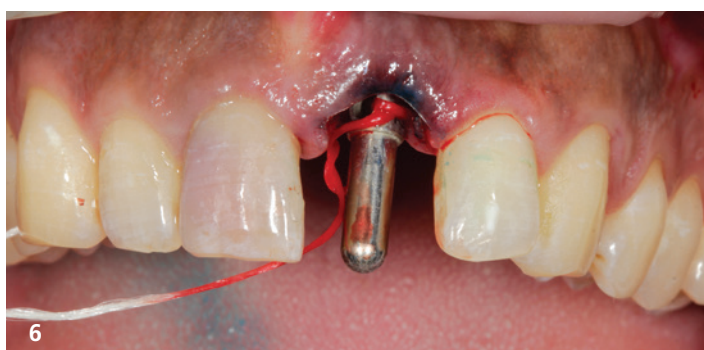
The implant osteotomy site was prepared with sequential drills, and 3D position verified with paralleling tools (Fig. 6). The implant (copaSKY, 4 × 12 mm; bredent medical) was placed with sufficient primary stability (torque of 45 Ncm), facilitating predictable immediate loading of the implant. The implant was placed 4 mm below the gingival margin to accommodate biologic width (Fig. 7).

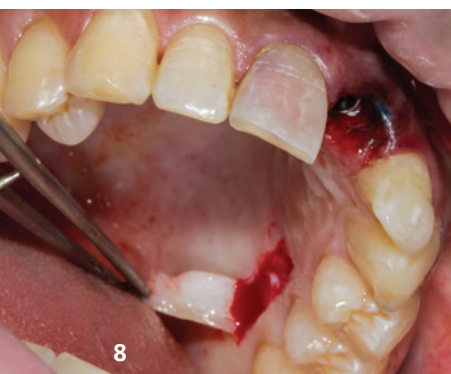
A free gingival graft was harvested from the palate, de-epithelialised and stabilised under the labial gingiva, as the existing labial tissue appeared thin (Fig. 8). The connective tissue graft was then stabilised with a sling suture using #6/0 Deme-

Fig. 8: Free gingival graft obtained from the palate. **Fig. 9:** De-epithelialised free gingival graft (connective tissue) stabilised in a pouch. **Fig. 10a:** CopaSKY exso abutment placed for provisionalisation. **Fig. 10b:** Putty index with extracted tooth for relining over the abutment. **Fig. 11:** Provisional crown highly polished extra-orally.

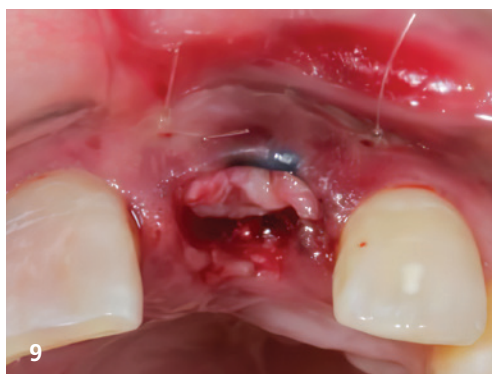
DIOX polydioxanone resorbable monofilament thread (DemeTECH; Fig. 9).

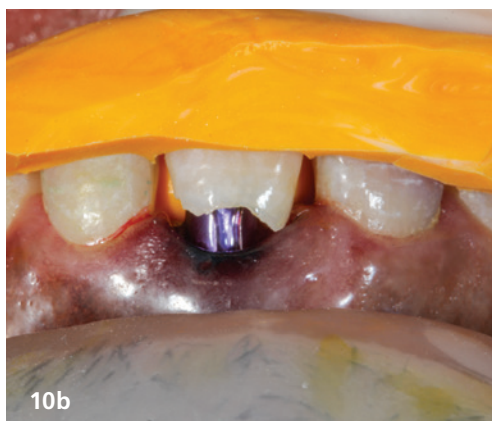
The extracted tooth was relined with flowable composite and used for the provisionalisation on an copaSKY exso abutment using the previously fabricated putty index (Figs. 10a & b). The screw-retained provisional restoration was polished extra-orally and the abutment screw torqued to 15Ncm (Fig. 11). The screw access channel was plugged with PTFE and composite and kept out of occlusal contact.

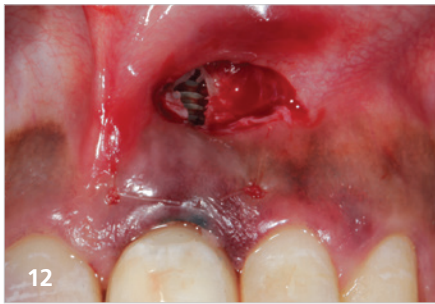
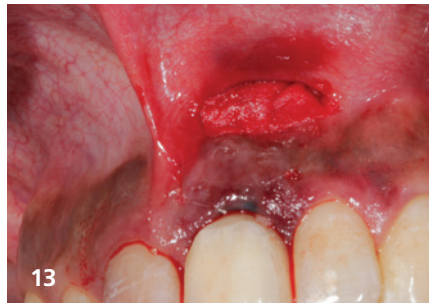
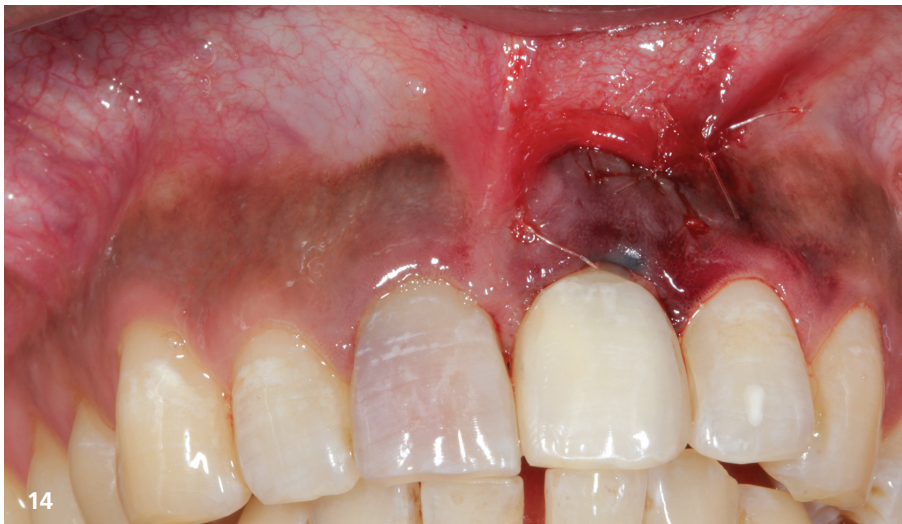
Guided bone regeneration was done at the site of the fenestration to ensure bone filling of the defect. Guided bone regeneration provides an environment conducive to bone formation. A membrane is applied to exclude non-osteogenic tissue from interfering with bone regeneration. A semilunar incision was made on the mucogingival junction to expose the area of fenestration (Fig. 12). After debridement, 50/50 NonDemin mineralised cortical and cancellous human allograft (0.5cm³; Implants), along with autogenous bone, was mixed together with injectable platelet-rich fibrin to make sticky bone, which was then packed on the exposed implant side and later covered with a resorbable collagen bilayer membrane, and the flap was sutured with the same aforementioned suture thread (Figs. 13 & 14). An immediate postoperative radiograph was taken (Fig. 15).

Fig. 12: Fenestration exposed with semilunar incision. **Fig. 13:** Guided bone regeneration done with bone grafting material and a membrane. **Fig. 14:** Tension-free closure. **Fig. 15:** Immediate post-op radiograph after seating of the provisional crowns.

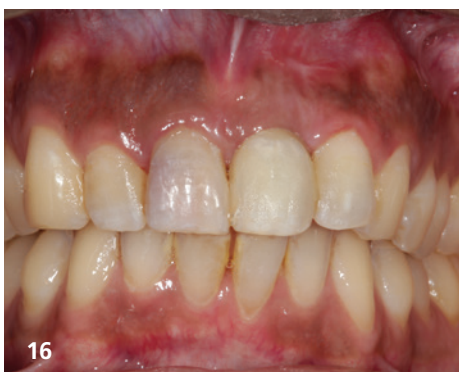
The screw-retained provisional crown was removed after four months, revealing healthy underlying tissue with well-maintained gingival contours (Figs. 16 & 17). The resonance frequency analysis performed with the bredent penguinRFA revealed an implant stability quotient value of 86, indicating sound osseointegration and implant stability. An analogue impression was taken with customised impression copings to register the soft-tissue contour (Fig. 18). The crowns were digitally fabricated by the technician (Fig. 19). For the implant crown, a titanium base was used and a single zirconia crown with a palatal screw access channel was fabricated. In addition, the adjacent tooth #11 was prepared for a definitive zirconia crown. The definitive implant crown was cemented extra-orally, steam-cleaned, torqued to 25Ncm and plugged with PTFE and composite intra-orally (Fig. 20). A postoperative radiograph was taken after the definitive restoration, and an excellent aesthetic outcome was achieved (Figs. 21 & 22).

Fig. 16: Four-month post-op clinical evaluation, showing maintenance of the gingival contours. **Fig. 17:** Removal of the prosthesis revealed healthy underlying tissue. **Fig. 18:** Customised impression coping for recording soft-tissue contour.

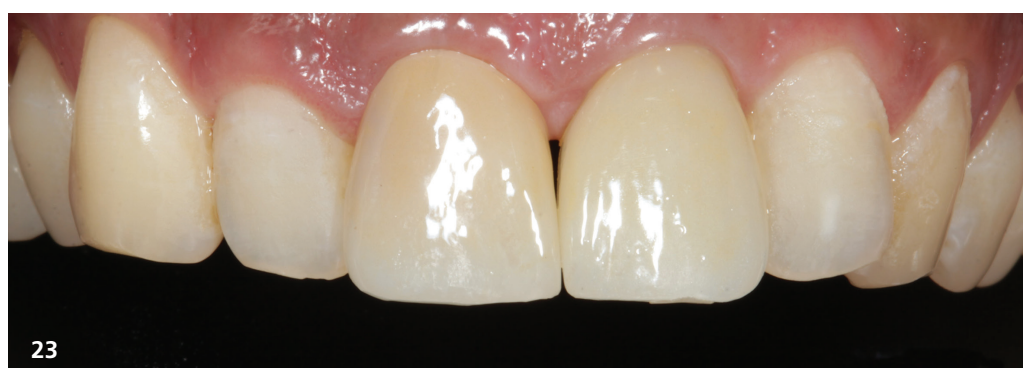
23

Clinical examination after six months revealed a healthy peri-implant mucosa and no bleeding on probing. The patient was satisfied with the results (Fig. 23). Furthermore, a six-month postoperative radiograph revealed maintained crestal bone levels (Fig. 24).

Fig. 21: Immediate post-op radiograph after placement of the definitive crowns. **Fig. 22:** Definitive restorations of teeth #11 and 21. **Fig. 23:** Six-month follow-up clinical image. **Fig. 24:** Six-month follow-up radiograph.
