## A periodontal and restorative success formula

# Rehabilitation of a failing central incisor

Dr Rita Singh, Nepal

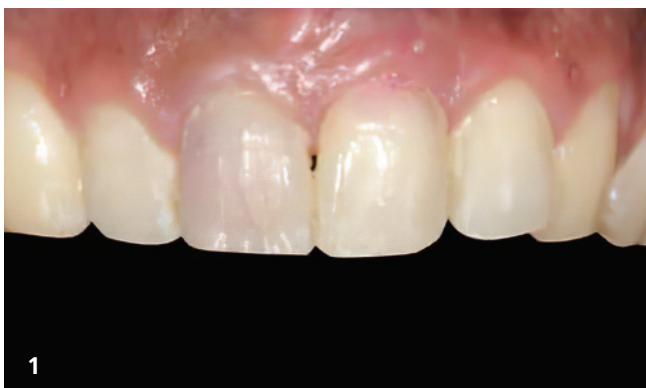
**Fig. 1:** Pre-op clinical image showing the affected teeth #11 and 21. **Fig. 2:** CBCT evaluation showing fenestration at tooth #21.

The patient presented with the chief complaint of discomfort and mild mobility of the maxillary left central incisor and gave a history of trauma to the same jaw region about ten to twelve years before that had led to avulsion of the same tooth, following which the tooth was replanted. The right central incisor showed purple discoloration and required endodontic re-treatment (Fig. 1)

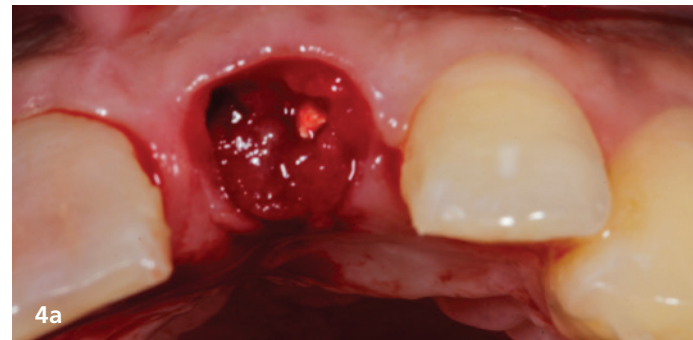
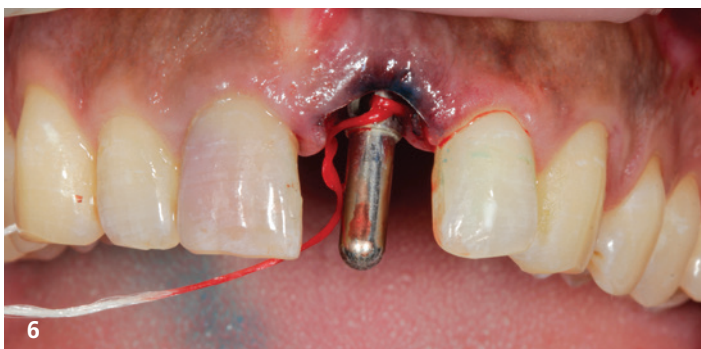
**Fig. 3:** Fractured cervical portion of tooth #21. **Fig. 4a:** Granulation tissue after extraction. **Fig. 4b:** Extraction socket after mechanical debridement. **Fig. 5:** HELBO antimicrobial photodynamic therapy. **Fig. 6:** Verifying implant position and angulation. **Fig. 7:** Implant placement 4 mm below the gingival margin, respecting biologic width.

The procedure was flapless in order to minimise hard- and soft-tissue trauma. The fractured portion of the tooth was gently removed with a tweezer and the remaining root was atraumatically luxated (Fig. 3). Thorough curettage was done to ensure the total removal of the granulation tissue (Figs. 4a & b). To ensure complete disinfection of the site, antimicrobial photodynamic therapy was done using the HELBO laser (bredent medical). Blue photosensitiser (methylene blue) was applied inside the socket and left *in situ* for 60 seconds to stain the bac-

teria. After the dye had been rinsed off, the socket was then exposed to the HELBO TheraLite diode laser for 1 minute (Fig. 5). This ensures focused antibacterial action by singlet oxygen molecules, destroying bacteria in the biofilm.

The implant osteotomy site was prepared with sequential drills, and 3D position verified with paralleling tools (Fig. 6). The implant (copaSKY, 4 × 12 mm; bredent medical) was placed with sufficient primary stability (torque of 45 Ncm), facilitating predictable immediate loading of the implant. The implant was placed 4 mm below the gingival margin to accommodate biologic width (Fig. 7).
