## A periodontal and restorative success formula

# Rehabilitation of a failing central incisor

Dr Rita Singh, Nepal

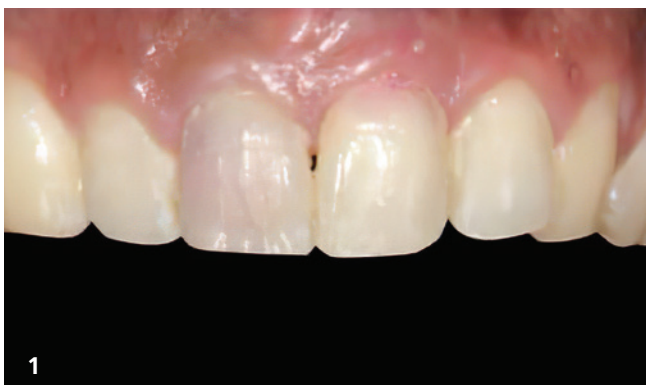
**Fig. 1:** Pre-op clinical image showing the affected teeth #11 and 21. **Fig. 2:** CBCT evaluation showing fenestration at tooth #21.

The patient presented with the chief complaint of discomfort and mild mobility of the maxillary left central incisor and gave a history of trauma to the same jaw region about ten to twelve years before that had led to avulsion of the same tooth, following which the tooth was replanted. The right central incisor showed purple discoloration and required endodontic re-treatment (Fig. 1)

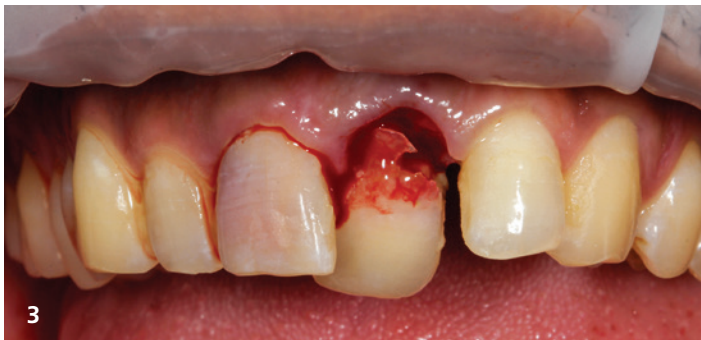
**Fig. 3:** Fractured cervical portion of tooth #21. **Fig. 4a:** Granulation tissue after extraction. **Fig. 4b:** Extraction socket after mechanical debridement. **Fig. 5:** HELBO antimicrobial photodynamic therapy. **Fig. 6:** Verifying implant position and angulation. **Fig. 7:** Implant placement 4 mm below the gingival margin, respecting biologic width.

The procedure was flapless in order to minimise hard- and soft-tissue trauma. The fractured portion of the tooth was gently removed with a tweezer and the remaining root was atraumatically luxated (Fig. 3). Thorough curettage was done to ensure the total removal of the granulation tissue (Figs. 4a & b). To ensure complete disinfection of the site, antimicrobial photodynamic therapy was done using the HELBO laser (bredent medical). Blue photosensitiser (methylene blue) was applied inside the socket and left *in situ* for 60 seconds to stain the bac-
