# Precautions for using zirconia implant abutments

**authors** Moustafa N Aboushelib\*, Egypt, and Rien van Paridon\*\*, Netherlands

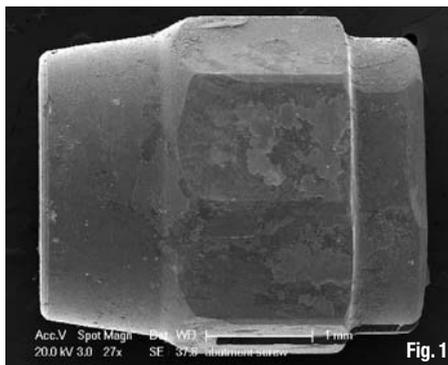
**Fig. 1** SEM image, 27x. Internal metallic nut which depends on friction fit inside the zirconia implant abutment.

This problem is solved by insertion of a friction fit internal metallic nut (Procera zirconia abutment for Strauman implants) which is equipped with an external hex for establishment of proper contact with the implant body (Fig. 1). Additionally, the fixation screw interlocks with the metallic nut during tightening procedure (Fig. 2). This design is associated with the problem of generation of internal stresses which could lead to unexpected fracture of the zirconia implant abutment. This article evaluated the fracture causes of several broken zirconia implant abutments. Fractographic analysis of the broken segments allowed recognition of the location and site of the critical fracture.

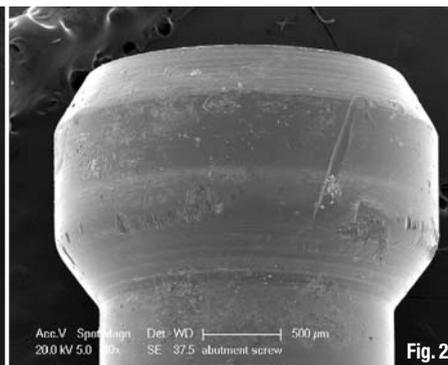
**Fig. 2** SEM image, 10x. The metallic fixation screw used to press on the metallic nut for providing adequate retention with the implant body.

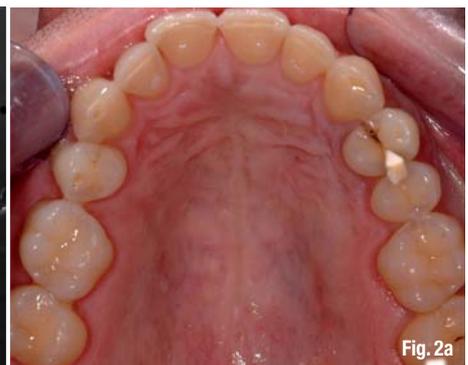
**Fig. 2a** A broken maxillary premolar was extracted and implant was immediately inserted.

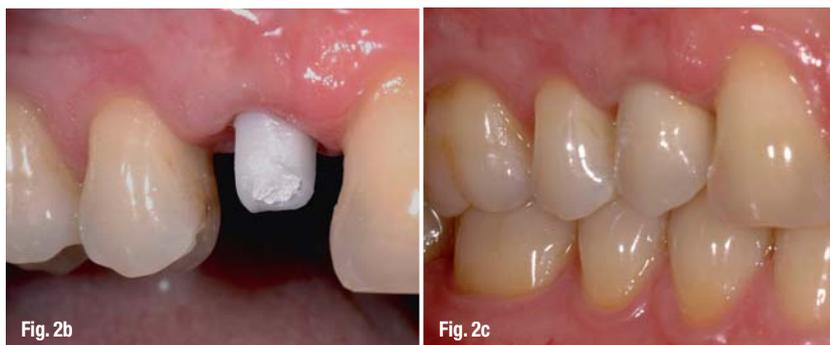
**Fig. 2b\_** Procera zirconia abutment. **Fig. 2c\_** Procera zirconia veneered crown inserted over the zirconia abutment.

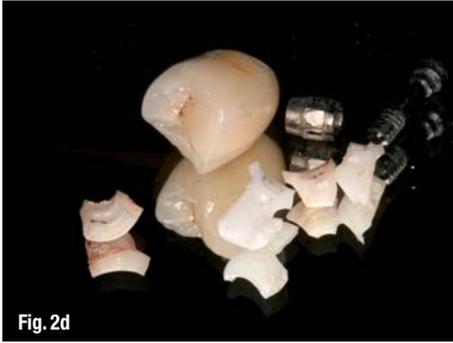
Fig. 2d

records indicated that the patient complained of loosening of the implant supported zirconia veneered crown (tooth 21). The treating dentist also complained that the internal metallic nut lost friction contact with the zirconia abutment and that he had to re-assemble the components before screw fixation. The abutment was fractured after two incidence of screw loosening. The same problem led to fracture of the second abutment after which the dentist decided to insert a titanium abutment. Scanning electron microscopic examination indicated that the abutment was fractured due to pressure from the metallic screw nut.

**Fig. 2d\_** The first and the second Procera zirconia abutments were fractured after short period of service intra-orally.

Once the metallic nut has lost friction fit with the zirconia abutment it can not be correctly reinserted inside the abutment and areas of friction contact between the improperly assembled components could lead to generation of high internal stresses causing fracture of the zirconia implant abutment as was reported for the two examined abutments. A new abutment should be used in such case.

Analysis of the broken zirconia implant abutment gave insight about the cause of fracture. For Procera abutments with the metallic nut, the friction fit system lost adequate retention after a short service time in the mouth leading to loosening of the inserted restorations. According to complains of the treating dentists, it is not recommended to re-assemble the metallic nut and tighten the fixation screw as this will not result in reliable retention of the restoration. In such case, it is recommended to insert a new abutment from the manufacturer using patient's records.

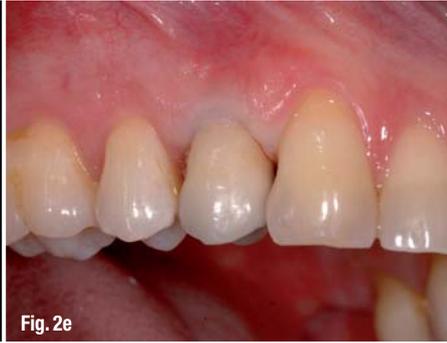
Fig. 2e

**Fig. 2e\_** A new zirconia veneered crown was inserted over a titanium abutment. Observe the grayish color at the cervical margin.

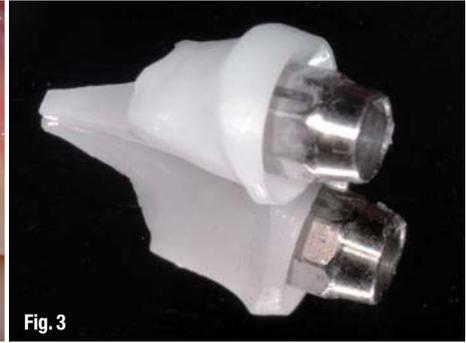
Fig. 3

A broken zirconia implant abutment was examined. SEM analysis revealed that it was an angled abutment which corrected the tilt of an implant replacing a maxillary lateral incisor. The entire buccal wall was fractured beneath the temporarily cemented zirconia veneered crown.

**Fig. 3\_** Digital image demonstrating a fractured zirconia abutment due to over reduction of the buccal wall.

Zirconia is a brittle ceramic material that must be used in adequate thickness to gain full potential of its high strength. A minimal wall thickness (0.5-0.7mm) is required in the entire structure of the zirconia implant abutment. This thickness must be increased in areas of high stresses to avoid unexpected fracture. Tilt correction—resulted in over reduction of the buccal wall (0.3 mm thickness) which resulted in fracture of the weakened segment. To reduce possibility of fracture, it is recommend to use a metallic abutment for correction of angle of insertion.

Moreover, over tightening the fixation screw beyond the recommended torque could lead to generation of wedging forces inside the zirconia abutment. The screw head could exert pressure on the metallic nut leading to spreading of its vertical walls. Using a confirmatory X-ray before tightening the fixation screw and restriction to the recommended torque could prevent such problem. For cases with marked angle correction, it is recommended to use a metallic abutment in order to avoid over reduction of its axial walls.

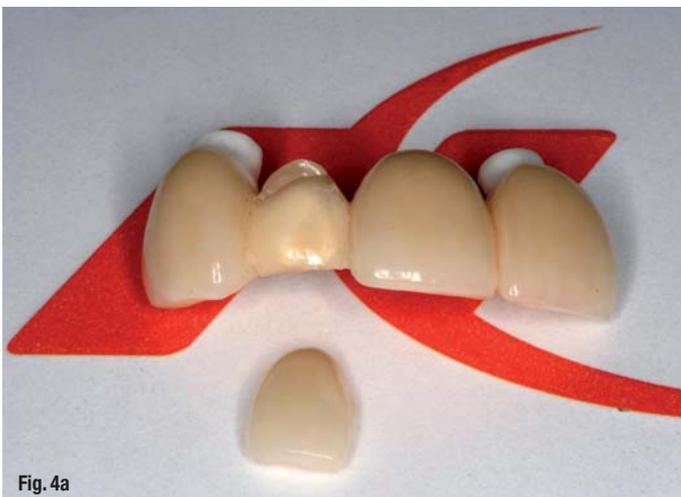
Fig. 4a

A broken veneer porcelain from a Procera zirconia superstructure. This new design combines both the implant abutment and the framework of the restoration in one single structure thus reducing the number of components the dentist uses during the prosthetic phase.

**Fig. 4a\_** Digital image of a broken veneer porcelain from a four unit implant supported fixed partial denture.

Using single component superstructures has several advantages as it simplify the handling procedure, does not require anti-rotation feature, and reduces the num-

ber of structural interfaces of the entire restoration. On the other hand, it requires careful design to provide adequate support for the veneer ceramic.

On the other hand, using single component zirconia implant superstructure which is composed of zirconia abutment and the framework as one component could facilitate easier handling and simplify insertion procedure due to reduction of the components used. Moreover, careful design consideration of the requirements of both the abutment and the zirconia framework is mandatory to ensure good function of each element. Lack of adequate support beneath the veneer ceramic or over reduction of the axial walls of the zirconia abutment could lead to unexpected fracture.

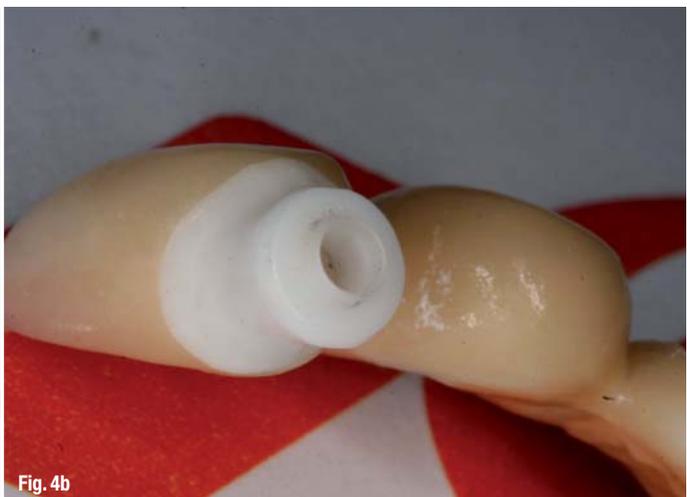
Fig. 4b

This single component zirconia structure does not utilize an internal metallic nut for achieving contact with the implant body. On the contrary, this single component super structure utilizes directly the fixation screw to obtain direct fixation to the implant body.

**Fig. 4b\_** Digital image demonstrating the contact surface with the implant body. Antirotation is not required for this fixed partial denture as the whole framework and the implant abutment are joined into a single superstructure.
