Comparing various implant designs and surfaces

A clinical study

_Abstract

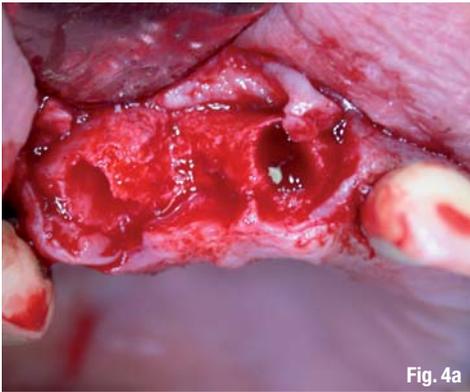
Fig. 4a

Fig. 4a_Extraction of central incisor and canine.

The objective of the study was to present the success rate of fixtures of different designs and surfaces used in complex implant procedures, implants placed in internal sinus lift procedures (Figs. 1a–b), implants placed in lateral sinus lift procedures (Figs. 2a–b) bone augmentations, implants placed including grafting of buccal defect (Figs. 3a–d), and implants placed simultaneously with teeth extractions (Figs. 4a–d), all performed by one team.

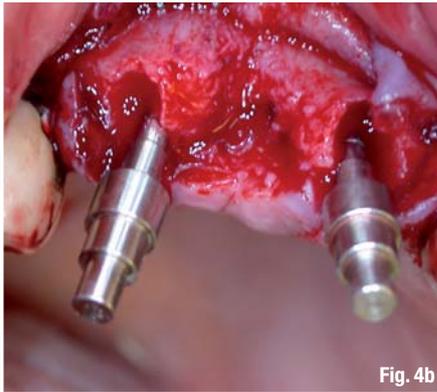
Fig. 4b

Fig. 4b_Parallelizing tools in extraction sites.

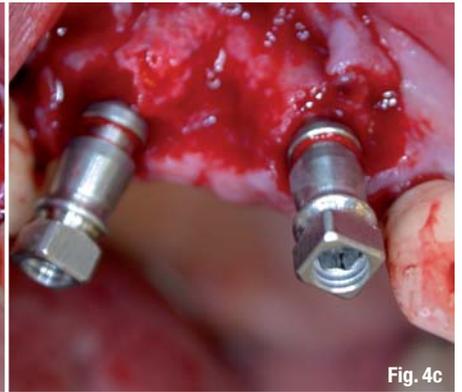
Fig. 4c

Fig. 4c_Two 3.75 mm Tapered Self Thread Implant placed in the fresh sockets.

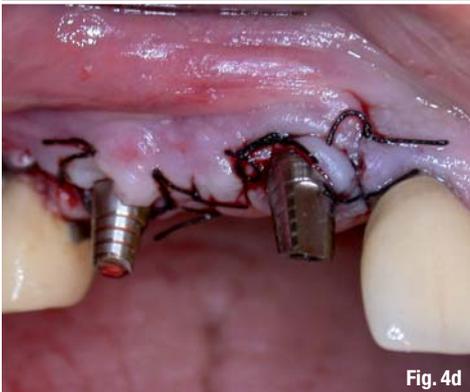
Fig. 4d

Fig. 4d_Abutments placed on implants for immediate provisional restoration.
