Implant-prosthetic troubleshooting

When dental technicians and dentists break into a sweat!

Authors_Dr Georg Bach & Christian Müller, Germany

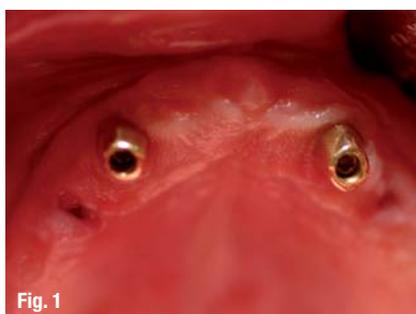
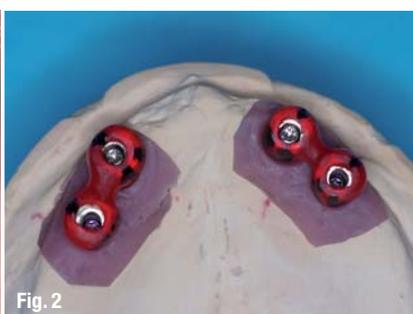
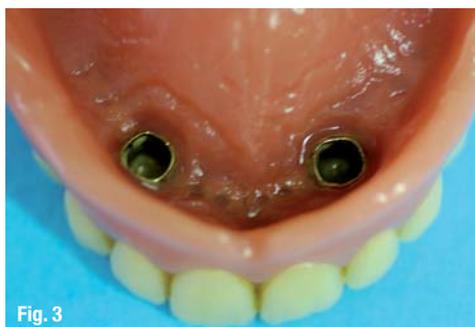
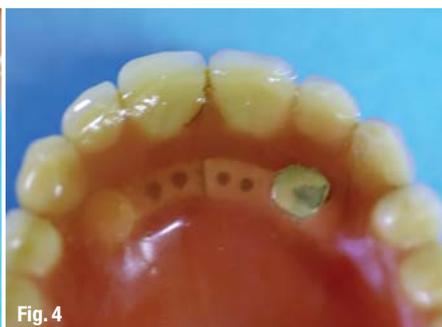
Unidentified jaw misalignment
Figs. 1–4 The former prosthesis (with two maxillary implants); note the discrepancy between the translucent templates and the axis of the plastic front teeth.

Just by looking at the maxillary prosthesis it was easy to notice the metal portions of the prosthesis, which were placed extremely palatally, showing through. An examination of the oral cavity revealed a considerable discrepancy between the implant placement and the axis of the plastic front teeth!

A wax-up marked the beginning of the actual treatment. It was modified until the patient was satisfied with the placement of his teeth and his subsequent appearance. Based on the results of this treatment planning, we were able to determine which position and alignment would be required for two additional implants (distally of the existing ones).

This in turn resulted in the creation of a drilling template, which was used during the insertion of the two additional artificial abutment teeth. After osseointegration of these two implants in regions #14 and 24, the new partial prosthesis (now supported by four implants (two existing and two new ones) was produced and integrated step by step.

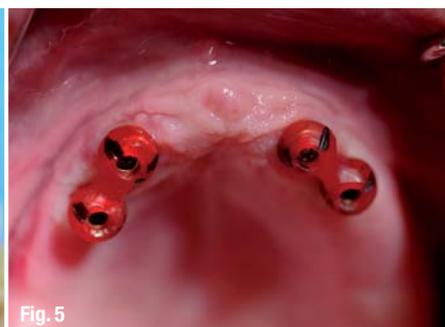
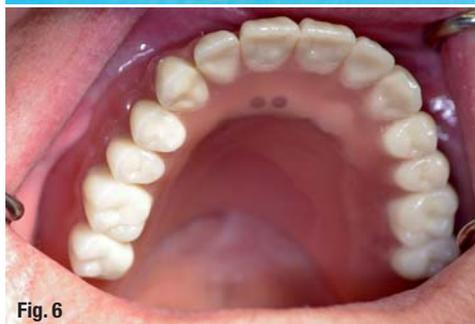
Figs. 5 & 6 After interdisciplinary planning between dental technician and dentist, two additional distally located implants were inserted; the four artificial abutment teeth each received a telescopic crown. We used individual insertion keys to facilitate incorporation of the telescopes.

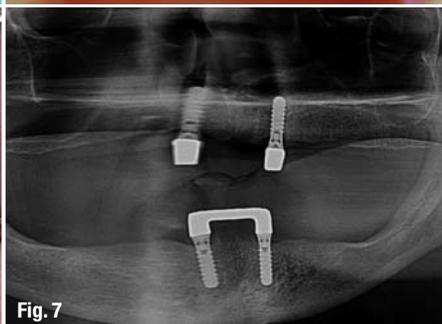
Fig. 7 Initial X-ray image (panoramic tomography) with two implants (treated with telescopes) in the maxilla.

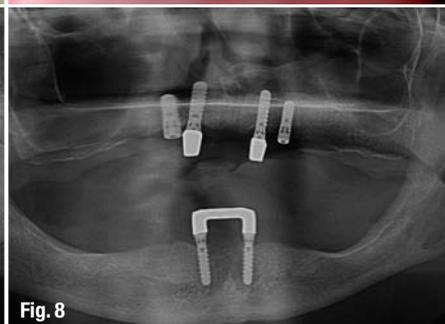
Fig. 8 Condition after the increase of abutment teeth in the maxilla, each inserted distally of the previous implants.

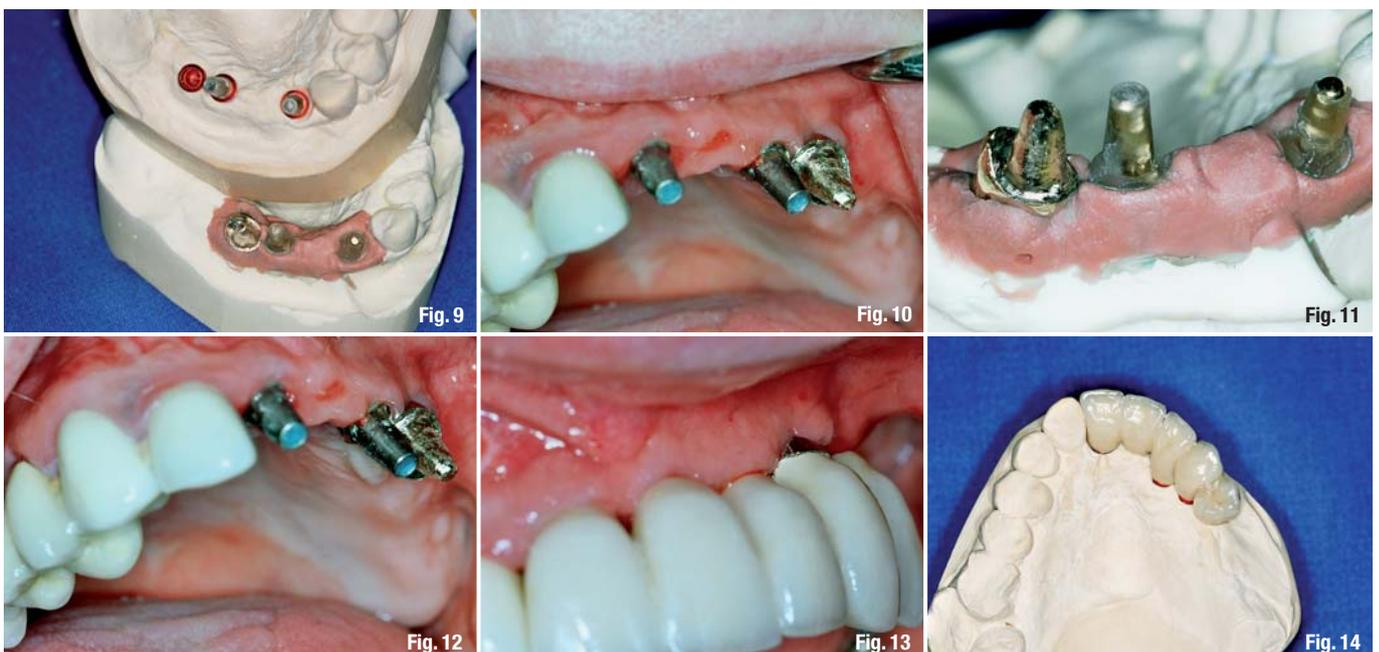
Fig. 9 The mesial abutment tooth of a bridge entirely supported by implants in the left maxilla was lost. After healing of the soft tissue, a further implant was inserted in a position as close as possible to the former implant position. The illustration shows the dental master model with the customised abutment.

Fig. 10 The former bridge structure was used as a customised "spoon" for the newly added implant so that a customised abutment could be created for the additional implant to be mounted distally (note the loss of vertical distance) for use in the existing restoration.

Fig. 11_ Customised abutment tooth as a terminal abutment.

Fig. 12_ Patient's oral condition.

Figs. 13 & 14_ We were able to preserve the bridge in the left maxilla.

A new implant was inserted after the soft tissue and bone had healed in the area where the lost implant had previously been in place. The bridge structure that had been temporarily affixed on the remaining implant was used as guidance for incorporation of a replacement implant and then removed for the actual implant procedure.

After osseointegration of the artificial abutment tooth, we inserted a plastic abutment and made a casting of the integrated bridge structure with polyether casting material. This customised abutment was transformed into metal and the bridge structure finally cemented in place after a trial insertion.

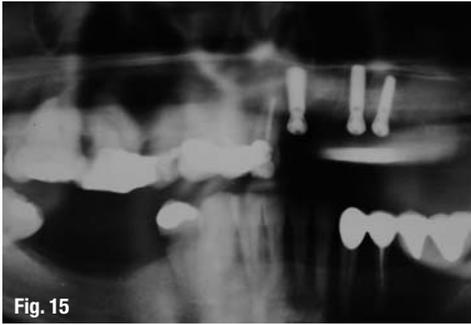
Fig. 15

Fig. 15_ Three implants had originally been inserted to treat anodontia in the second quadrant.

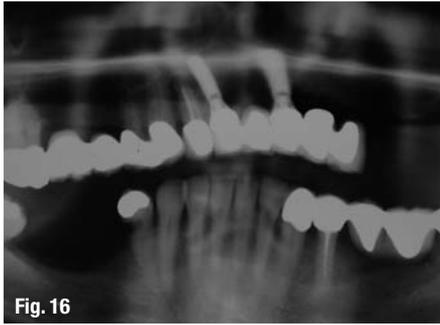
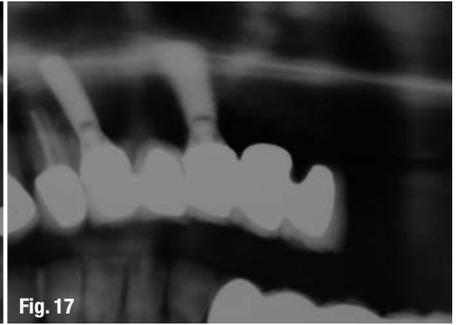
Figs. 16 & 17_ The distal implant was lost; the detailed view shows the non-functional crown #25.

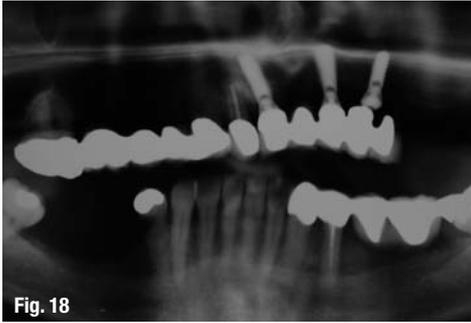
Fig. 18

Fig. 18_ Condition after re-implantation distally of the implant localization.

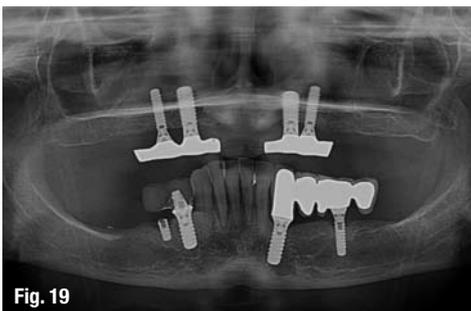
Fig. 19

Fig. 19_ The distal (diameter-reduced) implant of a bridge supported entirely by fractured implants.

The case presented here reflects the typical progress of this early phase. A purely implant-supported (two abutments) extension bridge was incorporated into the fourth quadrant. A diameter-reduced implant was used in spite of an orovestibular bone dimension that would have been sufficient for supporting a standard implant. The result was that the distal implant fractured after eight years.

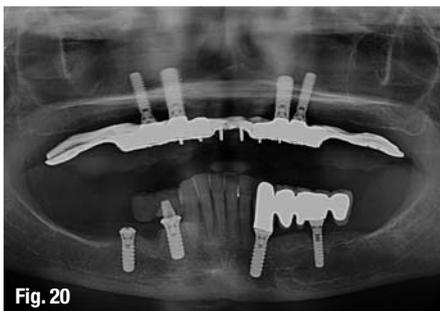
Fig. 20

Fig. 20_ An additional implant was inserted distally after removal of the fragment that had remained in the bone. After integration of the implant, a new bridge supported entirely by implants was created, while incorporating the former implant.

In one surgical session, we removed both the implant fragment remaining in the bone by way of an osteotomy and placed a further distal im-

plant. After its osseointegration, we incorporated a completely new bridge using the existing mesial implant.

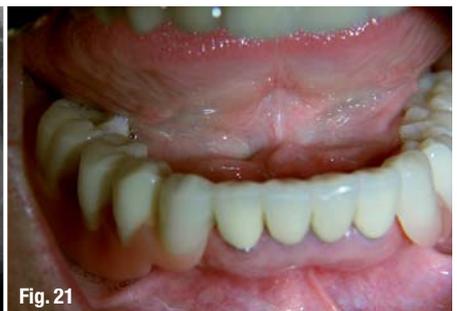
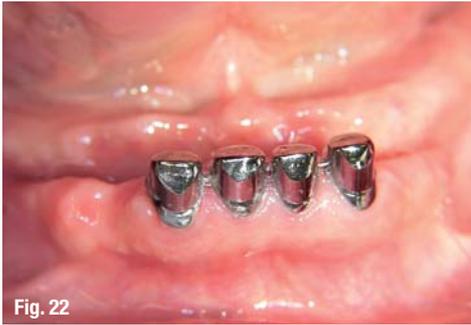
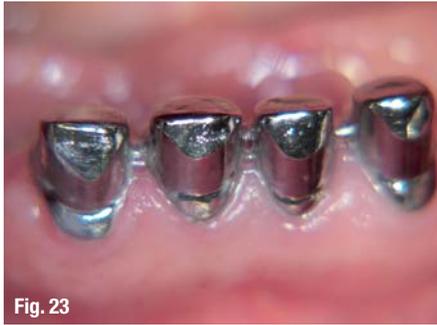
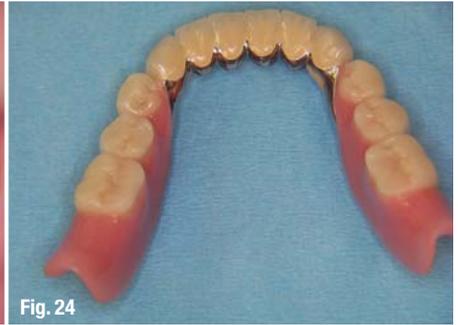
Figs. 21–25 Owing to the loss of prospective abutment teeth #43 and 33 during the prosthetic treatment phase, the remaining front teeth #42, 41, 31 and 32 received telescopic crowns.

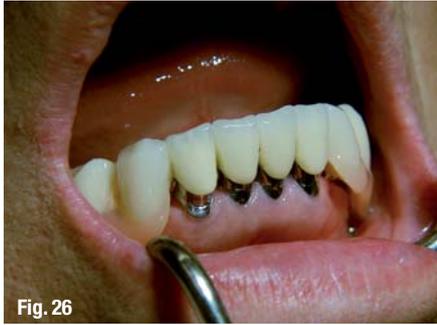
Fig. 26 The partial prosthesis showed insufficient mounting.

Anchoring of the partial prosthesis was poor; the patient was able to loosen it with minimal tongue-applied pressure. The pronounced tendency of the prosthesis saddles to cave in also resulted in complications in the form of multiple recurrent pressure sores. The patient was referred to us at this point. The reason for this according to her dentist was that implants, which the patient had inquired about, could be inserted

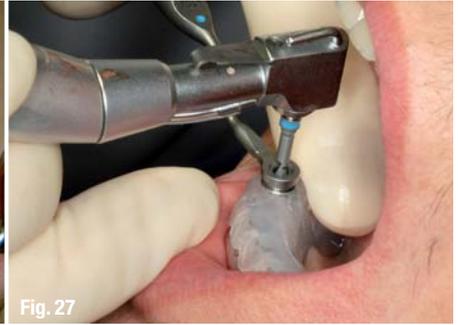
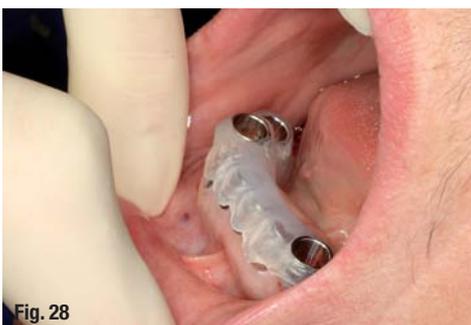
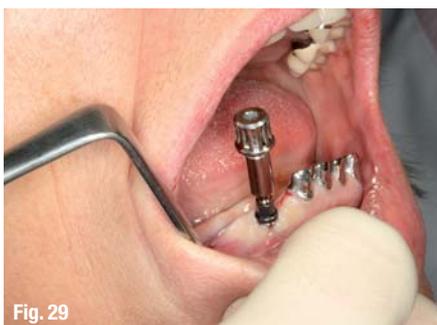
Figs. 27–29 With the aid of 3-D imaging and planning, four implants were inserted in regions #46, 43, 33 and 36—without any augmentative treatment.

The remaining front teeth proved very helpful as a place for securely anchoring the template. By opting for a shortened row of teeth with one implant each in the region of the former six-year molars and an additional artificial abutment in each of the former cuspid areas, we were able to keep the dimensions of the template relatively small.

The insertion of four implants in the regions of teeth #46, 43, 33 and 36 and their osseointegration were followed by treatment with the supra-structures, which consisted of two bridges in regions #46 to 43 and 33 to 36, entirely supported by implants, and four individual crowns on the

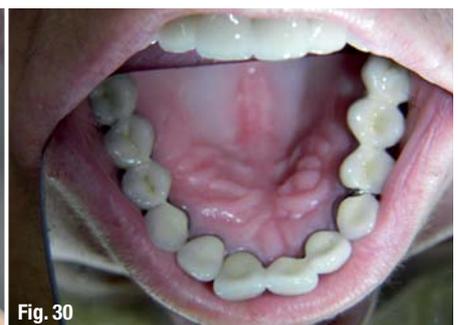
Fig. 30 After osseointegration of the artificial abutment teeth, two side-tooth bridges entirely supported by implants and four individual crowns were integrated with the remaining mandibular teeth.

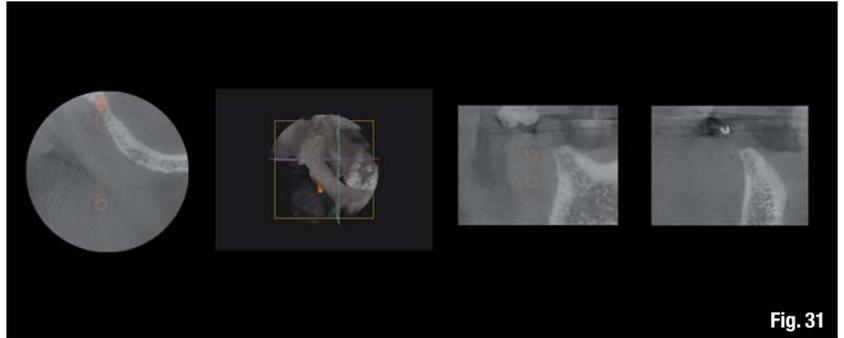
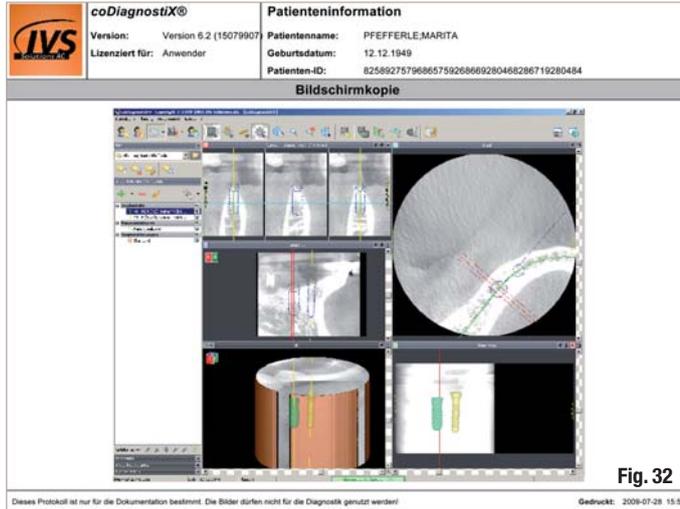
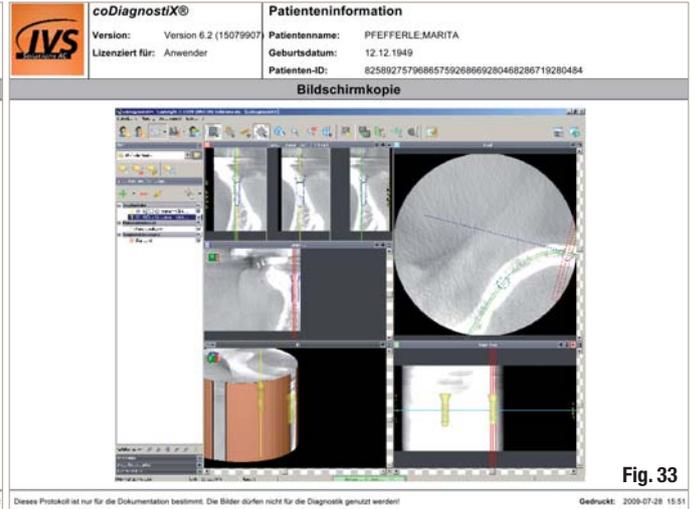
The patient thus showed considerable osseous deficits in both the oro-vestibular and horizontal dimension. In order to assess the basic possibilities of oral implants, we decided to perform 3-D imaging, which proved extremely helpful in this complex patient case. After illustration of the osseous situation, there were indications that implantation would be possible without carrying out augmentation procedures. We then prepared a virtual implant plan, the results of which led us to prepare a drilling template.

Figs. 31–33_Three-dimensional diagnosis and planning (see dental pins) of the third and fourth quadrant. **Fig. 34**_Orthopantomogram after incorporation of four implants, three of which were diameter-reduced Roxolid (Straumann) implants.
