# Second implantation after **implant fracture**

**Authors**\_Dr Michael Hopp, Andreas Klar, Prof Dr Reiner Biffar, Germany

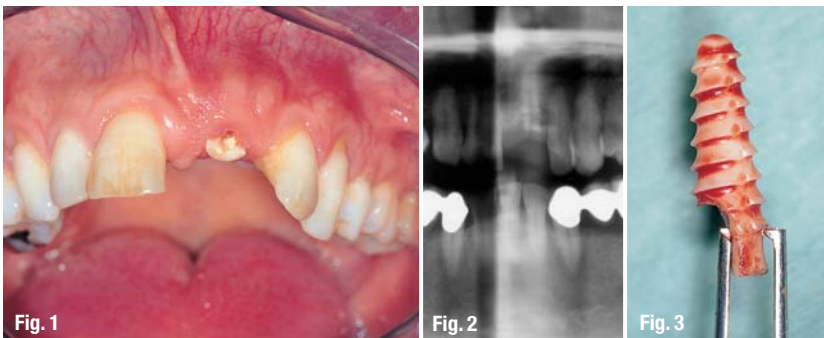
- Fig. 1**\_Original situation following fracture, frontal view.
- Fig. 2**\_X-ray (section) of the fractured implant.
- Fig. 3**\_Fractured implant.
- Fig. 4**\_Pilot drilling to extend the depth of the implant cavity.
- Fig. 5**\_After mechanical preparation of the implant cavity the cutter is now applied.
- Fig. 6**\_After the thread is cut the implant is placed in the bony cavity.
- Fig. 7**\_Implant in situ.
- Fig. 8**\_Suture closure of the trapezoidal flap.

gion of the neck, losing the prosthetic crown (Fig. 1). Figure 2 shows the situation on an X-ray image. The patient was treated with antibiotics (Clindamycin 900 mg/d), the planned intervention was explained to the patient and the removal of the implant and new implant planned for two days later. After preparation of a trapezial flap with a crestal incision and removal of the ceramic implant (Fig. 3), the deep-seated epithelium and connective tissue was removed and the remaining bony cavity prepared for the placement of a new implant with a greater diameter (Fig. 4). The remaining implant bed was revealed to be a very solid cortical structure, such that a thread had to be pre-cut for the new implant (Fig. 5). The IMPLA implant (Schütz Dental Group, Rosbach), 14.5 millimetres in length and with a diameter of 5.3 millimetres, was inserted and the insertion aid was removed (Figs. 6 & 7). To compensate for the loss in bone height in the crestal region, an augmentation was carried out using BioOss (Geistlich) and covered with the resorbable membrane, Ossequest (W. L. Gore, Putzbrunn). The membrane was fixed in place using the implant's cover screw and the margins of

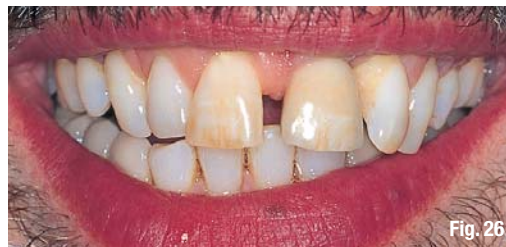
**Fig. 22** The gap requiring restoration.  
**Fig. 23** Fired ceramic crown.  
**Fig. 24** Inserted abutment.  
**Fig. 25** Crown in situ.

**Fig. 26** Oral situation.

the open tray technique (Fig. 16). The model made from type-IV gypsum with a gingival mask permits the production of an aesthetically high-quality crown (Fig. 17). An angled abutment was selected to correct the angulation and adapted to follow the line of the gingiva (Fig. 18). The internal hexagon connection prevents rotation (Fig. 19). A cementable metal ceramic crown, based on an alloy with a high gold content that can be fired, completes the restoration (Fig. 20). The diastema at the front was left in accordance with the patient's wishes, as was the slightly rotated and paradontally worn no. 2 (Fig. 21). The otherwise triangular crown of the no.1 was rounded off distally so that the papillary triangle between 21 and 22 was less prominent. The colour was adjusted to the lively colour of 11 in the laboratory in the presence of the patient (Figs. 22 & 23). The abutment (Fig. 24) was screwed in at a torque of 20 N/cm and the crown was inserted for three weeks on a provisional basis (Fig. 25).

Final cementing has not yet been carried out as the temporary cementing is very stable and it was not possible to remove the crown using adequate means. Figure 26 shows the lips and a portrait of the patient. The functional and aesthetic restoration was therefore successful.
