Second implantation after **implant fracture**

Authors_Dr Michael Hopp, Andreas Klar, Prof Dr Reiner Biffar, Germany

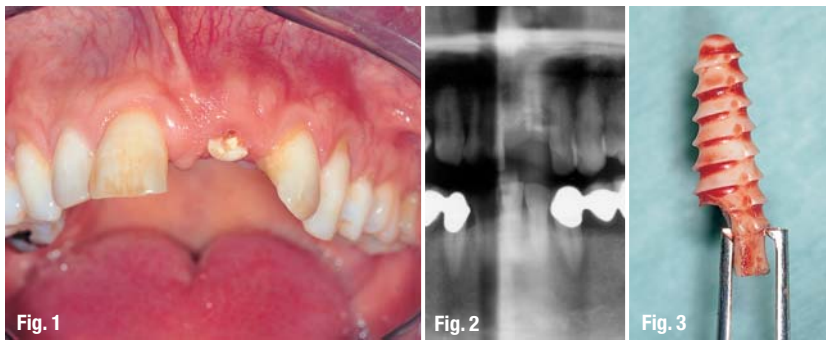
- Fig. 1** _Original situation following fracture, frontal view.
- Fig. 2** _X-ray (section) of the fractured implant.
- Fig. 3** _Fractured implant.
- Fig. 4** _Pilot drilling to extend the depth of the implant cavity.
- Fig. 5** _After mechanical preparation of the implant cavity the cutter is now applied.
- Fig. 6** _After the thread is cut the implant is placed in the bony cavity.
- Fig. 7** _Implant in situ.
- Fig. 8** _Suture closure of the trapezoidal flap.

gion of the neck, losing the prosthetic crown (Fig. 1). Figure 2 shows the situation on an X-ray image. The patient was treated with antibiotics (Clindamycin 900 mg/d), the planned intervention was explained to the patient and the removal of the implant and new implant planned for two days later. After preparation of a trapezial flap with a crestal incision and removal of the ceramic implant (Fig. 3), the deep-seated epithelium and connective tissue was removed and the remaining bony cavity prepared for the placement of a new implant with a greater diameter (Fig. 4). The remaining implant bed was revealed to be a very solid cortical structure, such that a thread had to be pre-cut for the new implant (Fig. 5). The IMPLA implant (Schütz Dental Group, Rosbach), 14.5 millimetres in length and with a diameter of 5.3 millimetres, was inserted and the insertion aid was removed (Figs. 6 & 7). To compensate for the loss in bone height in the crestal region, an augmentation was carried out using BioOss (Geistlich) and covered with the resorbable membrane, Ossequest (W. L. Gore, Putzbrunn). The membrane was fixed in place using the implant's cover screw and the margins of
