Second implantation after implant fracture

Authors Dr Michael Hopp, Andreas Klar, Prof Dr Reiner Biffar, Germany

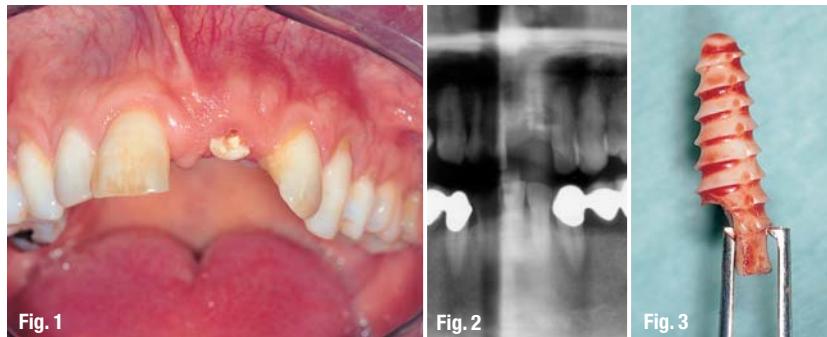
Fig. 1 Original situation following fracture, frontal view.

gion of the neck, losing the prosthetic crown (Fig. 1). Figure 2 shows the situation on an X-ray image. The patient was treated with antibiotics (Clindamycin 900 mg/d), the planned intervention was explained to the patient and the removal of the implant and new implant planned for two days later. After preparation of a trapezial flap with a crestal incision and removal of the ceramic implant (Fig. 3), the deep-seated epithelium and connective tissue was removed and the remaining bony cavity prepared for the placement of a new implant with a greater diameter (Fig. 4). The remaining implant bed was revealed to be a very solid cortical structure, such that a thread had to be pre-cut for the new implant (Fig. 5). The IMPLA implant (Schütz Dental Group, Rosbach), 14.5 millimetres in length and with a diameter of 5.3 millimetres, was inserted and the insertion aid was removed (Figs. 6 & 7). To compensate for the loss in bone height in the crestal region, an augmentation was carried out using BioOss (Geistlich) and covered with the resorbable membrane, Osseosequest (W. L. Gore, Putzbrunn). The membrane was fixed in place using the implant's cover screw and the margins of

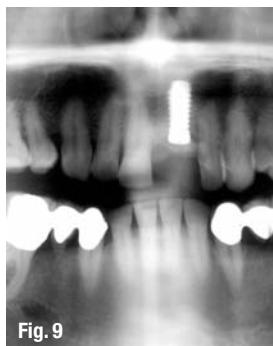
Fig. 9

Fig. 9_OPG after implantation.
Fig. 10_Temporary restoration with a removable denture.

the muco-periostal flap. The site of the operation was closed with 9 simple interrupted sutures (Fig. 8) after mobilization of the muco-periostal flap through periost slitting and a control X-ray was taken (Fig. 9).

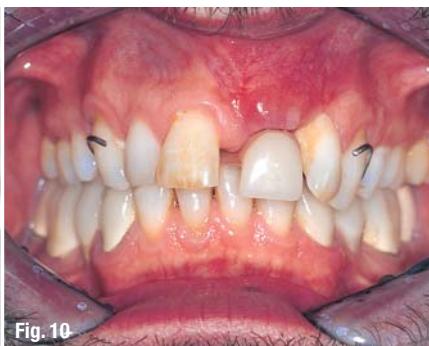
Fig. 10

During the 6-month healing phase, a denture with a prosthetic tooth anchored with a clamp was worn (Fig. 10), which had been relined underneath with Flexor CC (Schütz Dental, Rosbach) to prevent any pressure on the site.

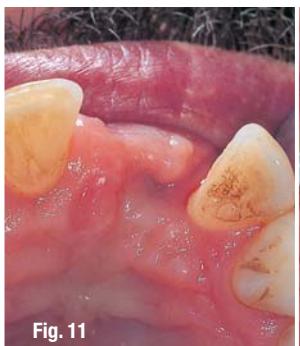
Fig. 11

Fig. 11_Situation after healing process, seen from occlusal view.

Following healing (Fig. 11), the covering mucosa was opened with a semi-circular cut with a scalpel under local anaesthetic (Fig. 12) and a cylindrical gingiva former, 2 mm in height, was inserted (Fig. 13). The X-ray shows an implant with good osseointegration (Fig. 14) and, to a large extent, maintenance and restoration of the gingival structures (Fig. 15). Only the papillary region between 21 and 22 is reduced. The prosthetic treatment was conducted after the gingival tissues had healed. The impression was made using Impregum (3M ESPE, Seefeld) and

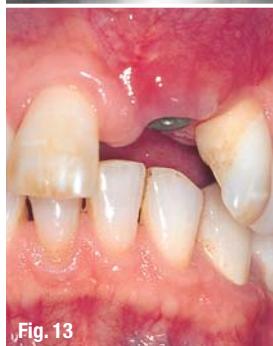
Fig. 13

Fig. 13_Situation with the gingiva former.

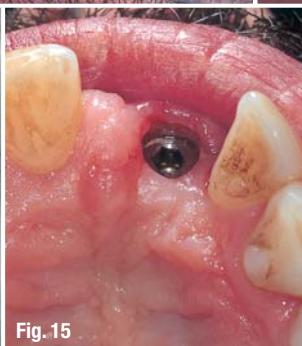
Fig. 15

Fig. 15_Gingival situation after opening up.

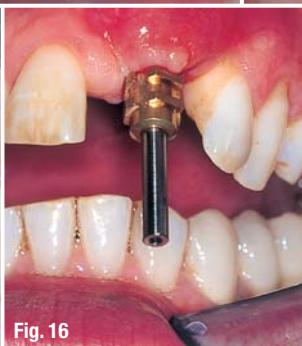
Fig. 16

Fig. 16_Inserted impression post.

the open tray technique (Fig. 16). The model made from type-IV gypsum with a gingival mask permits the production of an aesthetically high-quality crown (Fig. 17). An angled abutment was selected to correct the angulation and adapted to follow the line of the gingiva (Fig. 18). The internal hexagon connection prevents rotation (Fig. 19). A cementable metal ceramic crown, based on an alloy with a high gold content that can be fired, completes the restoration (Fig. 20). The diastema at the front was left in accordance with the patient's wishes, as was the slightly rotated and parodontally worn no. 2 (Fig. 21). The otherwise triangular crown of the no.1 was rounded off distally so that the papillary triangle between 21 and 22 was less prominent. The colour was adjusted to the lively colour of 11 in the laboratory in the presence of the patient (Figs. 22 & 23). The abutment (Fig. 24) was screwed in at a torque of 20 N/cm and the crown was inserted for three weeks on a provisional basis (Fig. 25).

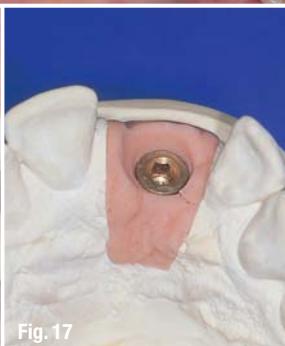
Fig. 17

Fig. 17_After taking the impression the model with gingiva mask is produced.

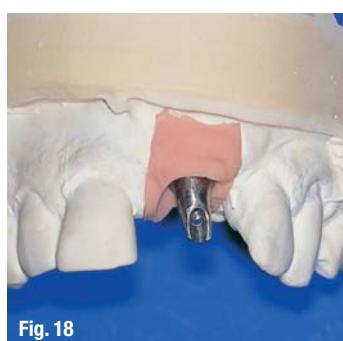
Fig. 18

Fig. 18_Adapted abutment.

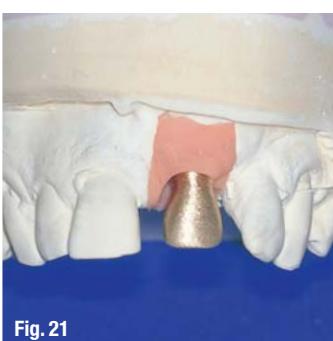
Fig. 21

Fig. 21_Processed crown cap prior to application of the ceramic.

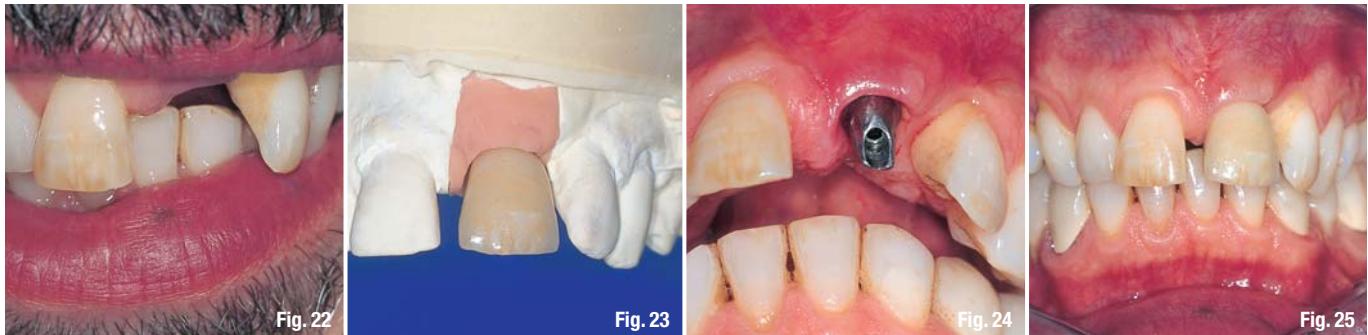
- Fig. 22**_The gap requiring restoration.
Fig. 23_ Fired ceramic crown.
Fig. 24_Inserted abutment.
Fig. 25_Crown in situ.
