The same-day tooth: From the diagnosis to the final restoration

Author Dr Stefanos G. Kourtis, Greece

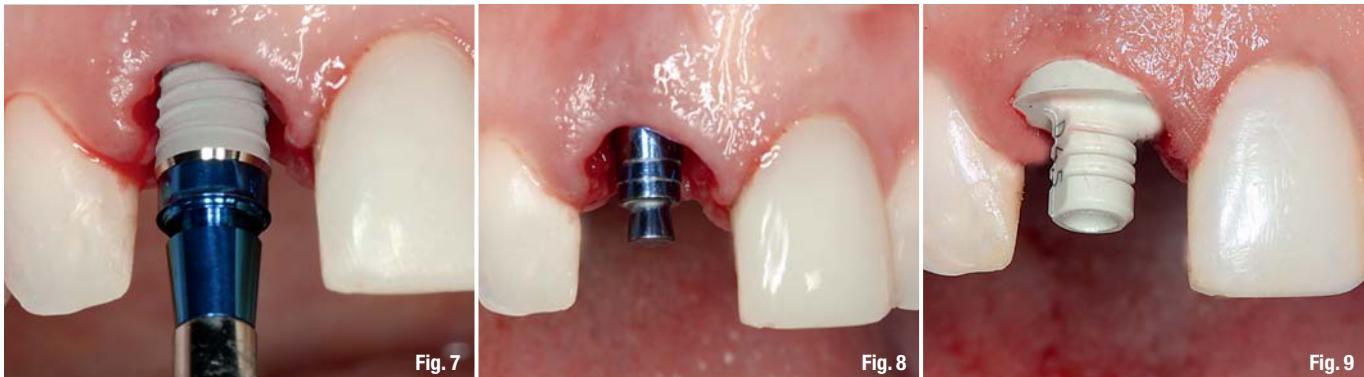
palatally. Hence, its periodontal conditions differed evidently from those of the remaining dentition. The left central incisor was discoloured and had extensive composite resin restorations with inadequate fit at the margins (Fig. 1).
