# Laser-assisted re-establishment of Canine Guidance:

## Esthetic and Functional Reconstruction of Worn Canines

**author** Carlos de Paula Eduardo<sup>1</sup>, Marina Stella Bello-Silva<sup>2</sup>, Karen Müller Ramalho<sup>3</sup>,  
Roberta Marques da Graça Lopes<sup>4</sup>, Patricia Moreira de Freitas<sup>5</sup>, Brazil

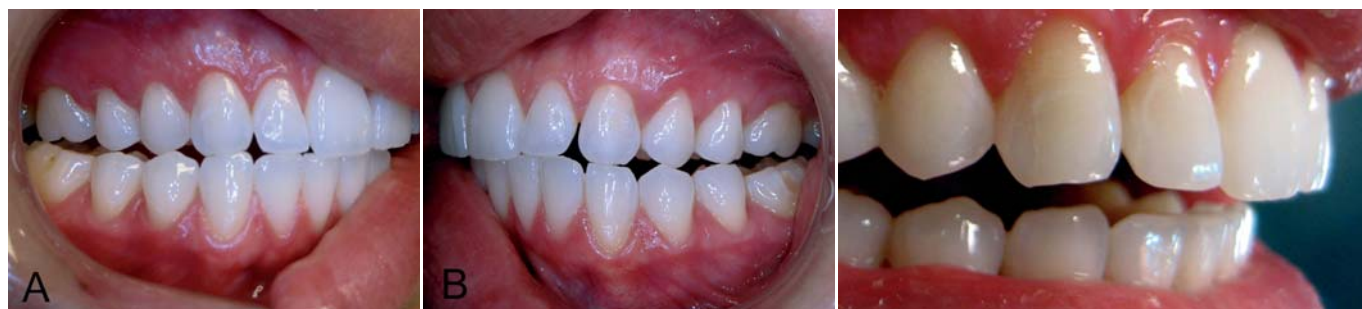
**Fig. 1 \_Initial clinical status.**

**A** \_Right side view: Loss of canine guidance and presence of contacts on lateral incisors, pre-molars and disto-buccal cusp of the first molar.

**B** \_Left side view: Loss of canine guidance and occlusal contacts on lateral incisors and pre-molars.

A diastema between the upper right canine and lateral incisor caused by the occlusal interference can be noticed.

our clinic presenting wear facets on the edges of the upper and lower canines (Fig. 1). The patient reported muscular fatigue in the morning and clenching during the day, and these symptoms were attributed to the patient's parafunctional bruxing habit. The canine guidance was no longer present, and the wear pattern indicated that jaw lateral excursive movements were predominant during bruxism episodes. This fact could also be attested by the presence of a diastema between the upper right canine and lateral incisor (Fig. 1B), as the patient reported that it first appeared after bruxism habit initiated. Since the canine edge was lost due to tooth wear, the canine guidance was substituted by group function guidance, and an intense contact between upper and lower lateral incisors during lateral excursive movements may have caused tooth movement and diastema appearance. The intense strength exerted on the canines during clenching and grinding resulted in the appearance of cracks (Fig. 2), as well as in the loss of tooth anatomy.

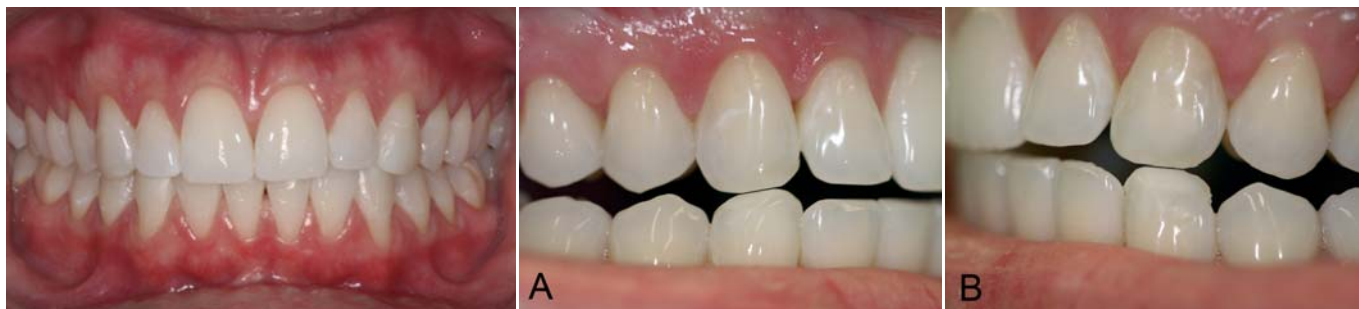
At 1-year follow-up, the patient reported that the occlusal splint was not used as oriented. This fact could be clinically observed, since worn facets were again present in the restorations of both upper and lower canines (Fig. 11). The resin lost during bruxism episodes resulted in the exposition of the opaque

resin used for the reconstruction of the dentin portion. This follow-up outcome is of extreme importance, since it indicates that adhesive procedures, including enamel etching with Er:YAG laser, were capable of providing the restoration with sufficient adhesion, so that it could tolerate the intensive occlusal charges generated during bruxing without any failure. Since adhesion was successful, the clinical consequence of continuous grinding during one year was the composite restoration wear. In spite of this, the canine guidance was still present, and the patient was oriented to effectively use the occlusal splint to avoid further wear and the need of a new restorative procedure. The presence of guidance was responsible for the closure of the diastema between the upper right canine and lateral incisor, and this could be observed one year after restoration (Fig. 11).

**Fig. 11** At 1-year follow-up, wear of the restorations was caused by the misuse of the occlusion guard. Restorations adhesion to teeth was sufficient to tolerate occlusal stress and the canine guidance was still present in both **A**) right and **B**) left sides. The re-establishment of the canine guidance was also responsible for the closure of the diastema.

ented, the patient did not use the occlusal splint and that lead to the continuing restoration wear. This fact was important to allow the observation of restorations behavior under intense occlusal stress. After one year, restoration adhesion to laser-etched enamel proved to be successful. The intense charges exerted during bruxing events were sufficient to cause loss of resin substance, but not to detach it. The use of Er:YAG laser for enamel etching has proved to provide adequate bonding resistance, since the laser is capable of creating a micro-rough surface that favors the mechanical adhesion of resin to enamel.<sup>13-15</sup> In case the patient had been provided with ceramic crowns, the misuse of the occlusal guard might have caused fracture of restoration, or even of teeth. Thus, the successful adhesion played an important part in the present case, since the permanence of the resin restoration during the following bruxing episodes was crucial to protect the teeth from further wear, without jeopardizing its resistance.
