# Using a Soft Tissue Dental Laser to Remove a Venous Lake

author\_Angie Mott, RDH, USA

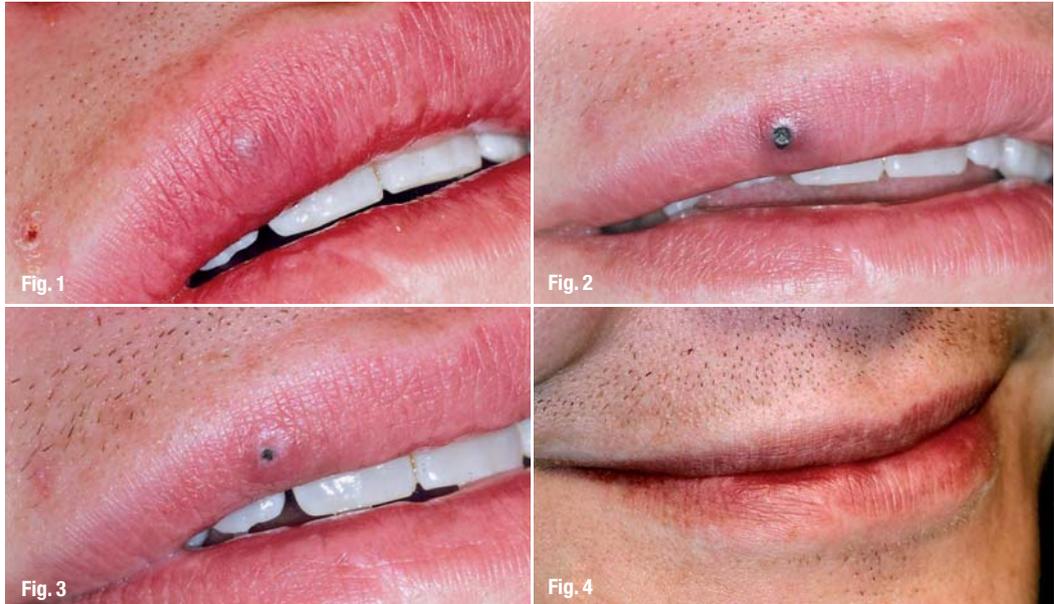
- Fig. 1**\_Initial view of Venous Lake.
- Fig. 2**\_View four days after lasering area, lesion “popped” open a few days after lasering and bled for a short time. Body is now able to heal itself.
- Fig. 3**\_This view is four more days later, area continues to heal.
- Fig. 4**\_Final view, notice that the lip is completely healed without any evidence of scarring.

Pre-op photos were taken to show case progress for documentation. The laser settings that were used were as follows, the laser tip was placed in non-contact mode approximately 2 mm away from area. Beginning with 0.5 W Continuous Wave (CW), point the laser tip towards the lesion, start by working around the borders of the lesion, circling around it several times, then "fill in" the lesion with overlapping strokes all in one direction. Then: reposition the laser tip 90° and go over entire lesion again creating a "cross-hatching" pattern, for a total time of 45–60 seconds. Continue to increase settings, example: 0.6 W, 0.7 W, 0.8 W and 0.9 W following above procedure until complete. Vitamin E was placed on lesion after laser treatment, because it helps to rehydrate the area and also to protect the lasered area. Additional vitamin E can be sent home with the patient for them to reapply as needed, this creates comfort for the patient as the area heals.

Typically, the area will look the same after the laser procedure has been completed. Occasionally, the area may appear to be smaller or change in color.
