# The use of the Er:YAG in laser-assisted **broken** abutment screw treatment

**Authors** \_Avi Reyhanian, Israel, Steven Parker, United Kingdom, Joshua Moshonov, Israel, Natan Fuhrman, Israel

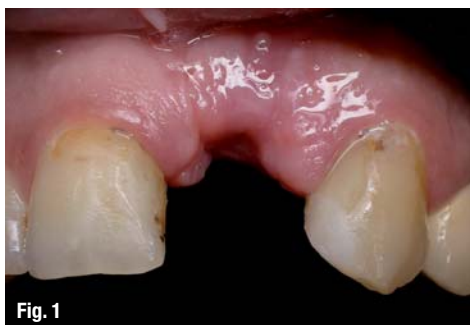
Clinical examination of the patient revealed a missing tooth at the location of #9 with no sign of an implant (Fig. 1). The patient brought the abutment, crown and broken screw with him (Fig. 3). Radiographic examination of the area showed the presence of a root-form cylindrical implant, consistent in appearance with a 13 mm long, 3.75 mm diameter abutment with an internal hex. The apical part of the screw remained threaded into the implant, but had fractured at the level of the hexagonal lock. Although
