## Six-year case report

# Fully guided immediate implant restoration in the aesthetic zone

Dr Guilherme Moreira, Brazil

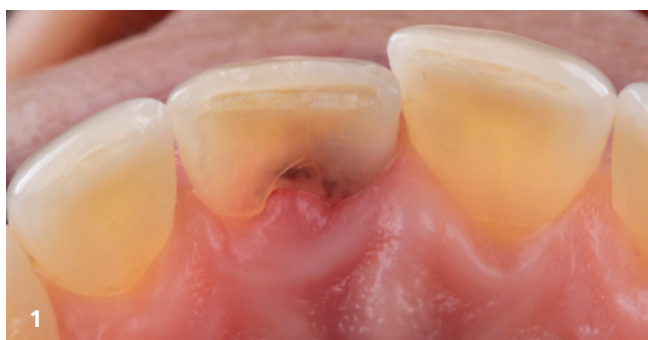
**Fig. 1:** Initial intra-oral examination showing external root resorption on the palatal surface of tooth #11. – **Fig. 2:** Tooth #11 appears darker and slightly intruded compared to its contralateral tooth.

The extra-oral examination showed a high smile line. The intra-oral examination of tooth #11 revealed signs of external root resorption on the palatal surface (Fig. 1). The tooth appeared darker and slightly intruded compared to its contralateral tooth (Fig. 2), raising suspicion of ankylosis. The tooth was non-sensitive to percussion, and the CO<sub>2</sub> test was negative. No signs of local infection, occlusal trauma, or periodontal inflammation were observed.

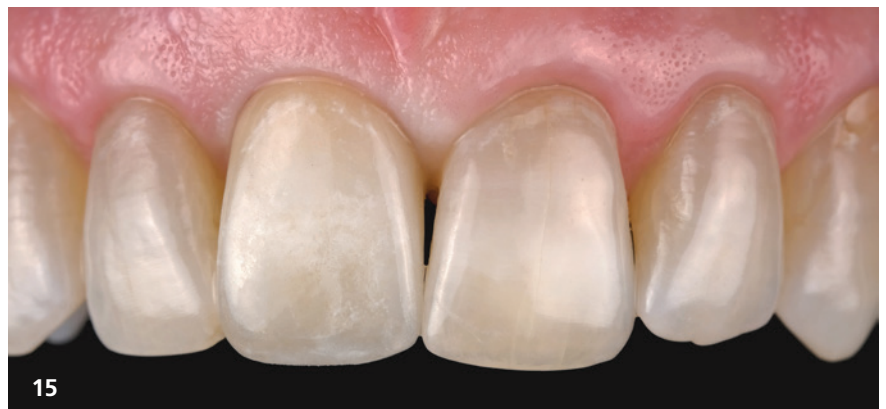
Clinical and radiographic evaluations were performed yearly. During these follow-up assessments, at two (Fig. 15) and six years (Figs. 16+17), the clinical examinations showed well-maintained gingival tissues and gingival margin around the implant. The prosthesis was deemed satisfactory in terms of aesthetics, and patient satisfaction. At six years, the radiographic evaluation confirmed the preservation of peri-implant bone tissue (Fig. 18).

**Figs. 12+13:** Four months after the surgery, presence of sufficient interdental papilla and buccal contours similar to those of the adjacent teeth. – **Fig. 14:** Radiographic examination of the final crown. – **Fig. 15:** Two-year follow-up showing well-maintained gingival tissues. – **Figs. 16+17:** Six-year follow-up showing stable gingival margin around the implant. – **Fig. 18:** Six-year follow-up radiographic evaluation.
