## A nine-year follow-up case report

# Long-term success of implant-supported rehabilitation in the aesthetic zone

Dres Léon Pariente and Karim Dada, France

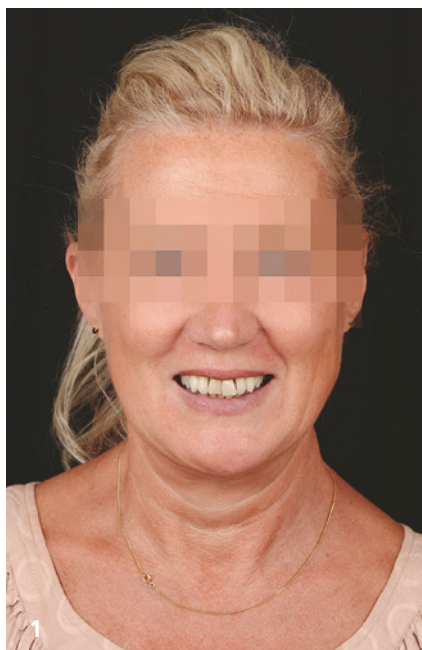
**Fig. 1:** The patient's extra-oral examination revealed a medium smile line. – **Fig. 2:** Misalignment observed in the maxillary front teeth. – **Fig. 3:** Intra-oral examination shows periodontal attachment loss and mobility in the upper left central incisor and lateral incisors. – **Fig. 4:** CBCT scan reveals the absence of buccal bone.

The patient's extra-oral examination revealed a medium smile line and misalignment of the front teeth (Figs. 1+2).

bility were noted in teeth #12, #21, and #22 (Fig. 3). Cone-beam computed tomography (CBCT) imaging indicated the absence of buccal bone on tooth #21 (Fig. 4).

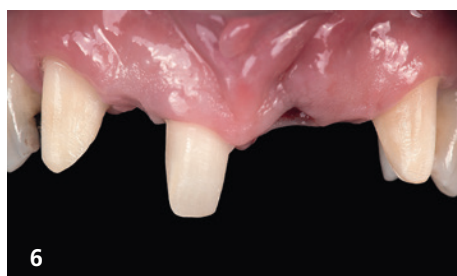
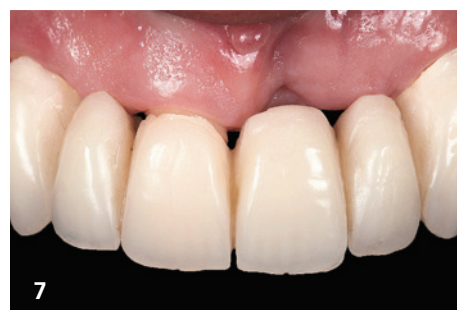
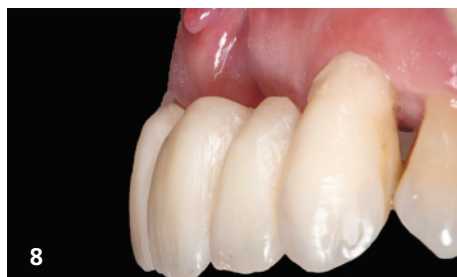
**Fig. 6:** Extraction of the upper left central incisor and lateral incisors, followed by the preparation of upper right central incisor and canines. – **Fig. 7:** Placement of a temporary resin-based bridge. – **Fig. 8:** Post-healing, horizontal and vertical ridge deficiencies observed at the site of #21. – **Fig. 9:** Six weeks after dental extractions, the patient exhibited uneventful wound healing. – **Fig. 10:** Placement of Straumann® Roxolid® SLActive® BLT Ø 3.3 mm implant at site #12, and a BLT Ø 4.1 mm implant at site #21. – **Fig. 11:** At five months post-surgery, the radiographic control of implant #21 confirmed proper positioning and implant integrity.

alveolar curettage. Additionally, dental preparations on teeth #13, #11, and #23 were carried out (Fig. 6).

A temporary resin-based bridge was placed in the second sextant (Fig. 7). Following wound healing, horizontal and ver-

tical deficiencies were observed at ridge position #21 (Fig. 8).

At the six-week follow-up post dental extractions, the patient presented with uneventful wound healing (Fig. 9). A mucoperiosteal flap, with a crestal incision, was raised to facilitate implant placement. The Straumann® Surgical Cassette was employed to prepare the implant bed. Subsequently, a Straumann® Roxolid® SLActive® BLT 3.3 mm implant was positioned at site #12, and a Straumann® Roxolid® SLActive® BLT 4.1 mm implant was placed at position #21 (Fig. 10). The implants were positioned using the hand-piece in a clockwise direction with a speed of 15 rpm and torqued to 35 Ncm. Simultaneously, bone augmentation was carried out at position #21 to enhance the structural integrity of the implant site.

A radiographic control was conducted on implant #21, five months post implant surgery, to assess the progress and ensure the integrity of the implant in its position (Fig. 11).

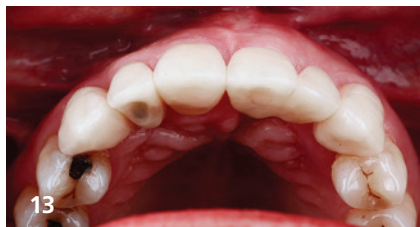
**Fig. 12:** Successful soft-tissue healing observed at the seven-month follow-up. – **Fig. 13:** Placement of the final restorations. – **Fig. 14:** The aesthetically pleasing appearance of the final crowns. – **Fig. 15:** Radiographic assessment at the time of final impression confirmed precise implant placement and verified bone structure integrity.

Soft-tissue conformation was evaluated seven months after the delayed loading of implant #21, with the aim to assess the maturation and adaptation of the surrounding soft tissues to the implant site (Fig. 12).

range of 15 to 35 Ncm revealing a natural and aesthetically pleasing appearance of the final crowns (Figs. 13+14).

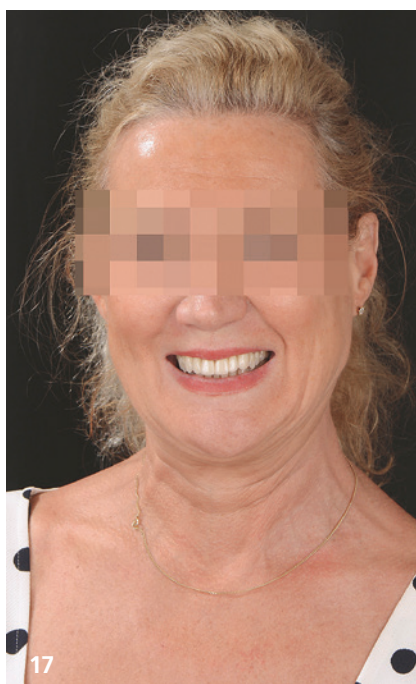
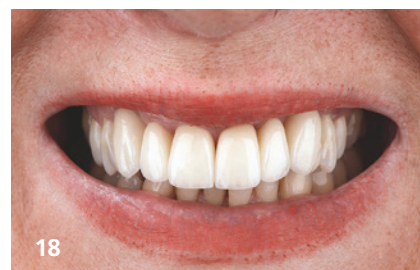
**Fig. 16:** A follow-up radiographic evaluation assessed the long-term stability and health of the implant sites. – **Fig. 17:** Six-year follow-up showing favourable aesthetic results. – **Fig. 18:** Six-year follow-up demonstrating a satisfactory clinical outcome.

Radiographic control was conducted at the time of the final impression to ensure an accurate assessment of the implant placement and surrounding structures (Fig. 15). Additionally, a follow-up radiographic evaluation was performed six years after the completion of the treatment to monitor the long-term stability and health of the treated area (Fig. 16).

At the six-year (Figs. 17+18) and nine-year (Fig. 19) follow-ups, comprehensive clinical and radiographic assessments underscored favourable outcomes, including osseointegration, the maintenance of bone density around the implants, and pleasing aesthetics. These findings collectively indicated the success of the long-term treatment.

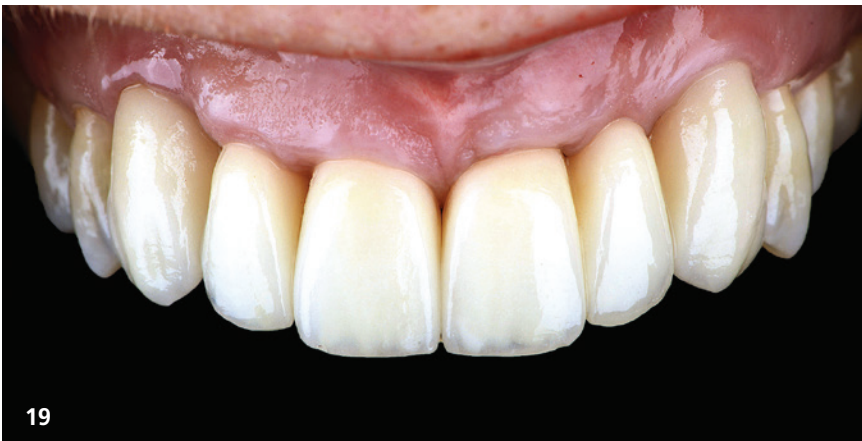
**Fig. 19:** Nine-year follow-up revealing successful results, with healthy soft and hard tissues maintained.
