Rehabilitation of an edentulous mandible

Restoration with one-piece zirconia implants

Prof. Ziv Mazor, Israel

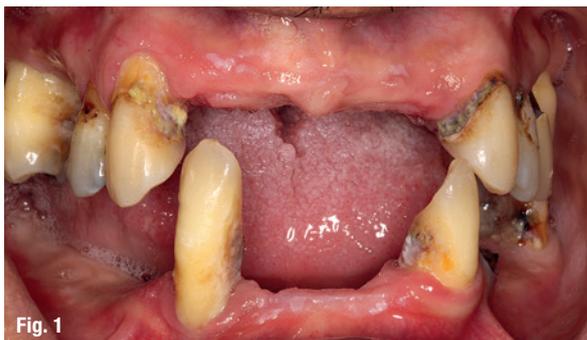
Fig. 1: Frontal view of the patient's mandible. Figs. 2 & 3: Implant positioning using the planning software Simplant.

A 37-year-old patient presented suffering from aggressive periodontitis which resulted in almost total edentulism in the lower jaw (Fig. 1). For that reason, the patient asked for fixed restorations. The treatment plan involved
