Zirconia implants and digital workflow: A case report

Drs Saurabh Gupta, India & Sammy Noubissi, USA

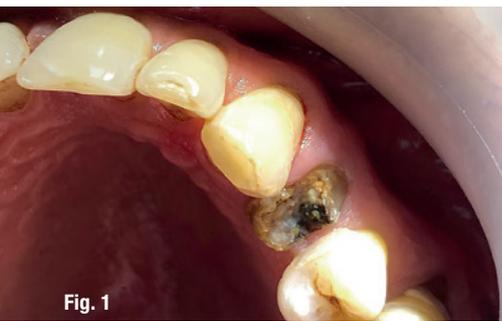
A 44-year-old patient attended the scheduled dental maintenance appointment complaining of a fractured tooth (Fig. 1), which had been treated endodontically and restored with a crown five years prior. The patient was a non-smoker and had an otherwise unremarkable medical history. Clinical assessments revealed little pain during percussion. A periapical radiograph confirmed the clinical findings and revealed the fracture line to be at the

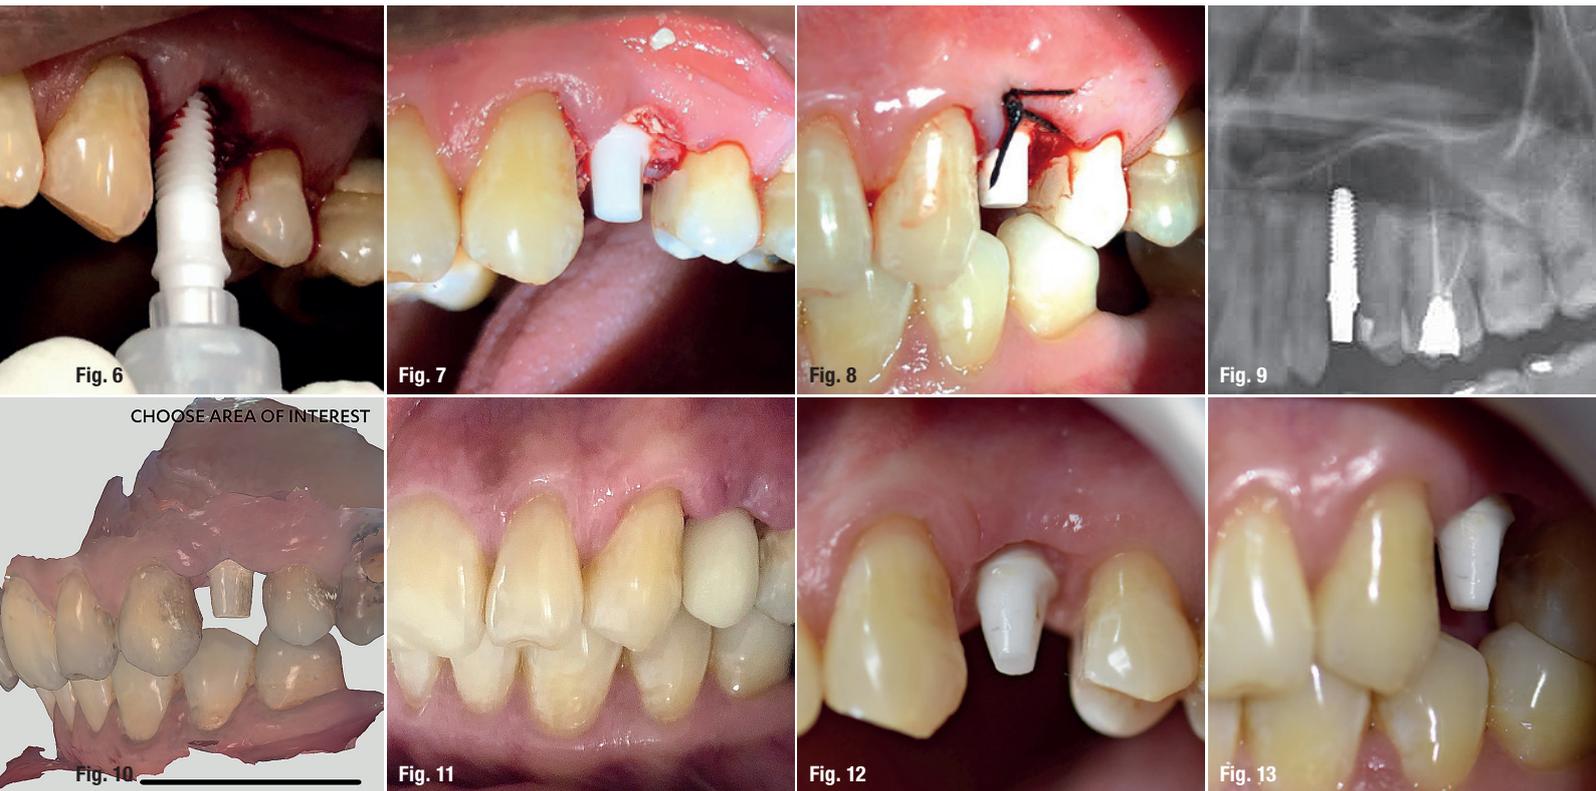
Fig. 6: Placement of the implant. **Fig. 7:** Bone grafting material placed around the implant body. **Fig. 8:** The horizontal mattress suture. **Fig. 9:** Radiograph taken immediately after surgery. **Fig. 10:** The optical scan after surgery. **Fig. 11:** The provisional restoration. **Figs. 12 & 13:** Tooth preparation.

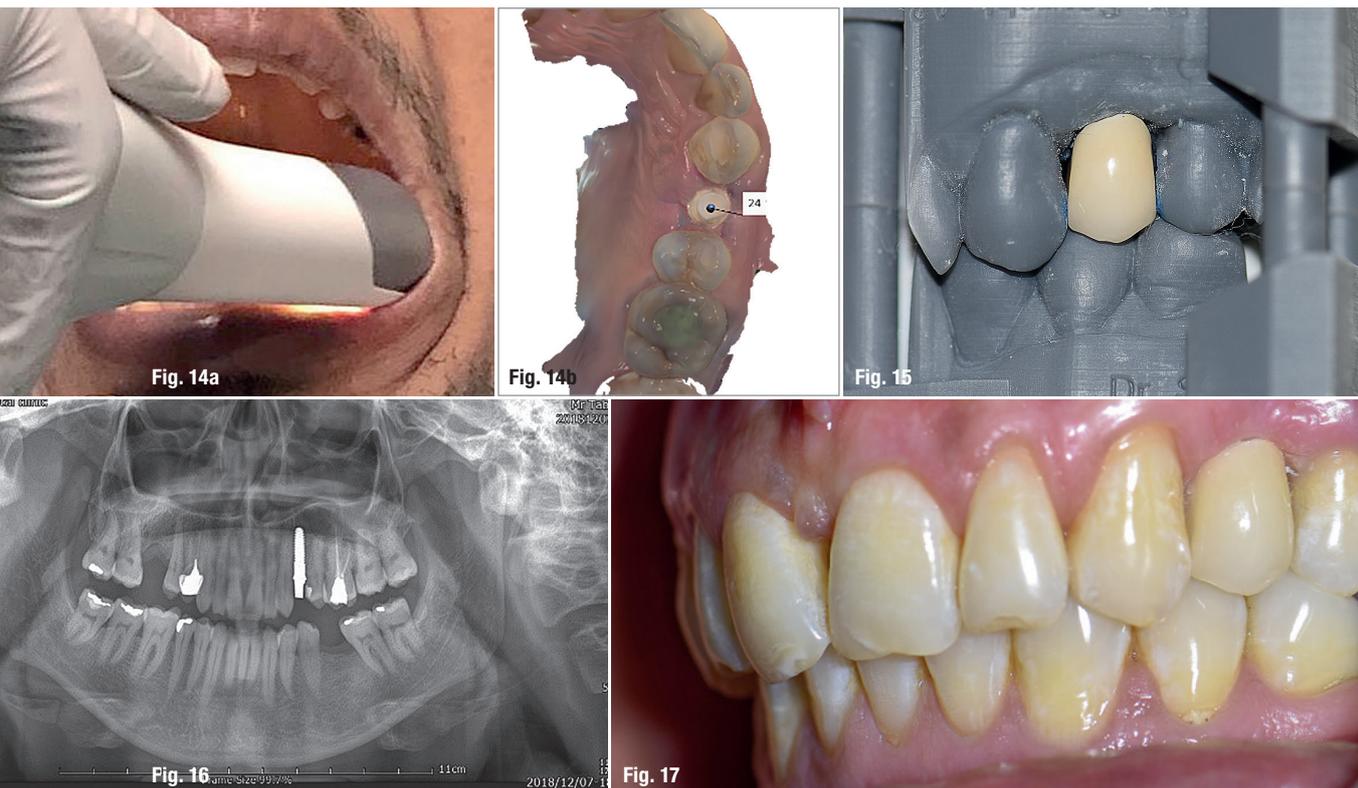
Fig. 14a: Intraoral scanning. **Fig. 14b:** Optical scan for final restoration. **Fig. 15:** The final crown. **Fig. 16:** Radiograph taken four months after surgery. **Fig. 17:** Situation one year after surgery.
