# Restoring the function and aesthetics of central incisors

Dr Philippe Jourdan, France

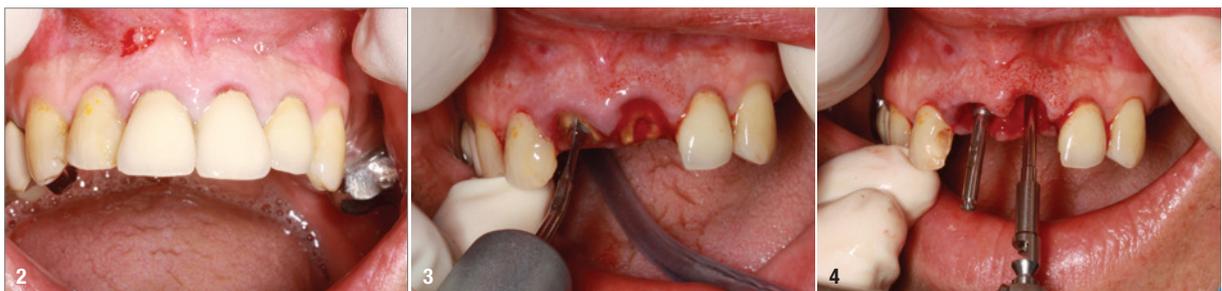
Fig. 2: Central incisors before implant surgery. Fig. 3: Preparation and extraction of central incisors. Fig. 4: Osteotomy preparation for implant placement.

Surgery began with using the piezo-surgical unit to atraumatically extract the roots of the central incisors (Fig. 3). The sockets were cleaned manually and an Er:YAG laser was used to remove the periodontal ligaments. The implant sites were prepared by creating osteotomies in each socket, the implant sites parallel to each other and positioned palatally (Fig. 4). The implants were placed into the sockets at 15 rpm (Figs. 5 & 6). Using a contra-angle handpiece makes this process much quicker and easier than carrying it out manually. Impression copings designed for taking closed-tray impressions were fitted once the implants had been placed (Fig. 7). Acrylic was applied around the impression copings and the excess material was removed distal to the lateral incisors. The acrylic was then used to take a closed-tray impression, which was treated by the dental technicians at the integrated dental laboratory at the author's practice. This impression taking technique is easier, faster and more accurate than other methods and one that the author often uses in cases where there are multiple implants and joined crowns.
