# Immediate implant placement and function in the aesthetic zone

## Single-tooth restoration with a narrow-diameter two-piece implant

Dr Roland Glauser, Switzerland

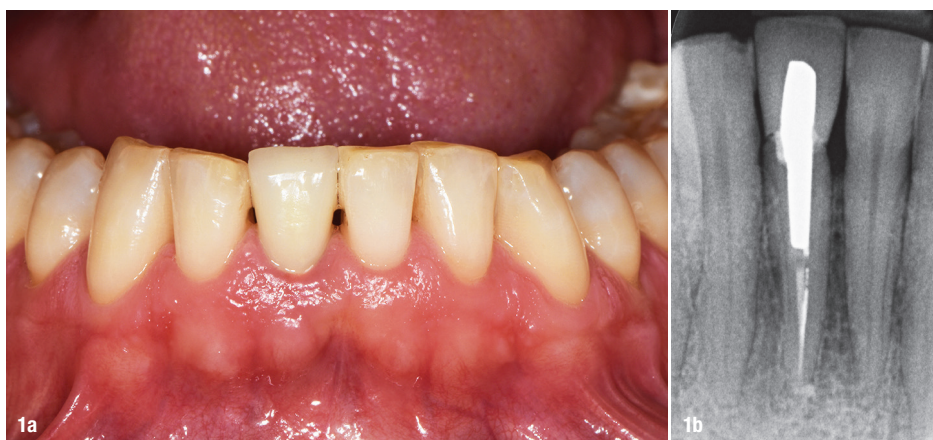
**Figs. 1a & b:** Frontal clinical view (a) and radiograph of the initial situation (b).

The 45-year-old male patient was referred to my practice. He presented for initial consultation complaining about a crown on his endodontically treated tooth #41 that had become loose. The patient had an accident in his youth which resulted in the traumatic fracture of the mandibular right central incisor. As a result, the tooth had to be endodontically treated and was restored with a gold post and core and a veneered ceramic crown (Fig. 1). The crown had been *in situ* without complications for 22 years. Upon removing the failing crown

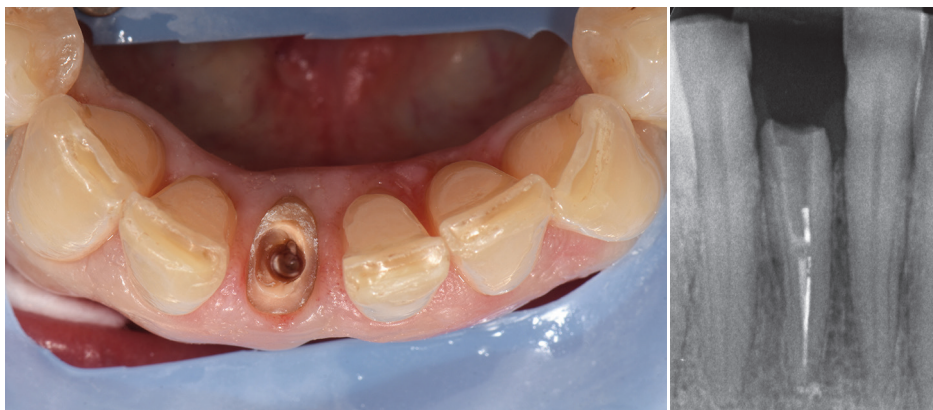
**Figs. 2a & b:** Occlusal clinical view (a) and radiograph after removal of the insufficient crown and post in region #41 (b).

and the post, a vertical root fracture was discovered (Fig. 2). Therefore, the remaining root was deemed unsalvageable.

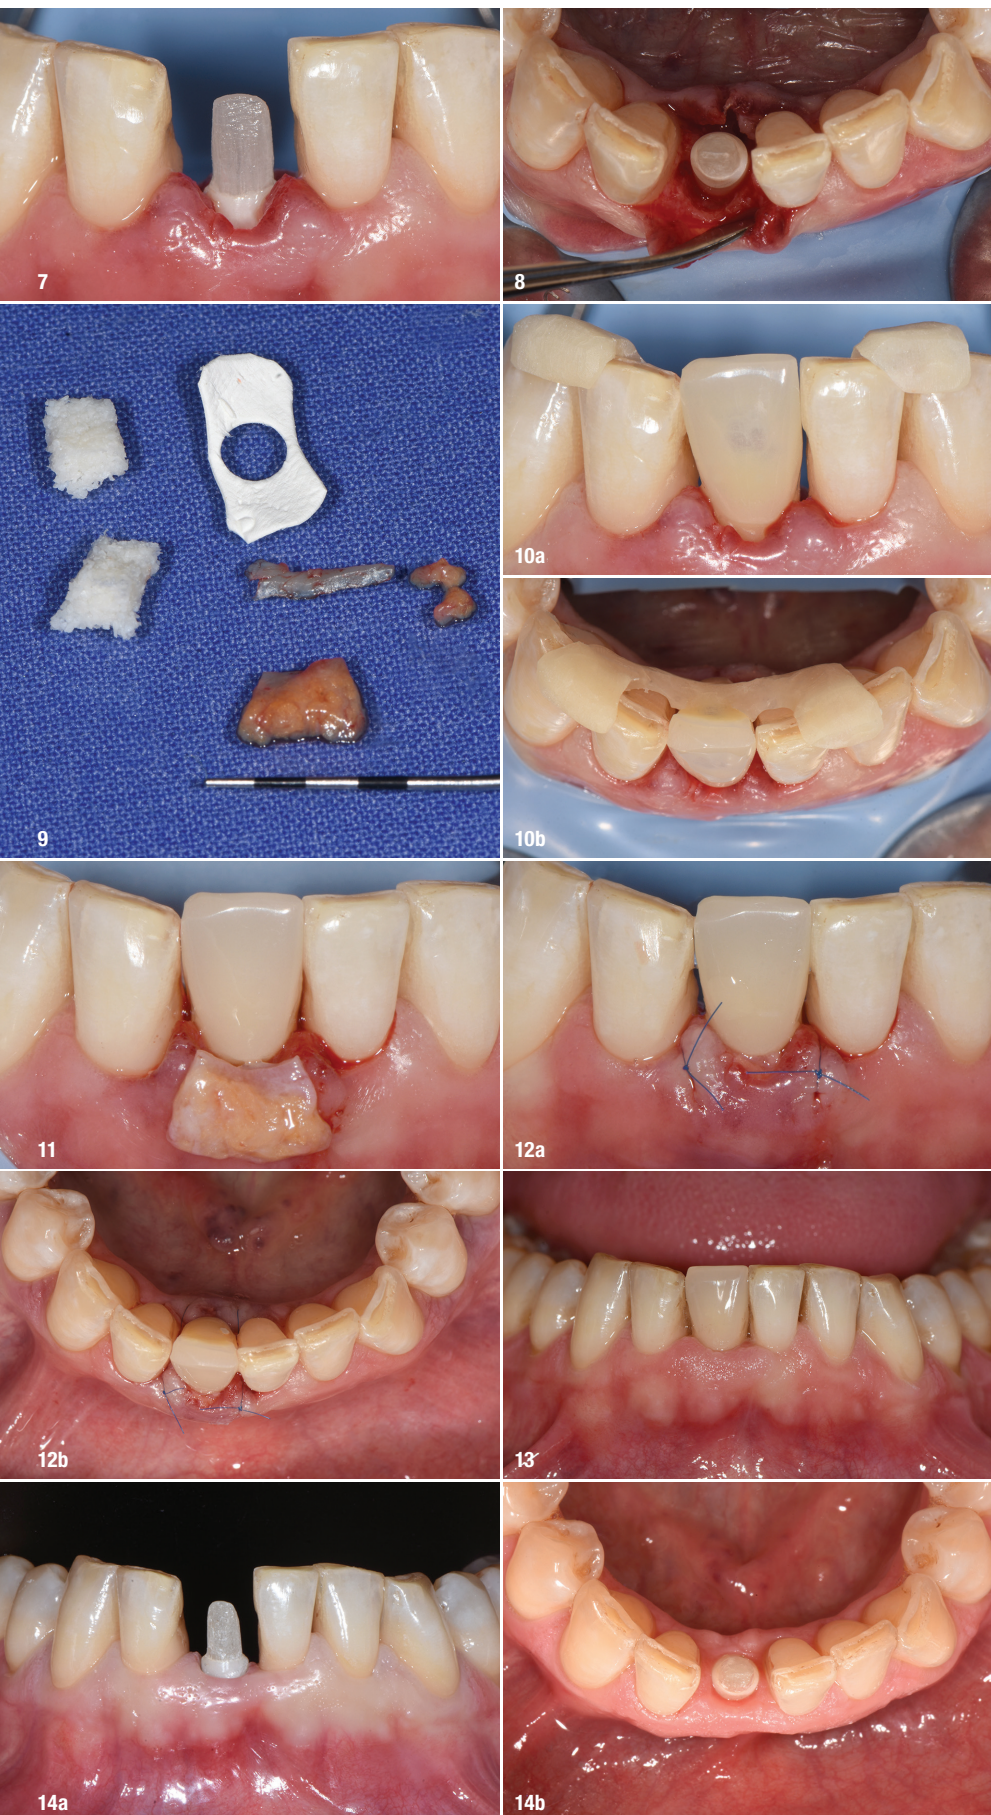
**Fig. 7:** Frontal clinical view of the glass fiber post cemented in place. **Fig. 8:** Occlusal clinical view prior to guided bone regeneration. **Fig. 9:** Bio-Oss Collagen®, resorbable Bio-Gide® membrane, and connective tissue graft. **Figs. 10a & b:** Frontal (a) and occlusal clinical views of the cemented provisional crown (b). **Fig. 11:** Frontal clinical view of the connective tissue graft *in situ*. **Figs. 12a & b:** Frontal (a) and occlusal clinical views of the sutured grafted site (b). **Fig. 13:** Frontal clinical view three weeks post-op. **Figs. 14a & b:** Frontal (a) and occlusal clinical views at the nine-month follow-up, before final impression taking (b).

Immediately after implant placement, the glass fiber post, which was prepared in advance by the dental laboratory, was inserted into the 3C connection of the implant and cemented in place using RelyX™ Unicem dental cement (3M; Fig. 7). Afterwards, a guided bone regeneration procedure was performed using Bio-Oss Collagen® and a resorbable Bio-Gide® membrane (Geistlich Pharma) to fill the gap between the wall of the extraction socket and the implant (Figs. 8 & 9). A circular hole was punched in the membrane to allow it to be placed over the grafted site with the implant penetrating through, enabling provisionalisation. The post was then isolated to avoid any chemical reaction between the glass fiber post and the composite. The provisional prosthesis was relined on the post with flowable composite (Fig. 10). The wings were subsequently cut off, and the crown was polished. The crown was cemented using a temporary cement (Temp-Bond™, Kerr Dental), and a lingual vent hole allowed for excess cement to be evacuated. A connective tissue graft was placed labially to bulk up the soft tissue and increase volume (Fig. 11). The grafted site was finally sutured closed (Fig. 12).

At the three-week follow-up, healing was considered uneventful (Fig. 13). At the nine-month follow-up (Fig. 14), a conventional full-arch impression was taken, which served as the basis for the fabrication of the master model and the definitive crown by the dental laboratory (Figs. 15 & 16). At the ten-month follow-up, the definitive prosthesis was delivered (Fig. 17). At the 12-month follow-up, the definitive prosthesis was considered highly aesthetic, and the peri-implant soft-tissue conditions were stable and healthy (Fig. 18).
