Explantation of an implant in a heavy smoker

Dr Branislav Fatori, Dr Inge Schmitz & Prof. Werner Götz, Germany

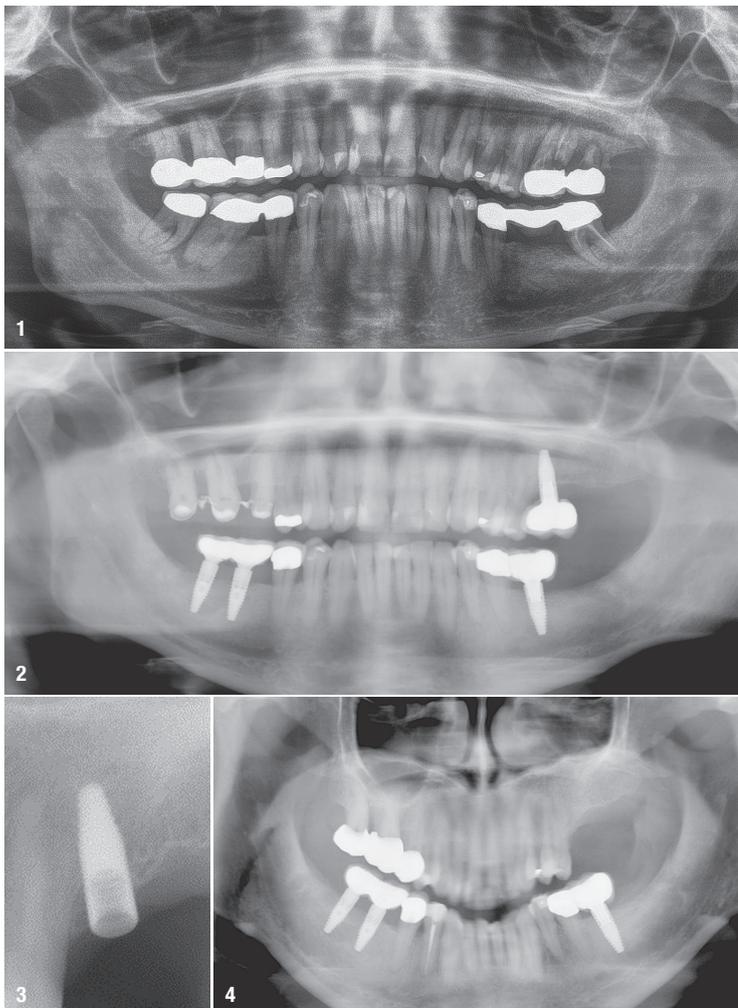
After 4.5 years, the implant screw fractured and another intervention was required (Figs. 3 & 4). There was no peri-implantitis. The implant screw was sent in for his-

Fig. 1: Radiograph showing the situation before the initial implantation. **Fig. 2:** Radiograph showing the situation immediately after the initial implantation. **Fig. 3:** Part of a radiograph showing the fractured implant screw prior to removal. **Fig. 4:** Radiograph showing the situation after implant removal.

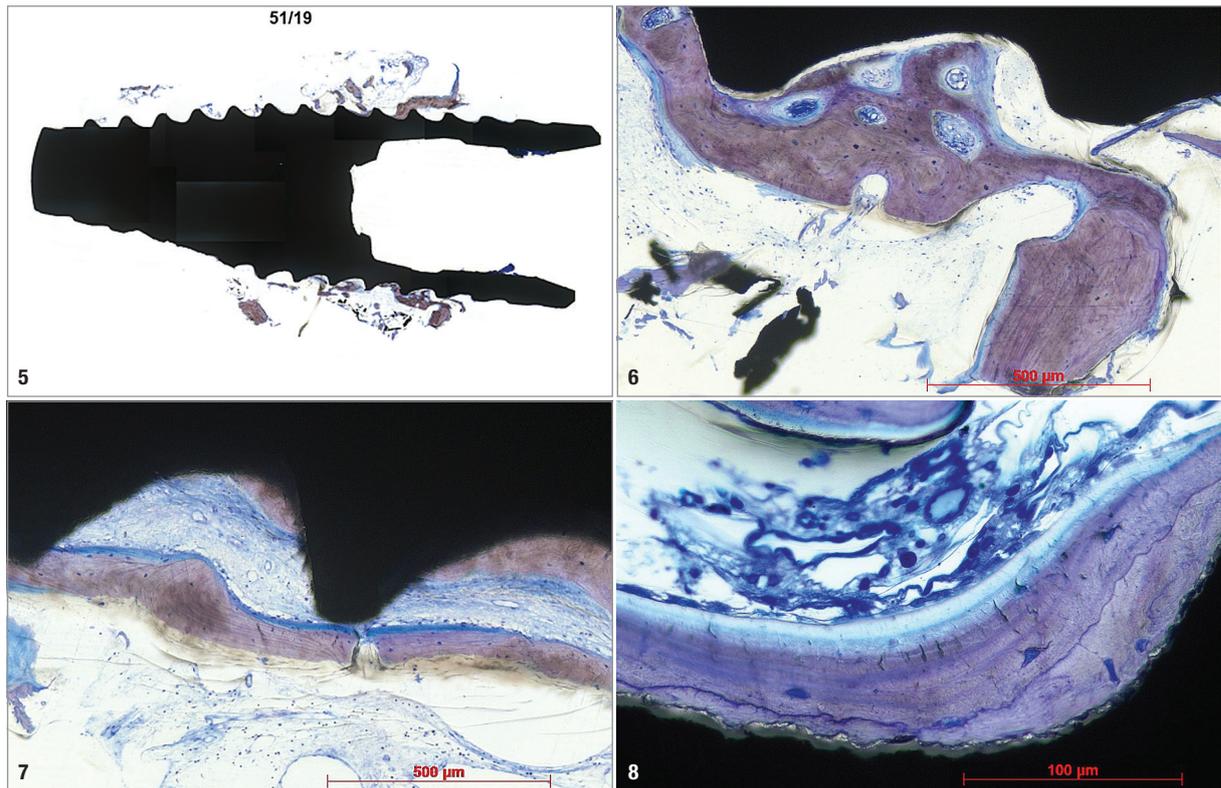
Fig. 5: Thin-section view of the explanted implant: there was cancellous bone and soft tissue attached at the middle and crestally; three to four upper threads were approximately 70% covered with bone crestally; there was attached loose connective tissue and peripherally attached soft tissue consisting of loose connective tissue rich in vessels; some bone fragments were detected crestally. When magnified further, tight bone-to-implant contact was visible. **Fig. 6:** Higher magnification: the bone-to-implant contact was too tight, especially crestally under formation of a 5–10 nm wide amorphous interface; there was lamellar bone with vital osteocytes; osteocytes were near to the implant surface; on the outer bone surface, there were signs of osteogenesis with osteoblast seams and osteoid sediments; peripherally, there was slightly more dermal osteogenesis with formation of osteoblast condensations, osteoids and fragments of mature lamellar bone; there was loose connective tissue rich in cells and vessels with some mastocytes and fat cells; near to the implant, there was accumulation of focal vessels; there were small osteoclasts in a few places; crestally, there was resorption on the surface; no necrosis or infiltrates were detected. **Fig. 7:** Microscopic image of the explanted implant showing good bone-to-implant contact and successful osteogenesis. **Fig. 8:** Microscopic image of the explanted implant showing good vascularisation.

tological examination, for which the material was processed conventionally by means of thin-section microscopy according to Donath and dyed with toluidine blue. The histological examination based on particulate blocks of the explant showed good contact between the bone and explant (Figs. 5–8). Crestally, there was good osseointegration with good bone-to-implant contact. Near the implant, regular osteogenesis and peripheral contact osteogenesis could be observed. In addition, there was very good vascularisation in the peri-implant area. No necrosis or inflammatory tissue was detected. Bone augmentation by means of NanoBone (Artoss) was necessary for the replacement of the implant (Fig. 9).

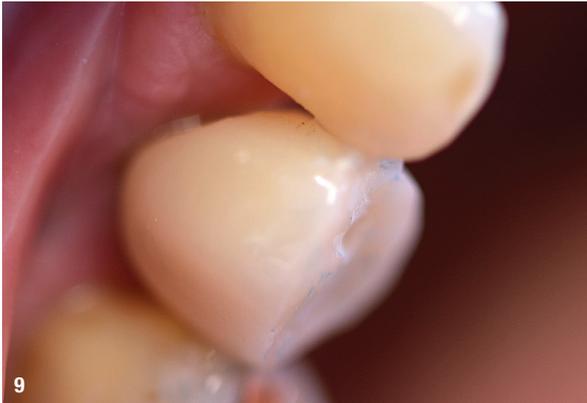
Fig. 9: Clinical situation showing the newly replaced implant.
