# How clean do **sterile** implants have to be?

## Analysis and clinical relevance of **factory-related** contaminations

Dr Dirk U. Duddeck, Germany

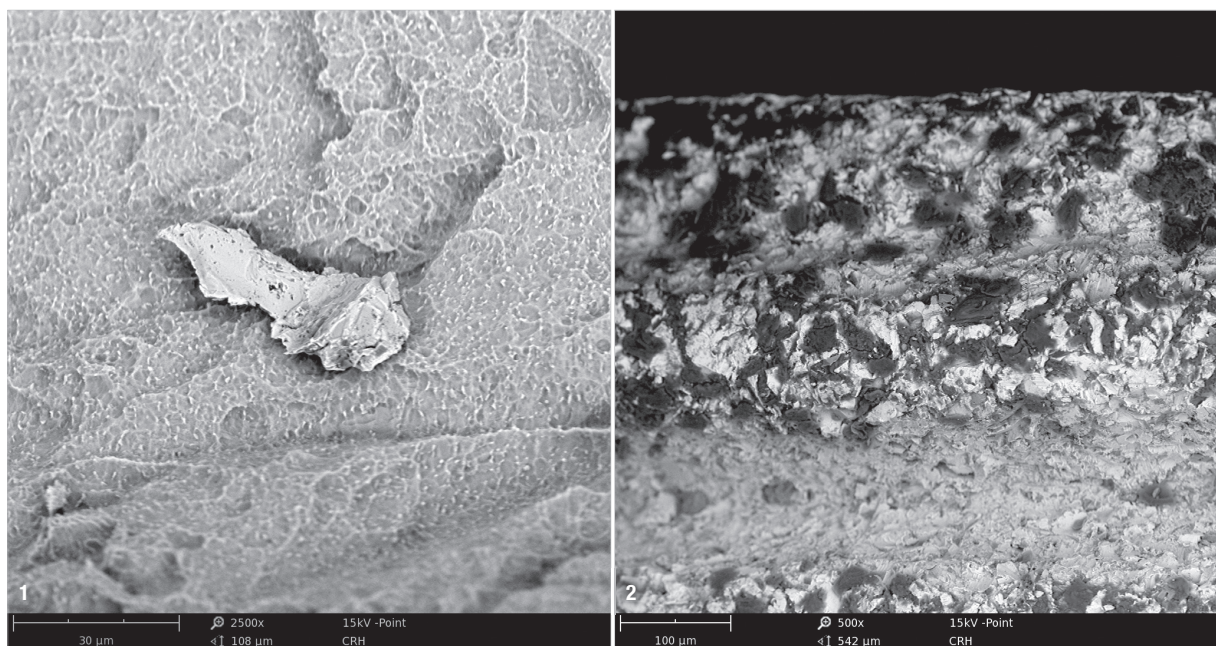
**Fig. 1:** Metal particle of iron, chromium and nickel on the surface of a titanium implant (Adin). SEM 2,500× magnification. **Fig. 2:** Numerous organic particles on the entire implant shoulder (OCO Biomedical). SEM 500× magnification.

for the analysis of particulate and film-like contaminants on sterile-packaged dental implants. Back-scattered electrons from the implant surface have typical energy of up to 10 keV. The intensity of these signals depends on the average atomic number of the sample material in focus. Compared with titanium or zirconium, heavier elements, such as iron or nickel, show more intense back scattering so that corresponding image areas appear bright (Fig. 1). In contrast, locations with lighter elements, such as carbonaceous plastic particles, are displayed darker than areas with titanium or zirconium (Fig. 2).

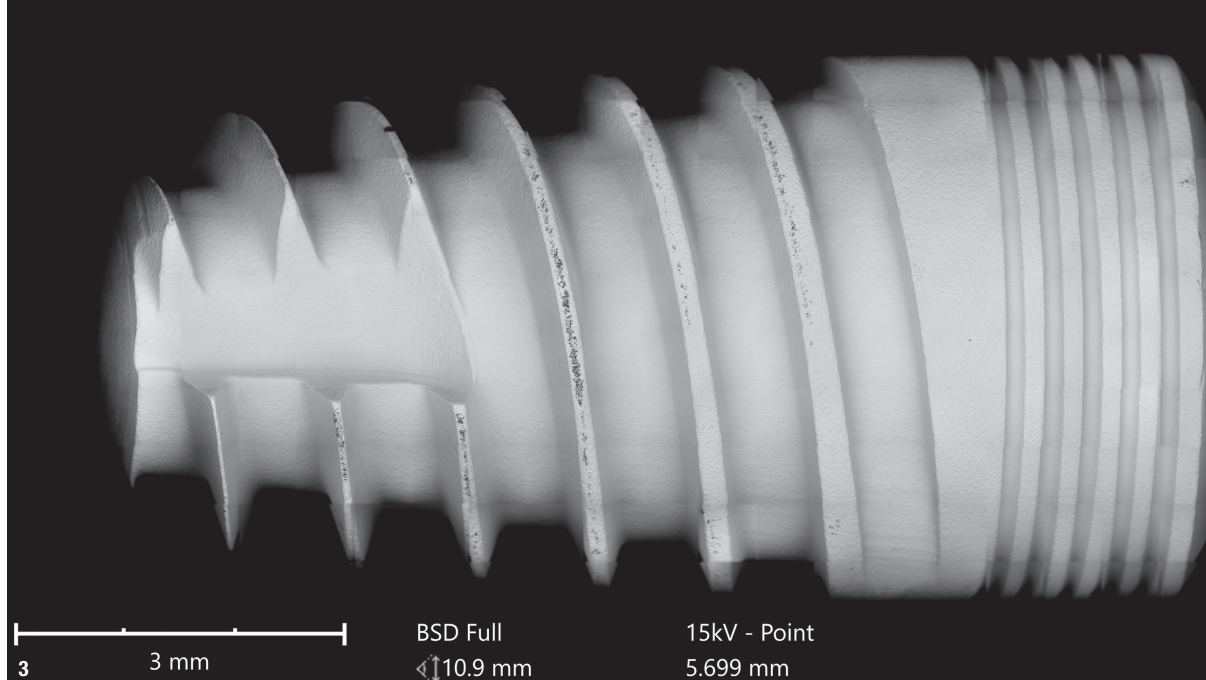
**Fig. 3:** Factory-related contamination of entire implant threads (Ritter Implants). Full-size SEM image of the implant electronically compiled from hundreds of single images at 500× magnification using the material contrast technique (back-scattered electron mode).

to depict details at high magnification without pixelation, up to 600 individual SEM images must be electronically stitched together in high resolution for these comprehensive overview images. The resulting SEM image in material contrast provides a detailed overview and allows the quantitative detection of individual particles (Fig. 3).

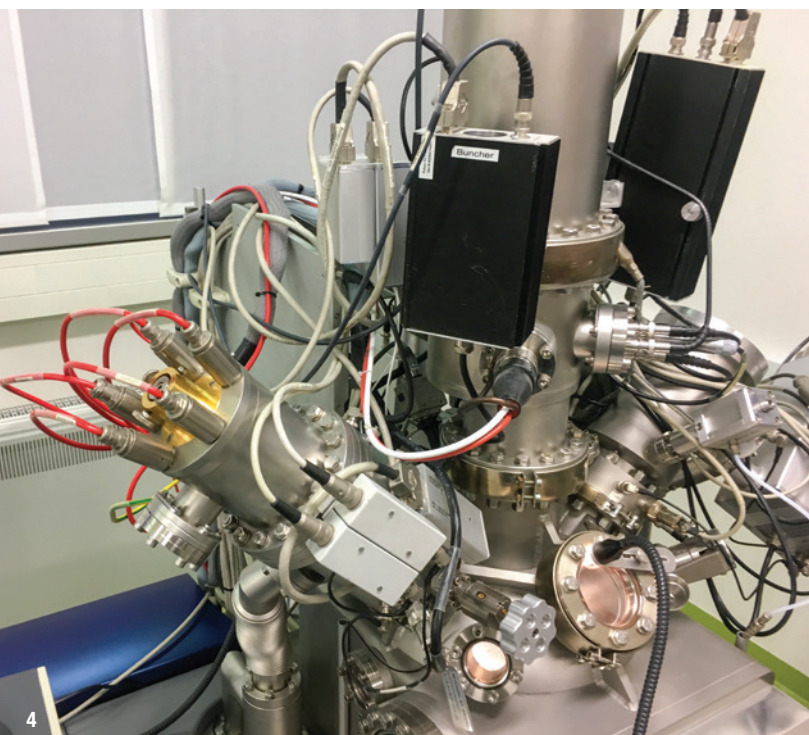
**Fig. 4:** Time-of-flight secondary ion mass spectrometry instrument (tascon).

Time-of-flight secondary ion mass spectrometry (ToF-SIMS) provides even more precise information about the chemical composition of an impurity. The method provides information on the atomic and molecular structure of the uppermost monolayers of a substrate on an analysis area of  $500 \times 500 \mu\text{m}^2$  with sensitivity in the parts per million range and a lateral resolution of up to 100 nm. Comparison of the spectra with known substances allows precise material determination of the respective contamination (Fig. 4).

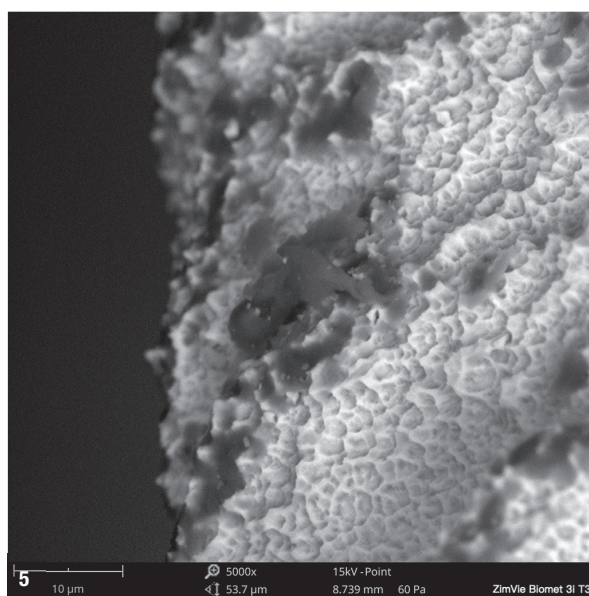
**Fig. 5:** Carbonaceous particles (polysiloxanes) on a titanium implant at the implant apex of a titanium implant (T3, ZimVie). SEM 500 $\times$  magnification.

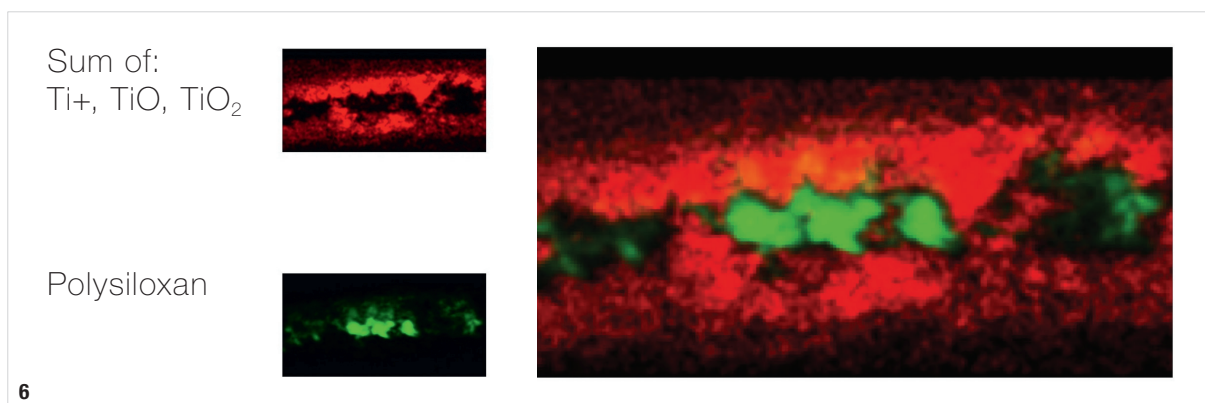
**Fig. 6:** Time-of-flight secondary ion mass spectrometry detection of polysiloxane on a titanium implant.

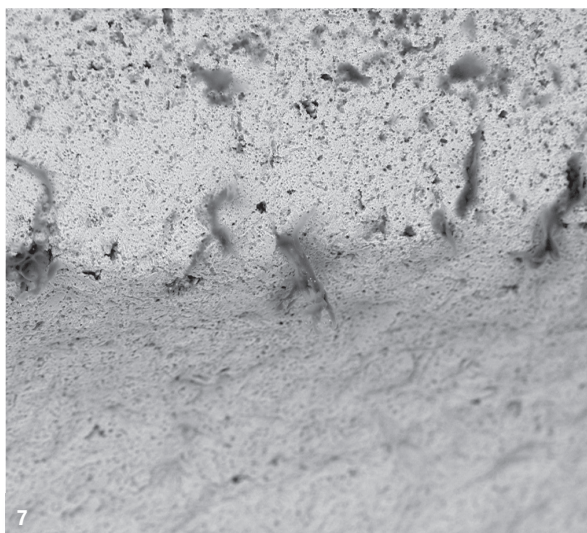
**Fig. 7:** Significant plastic material (polyacetal) on the shoulder of a ceramic implant (vitaclinical, VITA Zahnfabrik) from abrasion from the packaging.

Unfortunately, implant systems do not have consistent, comparable quality, as summarised in 2020 by Dr Norton, a past president of the Academy of Osseointegration, in an opinion piece in the *British Dental Journal* that is well worth reading.<sup>11</sup> The use of factory-contaminated implants not only may lead to inferior clinical outcomes but also carries the risk of legal implications. The problem of possible factory-related contamination concerns not only implants made of titanium or titanium alloys but also ceramic implants, as scientists from the universities of Gothenburg, Malmö and Berlin impressively described in a study published in 2021.<sup>12</sup> The bottom line of the study is that just because the material of ceramic implants is white does not necessarily mean that they are clean (Fig. 7).
