# Immediate two-piece ceramic implants with immediate provision-alisation in the posterior region

Drs Alexandre Marques Paes da Silva, Alice Maria de Oliveira Silva, Lissya Tomaz da Costa Gonçalves, Rodrigo Franco Motta, Daniel Moraes Telles, Mayla Kezy Silva Teixeira & Eduardo Veras Lourenço, Brazil

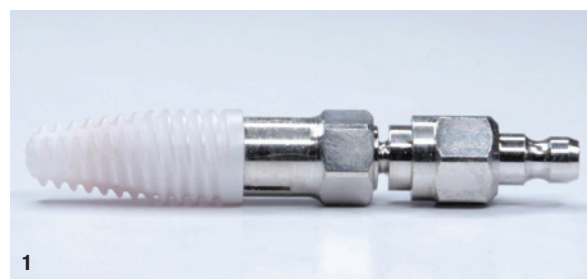
Fig. 1: Neodent Zi Ceramic Implant System.

The objective of this case report is to demonstrate the clinical and radiographic performance of a two-piece ceramic implant system (Neodent Zi, Straumann; Fig. 1) employed in two patients who visited the SobreImplantes private clinic located in the city of Rio de Janeiro in Brazil in order to undergo oral rehabilitation of posterior teeth with single implants and to report the degree of satisfaction of these patients in relation to the aesthetics of the treatment. Both patients were non-smokers and had good general health or controlled systemic conditions. For planning and diagnosis, the patients were asked to undergo CBCT (Figs. 2 & 3).

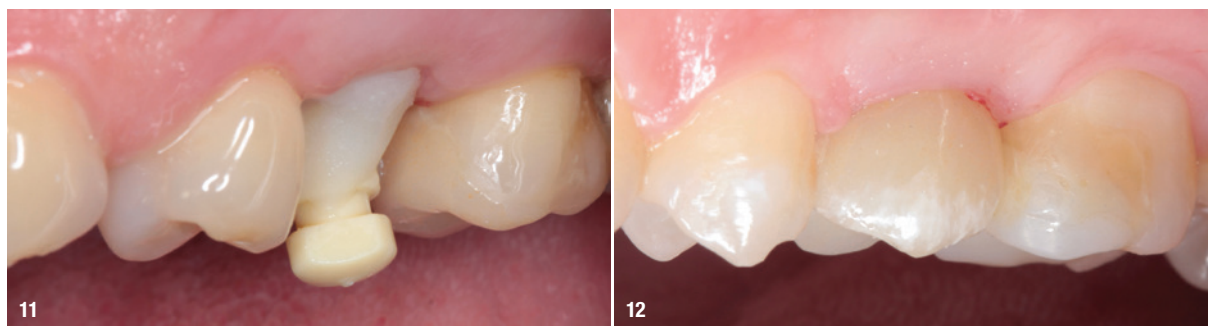
**Fig. 11:** Analog flow—emergency profile molding. **Fig. 12:** Cemented definitive crown (e.max).

After three months, the patients were re-evaluated, and there had been no complications during the healing period. Following a conventional workflow, the definitive crowns were manufactured. It is important to highlight that the gingival emergence profile was carefully copied, using a light-polymerised flowable resin (Master Flow, Biodinamica; Fig. 11). One patient received a milled crown (IPS e.max, Ivoclar Vivadent; Fig. 12) and the other a milled monolithic zirconia crown (Fig. 13), and the pros-
