Peri-implantitis prevention starts with the choice of a clean implant

Drs Dirk U. Duddeck and Dana Adyani-Fard, Germany

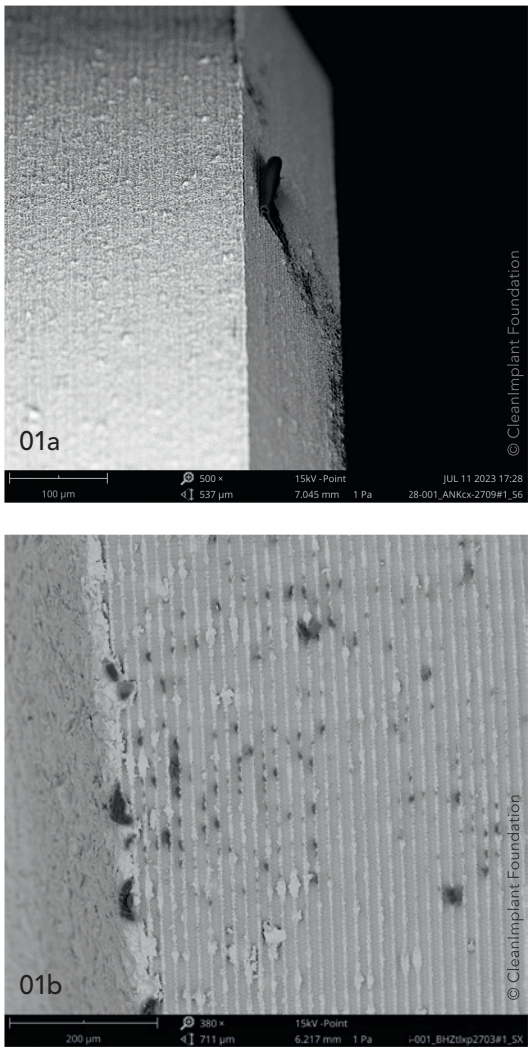
01a + b SEM 500x (a) and SEM 380x (b). Significant impurities located at the shoulders of two sterile packaged titanium implants.

polysiloxanes on sterile implant surfaces. Both titanium implants (Figs. 1a–2b) and zirconia (ceramic) implants from various manufacturers were found to be affected by these contaminants.

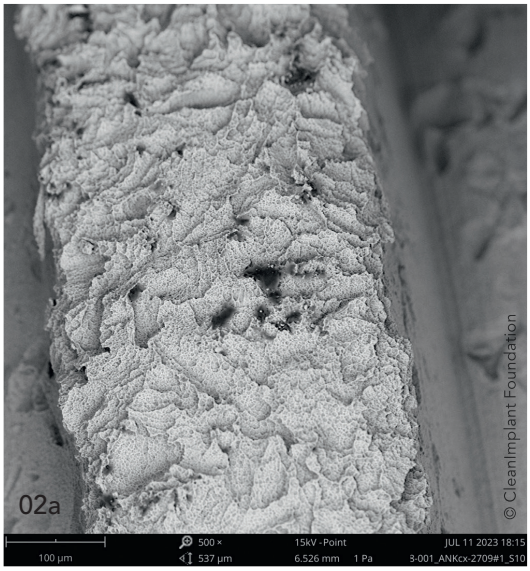
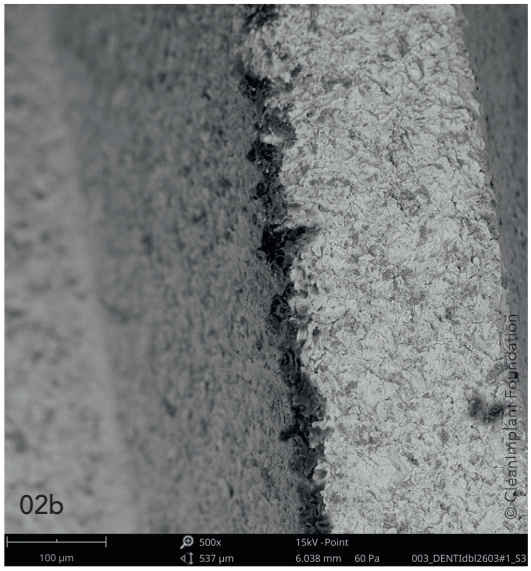
02a + b
Major carbon-based contamination of titanium implant threads straight after unpacking, shown at SEM 500x.

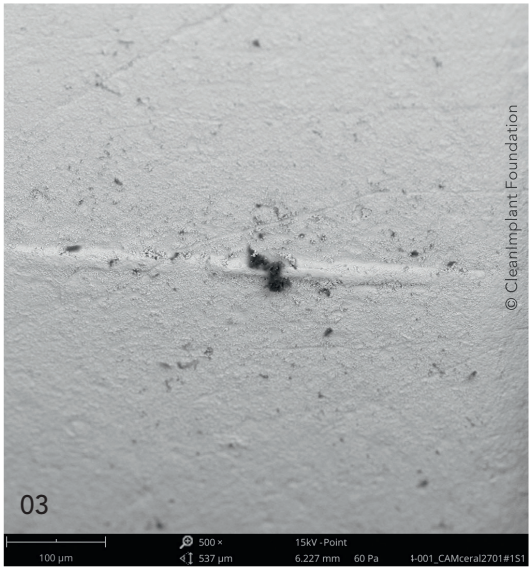
Certain ceramic implants were found to have significant deposits of polysiloxane, which could be traced back to the packaging material (Fig. 3). Another potential threat to successful healing (osseointegration) after implantation comes from thin-layer residues of highly aggressive, cytotoxic cleaning agents, such as dodecylbenzene sulphonic acid (DBSA)[7] or the pesticide didecyldimethylammonium chloride (DDAC-C10)[8]. This quaternary ammonium compound was identified using ToF-SIMS on the surface of a sterile-packaged ceramic implant (Figs. 3 & 4).

03
SEM image at 1,000× revealing significant plastic material and thin-film contamination on a sterile-packaged ceramic implant.

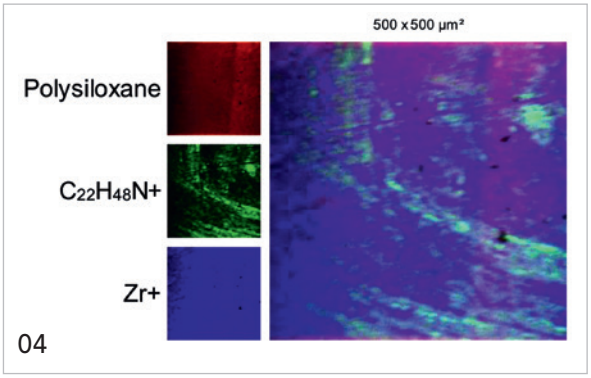
04
ToF-SIMS visualisation of polysiloxane (red) and the quaternary ammonium compound DDAC ($C_{22}H_{48}N+$; green) on the surface of the ceramic implant shown in Figure 3 (with permission of Tascon GmbH, Münster, Germany).

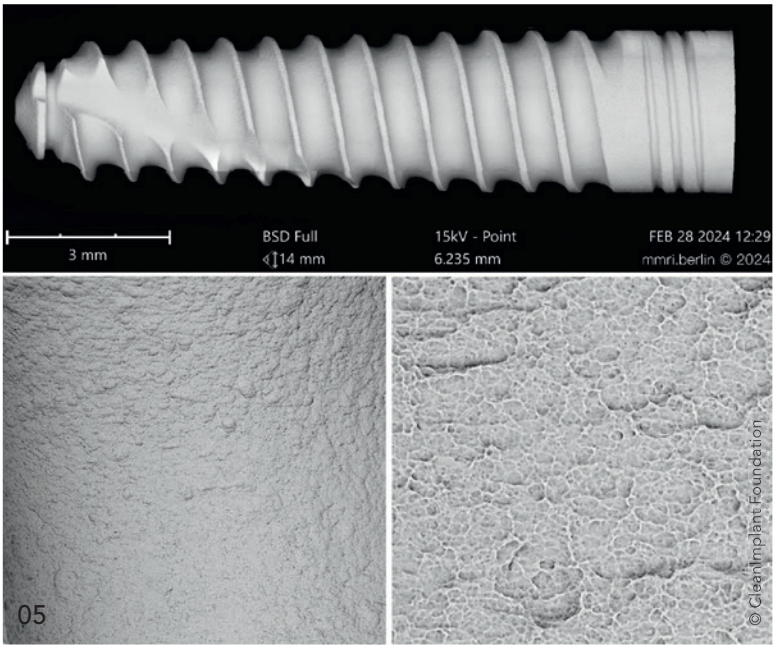
However, it is important to note that many implants examined under SEM revealed flawless surfaces, completely free of inorganic, organic, and plastic particles (Fig. 5). This demonstrates that contamination is not only a significant concern but also one that is technically preventable.

05
SEM mapping image of the whole implant after removal from the manufacturer's packaging (top); SEM magnification 500x (left) and 2,500x (right), demonstrating a clean surface free of any organic or metallic particles or other debris.

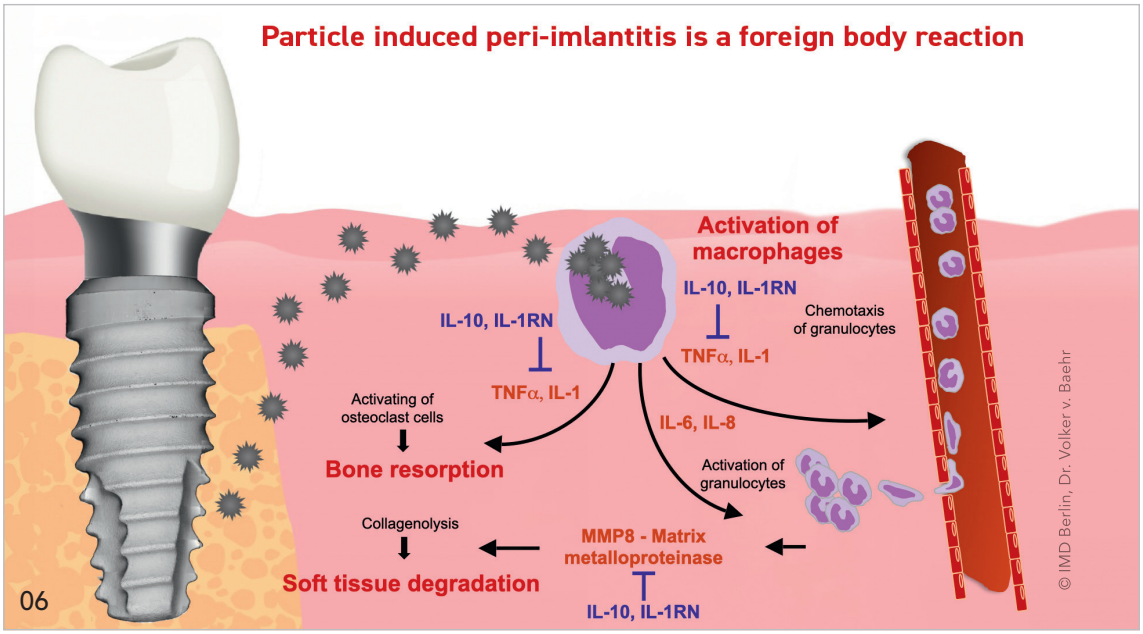
Carbon-containing organic particles that persist on the implant's surface during manufacturing or plastics from packaging can provoke an immune response in the form of a foreign body reaction (Fig. 6). During implant insertion, particles that detach from the surface are engulfed by macrophages through phagocytosis. This process triggers a cascade of proinflammatory cytokines, including TNF-α, interleukin(IL)-1β, and IL-6. These cytokines promote the differentiation of osteoclast precursors into mature osteoclasts, which can enhance osteoclastic activity and result in peri-implant bone resorption.[10]

06
Impurities detach during implant insertion from the surface and induce a storm of pro-inflammatory cytokines leading to bone resorption and soft-tissue degradation.
