Immediate implant placement and function in the aesthetic zone

Single-tooth restoration with a narrow-diameter two-piece implant

Dr Roland Glauser, Switzerland

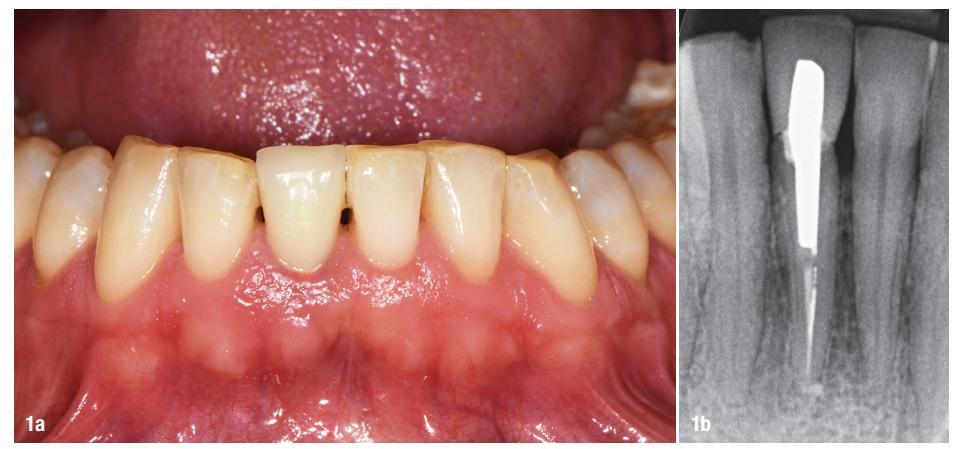
Figs. 1a & b: Frontal clinical view (a) and radiograph of the initial situation (b).

The 45-year-old male patient was referred to my practice. He presented for initial consultation complaining about a crown on his endodontically treated tooth #41 that had become loose. The patient had an accident in his youth which resulted in the traumatic facture of the mandibular right central incisor. As a result, the tooth had to be endodontically treated and was restored with a gold post and core and a veneered ceramic crown (Fig. 1). The crown had been *in situ* without complications for 22 years. Upon removing the failing crown

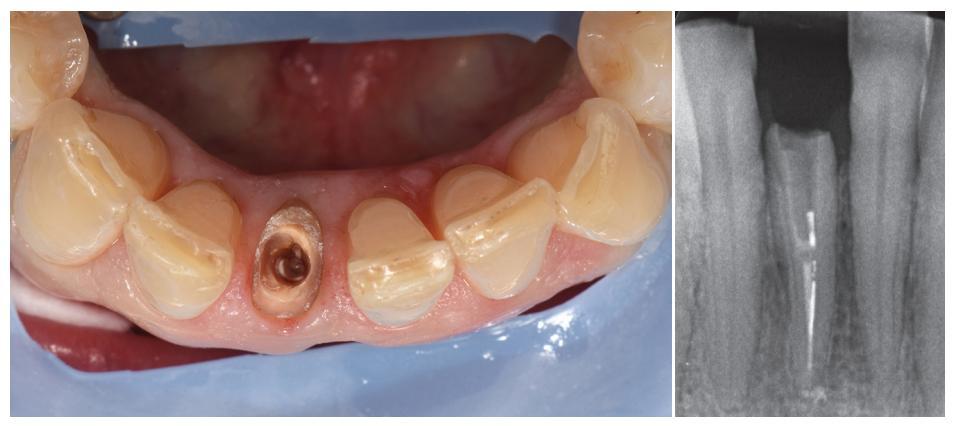
Figs. 2a & b: Occlusal clinical view (a) and radiograph after removal of the insufficient crown and post in region #41 (b).

and the post, a vertical root fracture was discovered (Fig. 2). Therefore, the remaining root was deemed unsalvageable.

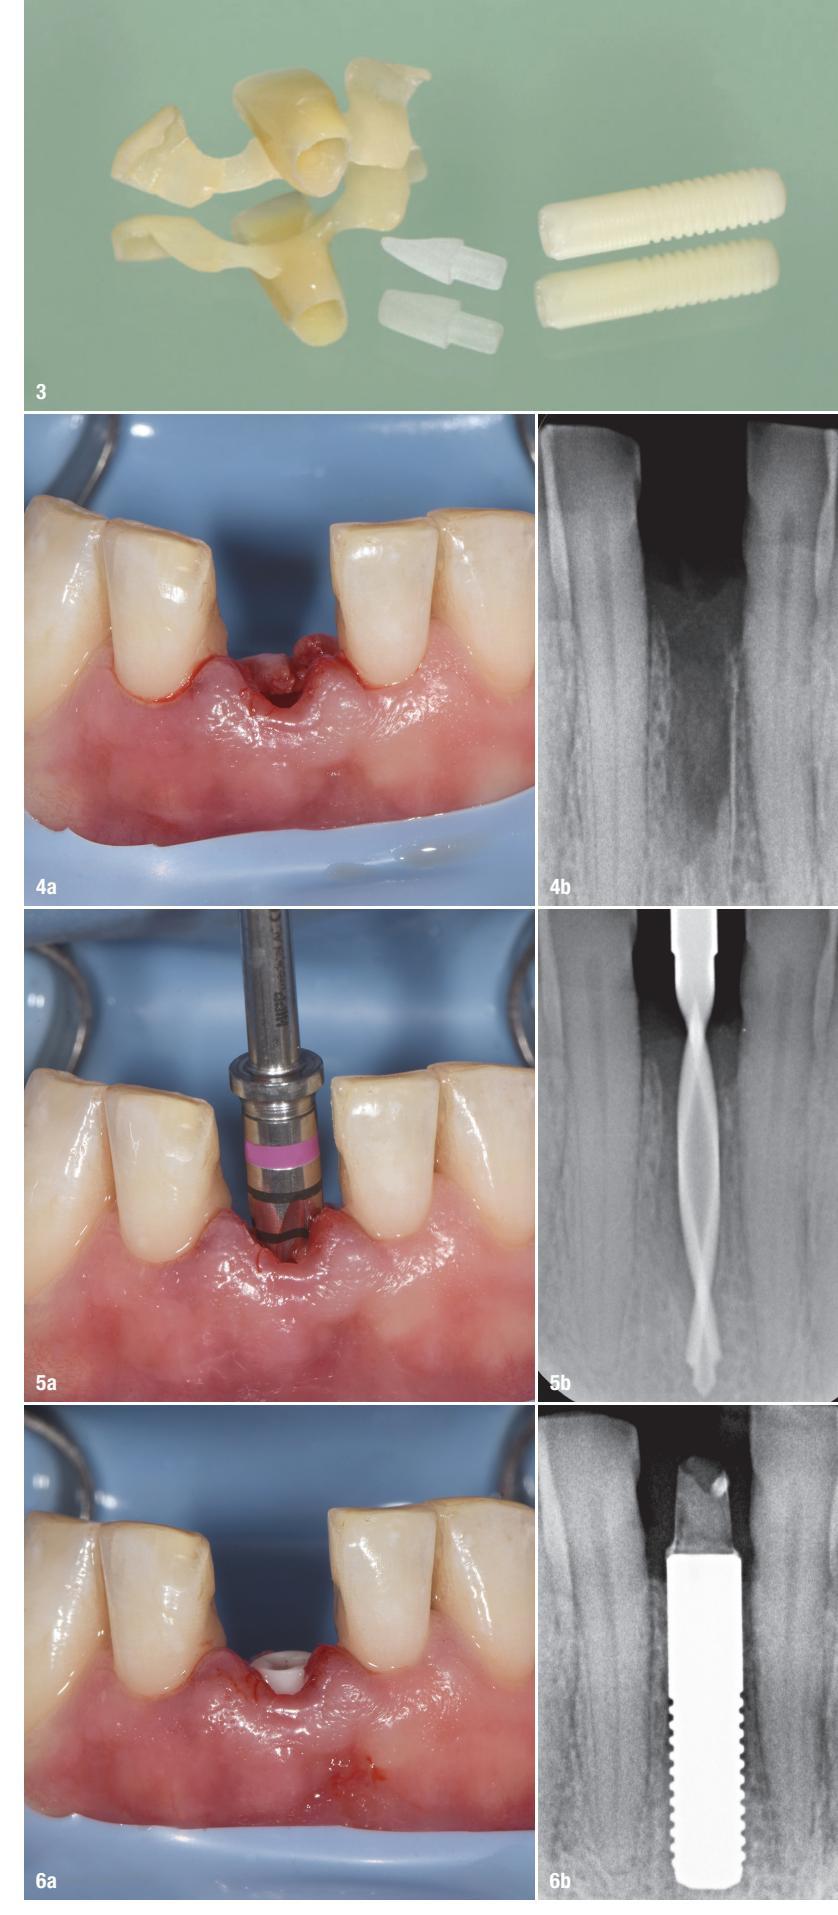
Fig. 3: From left: The shell provisional prosthesis with wings to be supported on the neighbouring teeth, the glass fiber post prepared in advance, and the individual narrow-diameter implant. Figs. 4a & b: Frontal clinical view (a) and radiograph after root extraction (b). Figs. 5a & b: Frontal clinical view (a) and radiograph after root extraction (b). Figs. 6a & b: Frontal clinical view (a) and radiograph after implant (b). Figs. 6a & b: Frontal clinical view (a) and radiograph after immediate implant placement (b).

Treatment would involve the extraction of root #41, and the restoration of this area with an immediate implant with immediate function using a provisional crown. Before the surgery, the dental laboratory conducted a spatial analysis on a study model. Additionally, the tooth to be extracted was ground off the stone model, and an implant analogue was placed in the ideal position. Thereafter, the glass fiber post was prepared on the model, and a shell provisional prosthesis was fabricated (Fig. 3). It incorporated wings to be placed on the neighbouring teeth to allow its correct positioning.

After local anaesthesia had been administered, a rubber dam was placed for isolation and optimum control of the operative site. Root #41 was then extracted, and the extraction socket was carefully curetted to remove any fibrous tissue and examined (Fig. 4). The osteotomy for the immediate implant was prepared according to the drilling protocol of the implant manufacturer (Fig. 5). An individual two-piece narrow-diameter zirconia implant of 3.5 mm in diameter and 13.0 mm in length (Patent[™] Dental Implant System, Zircon Medical Management), which was designed ahead of surgery, was inserted into the prepared osteotomy to a final torque of 28 Ncm, achieving adequate primary stability to proceed with the provisional prosthesis and immediate function (Fig. 6).

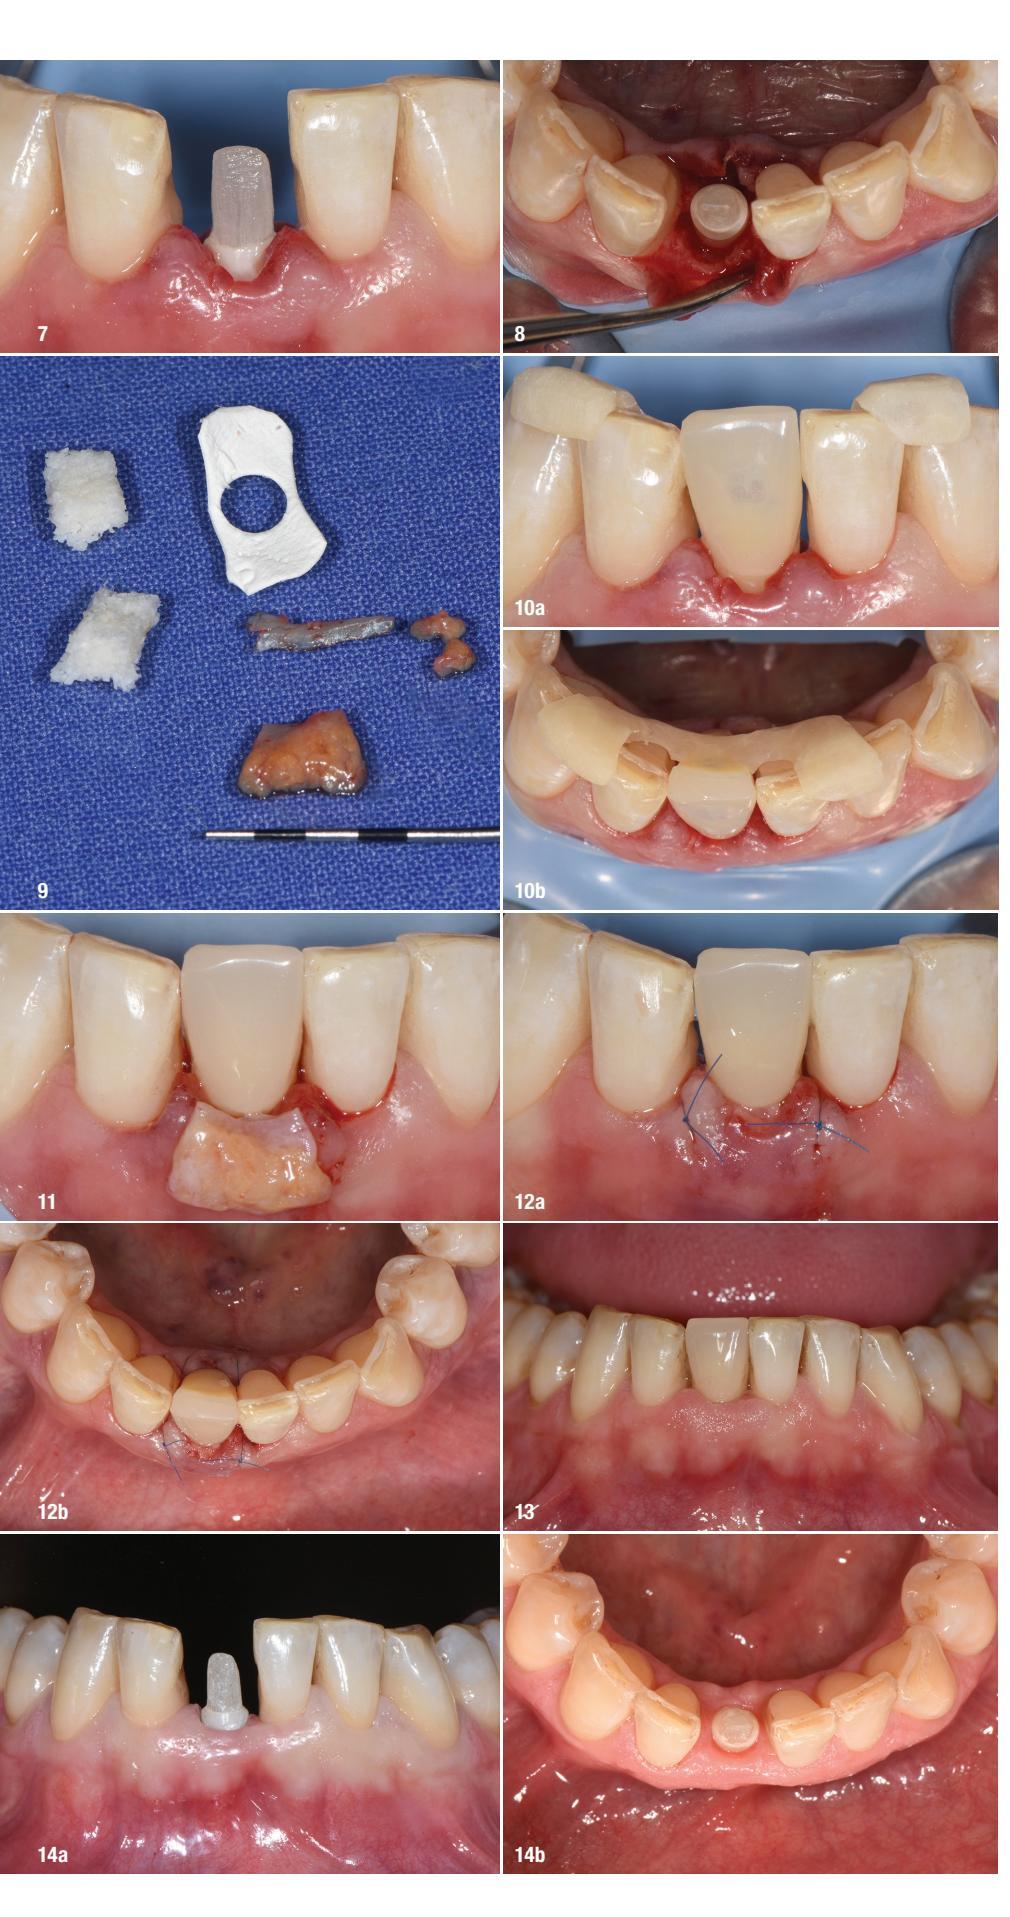
Fig. 7: Frontal clinical view of the glass fiber post cemented in place. Fig. 8: Occlusal clinical view prior to guided bone regeneration. Fig. 9: Bio-Oss Collagen®, resorbable Bio-Gide® membrane, and connective tissue graft. Figs. 10a & b: Frontal (a) and occlusal clinical views of the cemented provisional crown (b). Fig. 11: Frontal clinical view of the connective tissue graft *in situ*. Figs. 12a & b: Frontal (a) and occlusal clinical views of the sutured grafted site (b). Fig. 13: Frontal clinical view three weeks post-op. Figs. 14a & b: Frontal (a) and occlusal clinical views at the nine-month follow-up, before final impression taking (b).

Immediately after implant placement, the glass fiber post, which was prepared in advance by the dental laboratory, was inserted into the 3C connection of the implant and cemented in place using RelyX[™] Unicem dental cement (3M; Fig. 7). Afterwards, a guided bone regeneration procedure was performed using Bio-Oss Collagen® and a resorbable Bio-Gide® membrane (Geistlich Pharma) to fill the gap between the wall of the extraction socket and the implant (Figs. 8 & 9). A circular hole was punched in the membrane to allow it to be placed over the grafted site with the implant penetrating through, enabling provisionalisation. The post was then isolated to avoid any chemical reaction between the glass fiber post and the composite. The provisional prosthesis was relined on the post with flowable composite (Fig. 10). The wings were subsequently cut off, and the crown was polished. The crown was cemented using a temporary cement (Temp-Bond™, Kerr Dental), and a lingual vent hole allowed for excess cement to be evacuated. A connective tissue graft was placed labially to bulk up the soft tissue and increase volume (Fig. 11). The grafted site was finally sutured closed (Fig. 12).

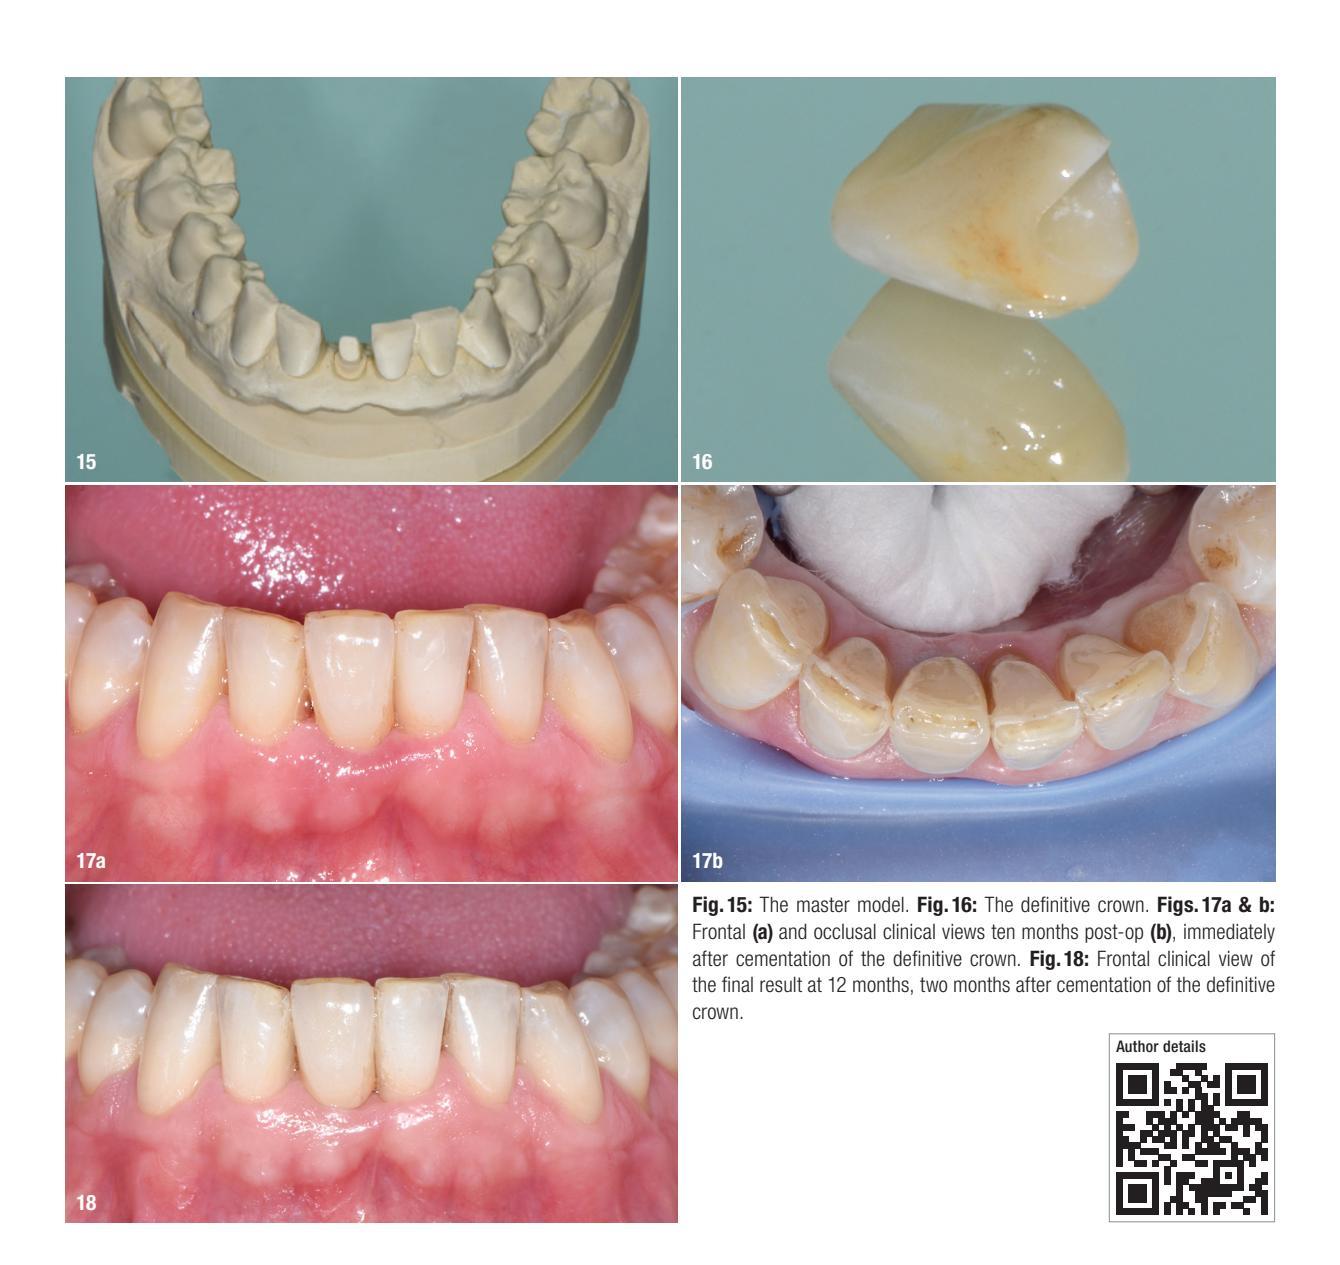
At the three-week follow-up, healing was considered uneventful (Fig. 13). At the nine-month follow-up (Fig. 14), a conventional full-arch impression was taken, which served as the basis for the fabrication of the master model and the definitive crown by the dental laboratory (Figs. 15 & 16). At the ten-month follow-up, the definitive prosthesis was delivered (Fig. 17). At the 12-month follow-up, the definitive prosthesis was considered highly aesthetic, and the peri-implant soft-tissue conditions were stable and healthy (Fig. 18).
