Multidisciplinary integration of odontology and sleep unit

Treatment of a patient with severe bruxism, loss of vertical dimension, tooth wear and fracture of dental implants

Dr Eduardo Anitua, DDS, MD, PhD, Spain

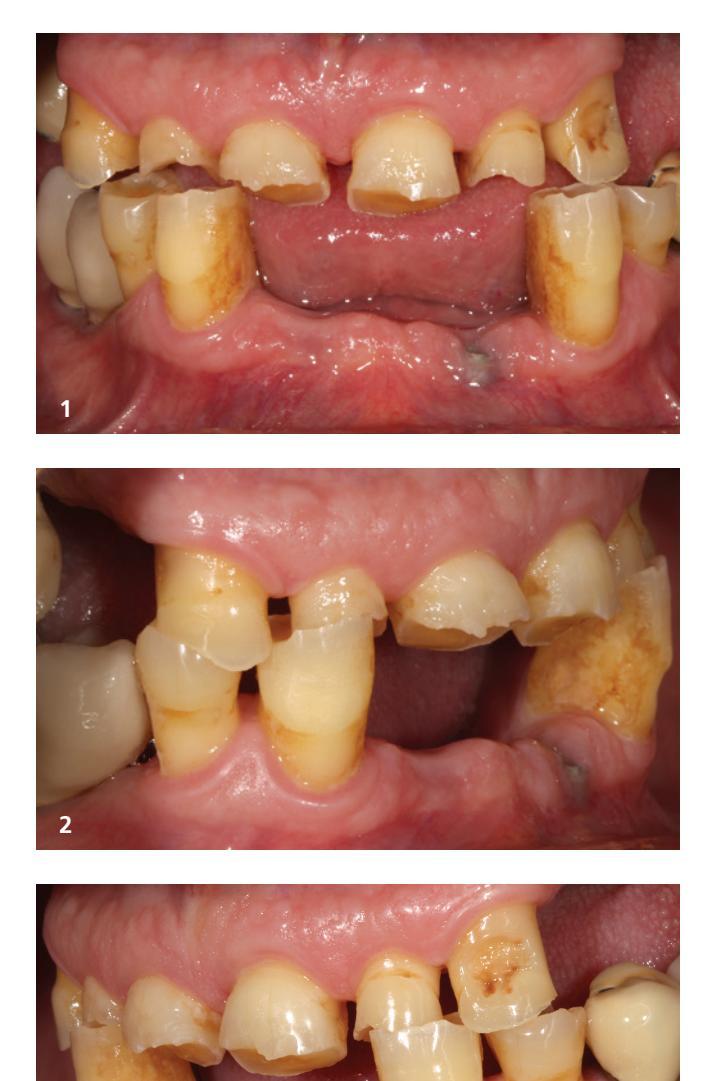
Fig. 1: Initial situation: Extreme wear of the upper arch with areas where dental pulp is practically exposed and moderate wear of the lower arch can be observed, as well as an implant without its crown in the mandibular anteriorinferior area. Figs. 2 & 3: Images of severe occlusal wear and collapsed bite, with contact only at the level of the anterior teeth, in addition to the extrusion of some pieces of the lower arch such as canines and premolars.

The 62-year-old male patient requested treatment for his very worn and highly sensitive teeth, and to replace missing teeth, some of which had already been replaced and the treatment had failed. In the initial examination, moderate dental wear could be observed in the lower arch, and severe dental wear in the upper arch, with areas where the pulp chamber could even be seen through the dentine. In the area corresponding to the lower left lateral incisor a fractured metal component was visible through the gingiva that the patient indicated to be a dental implant (Fig. 1). In the lateral images, the evident existing dental wear, a collapse of the occlusion with an evident loss of the vertical dimension and an extrusion of the lower teeth leaving part of their root exposed to the oral milieu was observed. These images also showed that the entire occlusion rested on the anterior area (Figs. 2 & 3). The radiograph also showed several implants without loading: two in the second quadrant, with broken prosthetic components inside the implant and two lower implants, with broken components in one of them and a fracture of the implant head in the other implant. There were also several cavities and some restorations on implants that were currently in function without complications (Fig. 4).

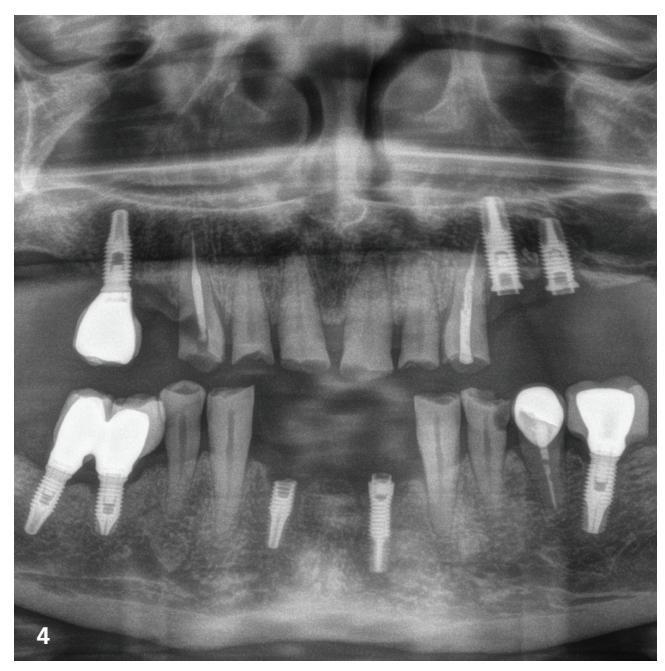
Fig. 4: Initial radiograph showing several caries in the remaining teeth as well as implants not loaded for different reasons. Fractured prosthetic components inside the connection within the two upper implants and the implant in position 32. Implant in position 42: fractured at the level of the implant crown. **Fig. 5:** Section of the planning CBCT showing how the extra-short implant can be placed in the second quadrant. **Fig. 6:** Panoramic radiograph after upper endodontics, core build-up and placement of temporary resin crowns to raise the vertical dimension.

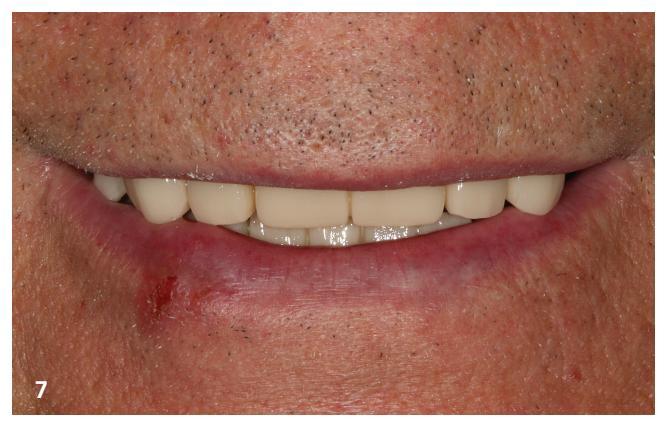
Figs. 7 & 8: Temporary situation after elevation of the vertical dimension.

avoiding a sinus lift at this level (Figs. 5 & 6) and reducing the morbidity of the process. This first opening of the vertical dimension with provisional prostheses allowed us to configure the final occlusal pattern and to generate a progressive extension of the masticatory muscles which was very contracted (Figs. 7 & 8).

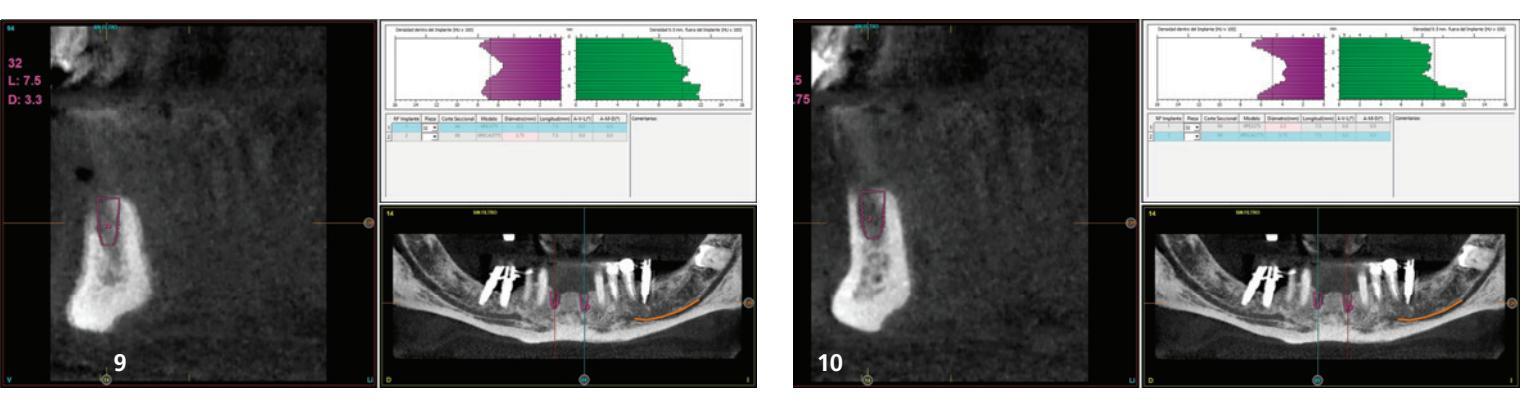
Figs. 9 & 10: Planning CBCTs of the implants for the mandibular incisors, showing the area of the removed implants has already regenerated.

Three months later, the implants could be placed in the areas of the explantations that are completely regenerated. For this purpose, the provisional prostheses were removed, and the implant placement surgery was performed in the lower incisor area (Figs. 9 & 10). The second quadrant area was also ready to receive the implant and an additional implant was placed in the first quadrant for greater stability in the future implant-supported rehabilitation of that area (Fig. 11). The patient continued with the provisionals, waiting for the new implants to be loaded,

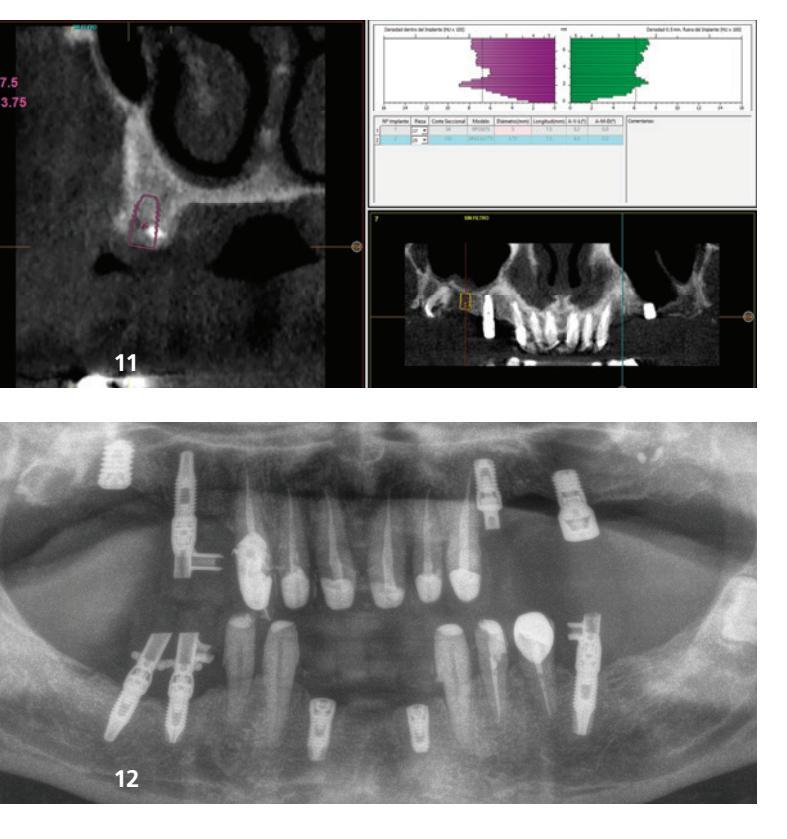
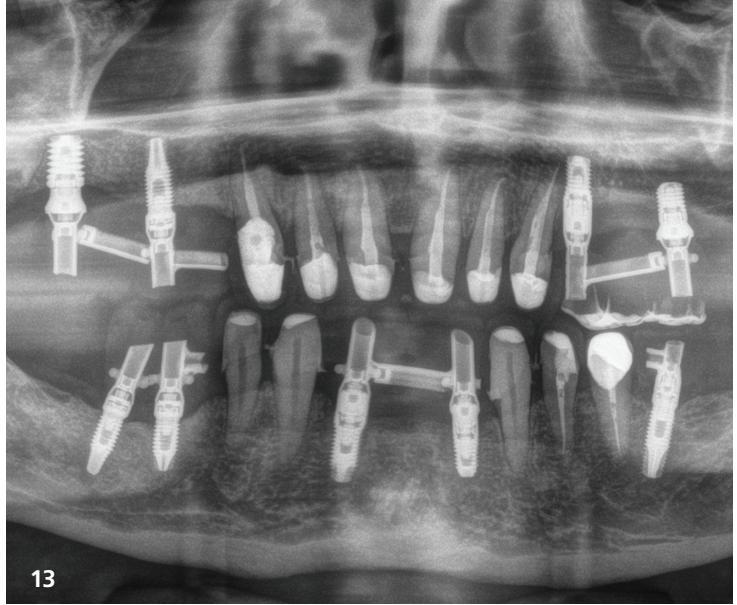
Fig. 11: Planning of the second quadrant implant placed in the area of previous implant removal. Fig. 12: Panoramic radiograph after insertion of the new implants. The patient continued with his provisional prosthesis while waiting for the new implants to be loaded. Fig. 13: Radiograph with the new progressive loading prostheses with all implants integrated.

which were scheduled in two surgical phases, while occlusal adjustment of the new vertical dimension continued (Fig. 12).

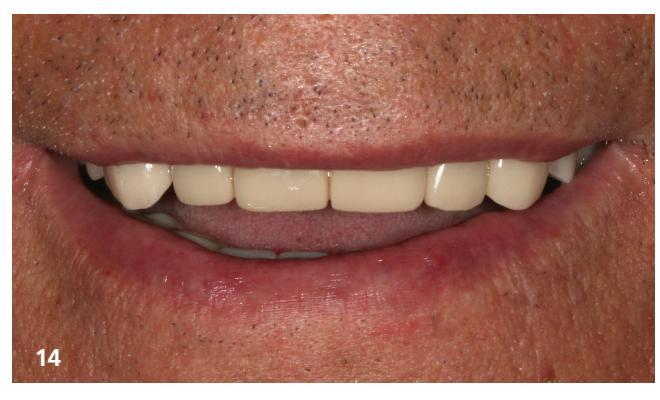
Figs. 14 & 15: Intra-oral and smile appearance of the second set of provisionals.

A further three months later, with the implants perfectly integrated in both the upper and lower arches, a second set of progressively loaded provisionals was made, including all the upper and lower implants. They were still resin prostheses to allow all the necessary adjustments to be made during these planning phases of the vertical dimension. Implant prostheses were also elaborated with a metallic base structure of articulated bars and the resin with the necessary anatomy was loaded on it (Figs. 13–15). These prostheses also provided the opportunity to carry out the aesthetic adjustments requested by the patient for the final prosthesis.

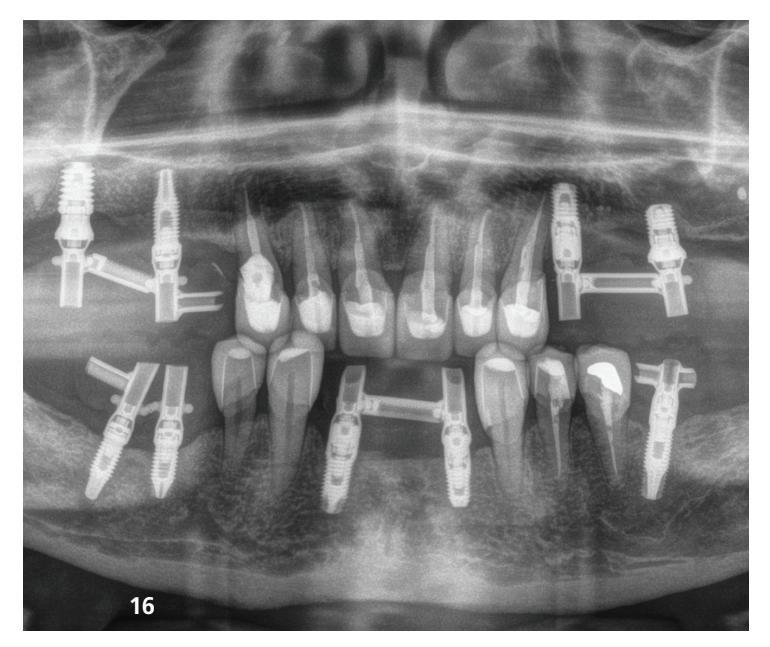
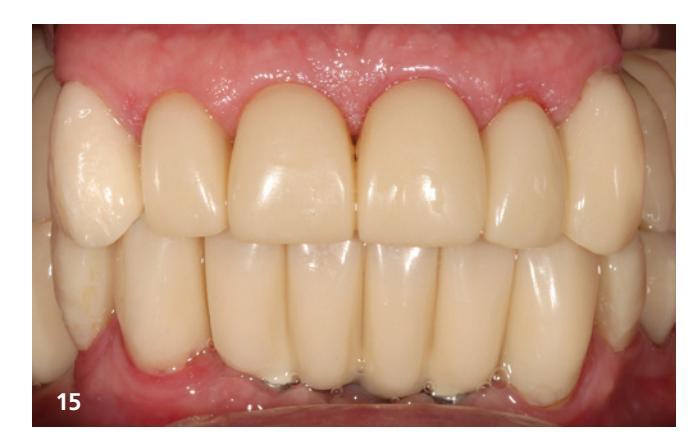
Fig. 16: Radiograph with the definitive crowns and the provisional prostheses on implants adapted to them. **Figs. 17 & 18:** Clinical images of the final crowns on teeth and implants. The aesthetic parameters achieved in this phase can be observed and the occlusion, vertical dimension and occlusal plane are stable.

Two months later, a stable vertical dimension was achieved, and the definitive crowns were placed. These crowns were made of ceramic (e.max) and cemented with resin cement. Once in place, the implant-supported temporaries were leveled for the final provisional phase (Fig. 16). One month later, the definitive crowns for the implants were placed, thus completing the case. The crowns on implants were screwed on multiple transepithelial (Multi-im) in metal-ceramic with metal drilling by CAD/CAM and subsequent addition of the ceramic by hand (Figs. 17–19). The aesthetic parameters achieved in this phase can be observed and the occlusion, vertical dimension and occlusal plane are stable.

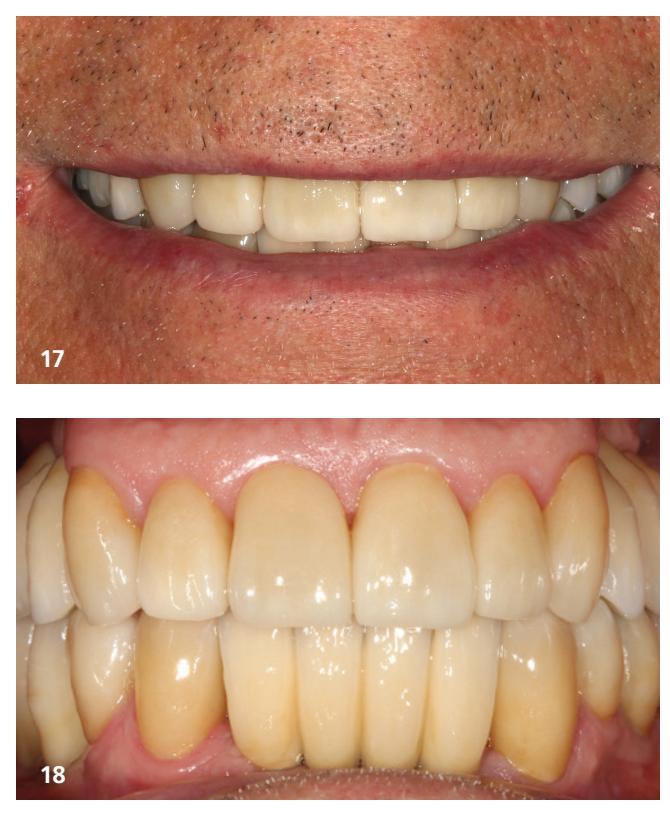
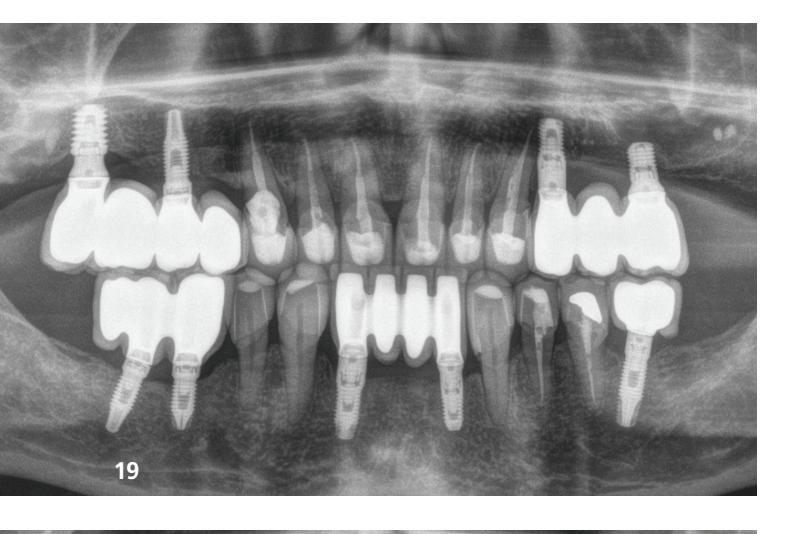
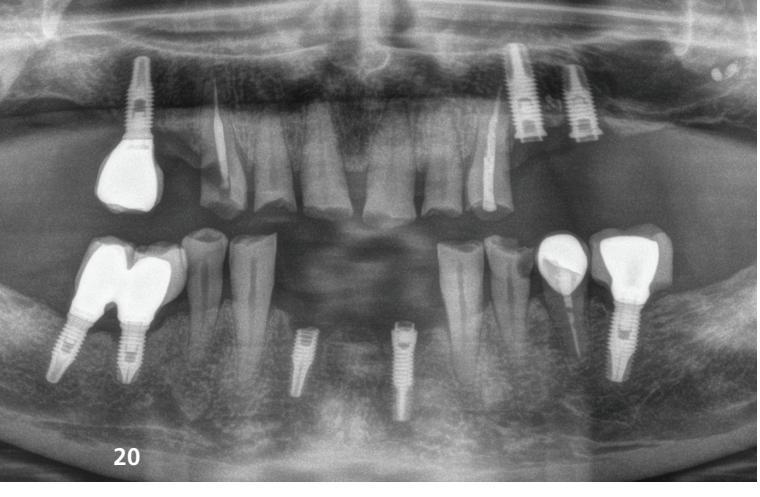
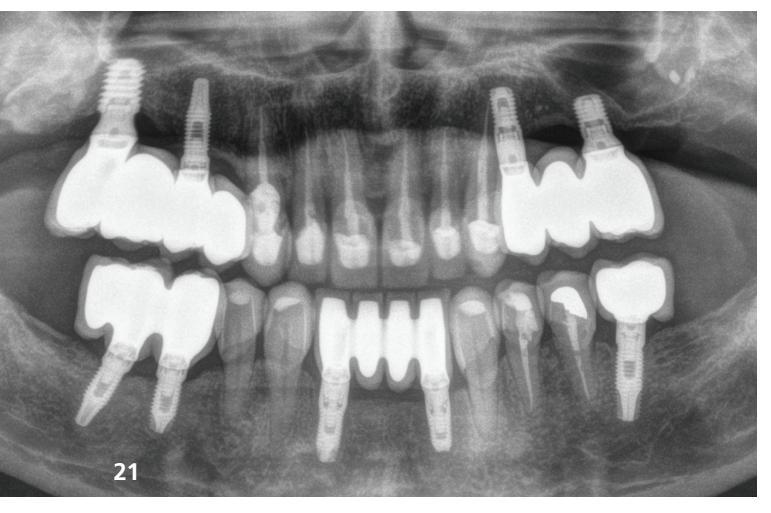
Fig. 19: Final radiograph of the patient with the complete prostheses and the definitive crowns. **Figs. 20 & 21:** Initial and final radiograph at one year follow-up with total stability of the treatment achieved.

At this point the patient was referred to the sleep unit, to treat his SAHS as good anterior and posterior stability and a recovered vertical dimension were achieved. The patient was treated with the mandibular advancement device and after two titrations with a change of tensor (to achieve the minimum effective protrusion) the patient's AHI was reduced to 3. The patient continued to undergo revisions and there were no prosthetic complications or fractures of the rehabilitation components one year later (Figs. 20–25).

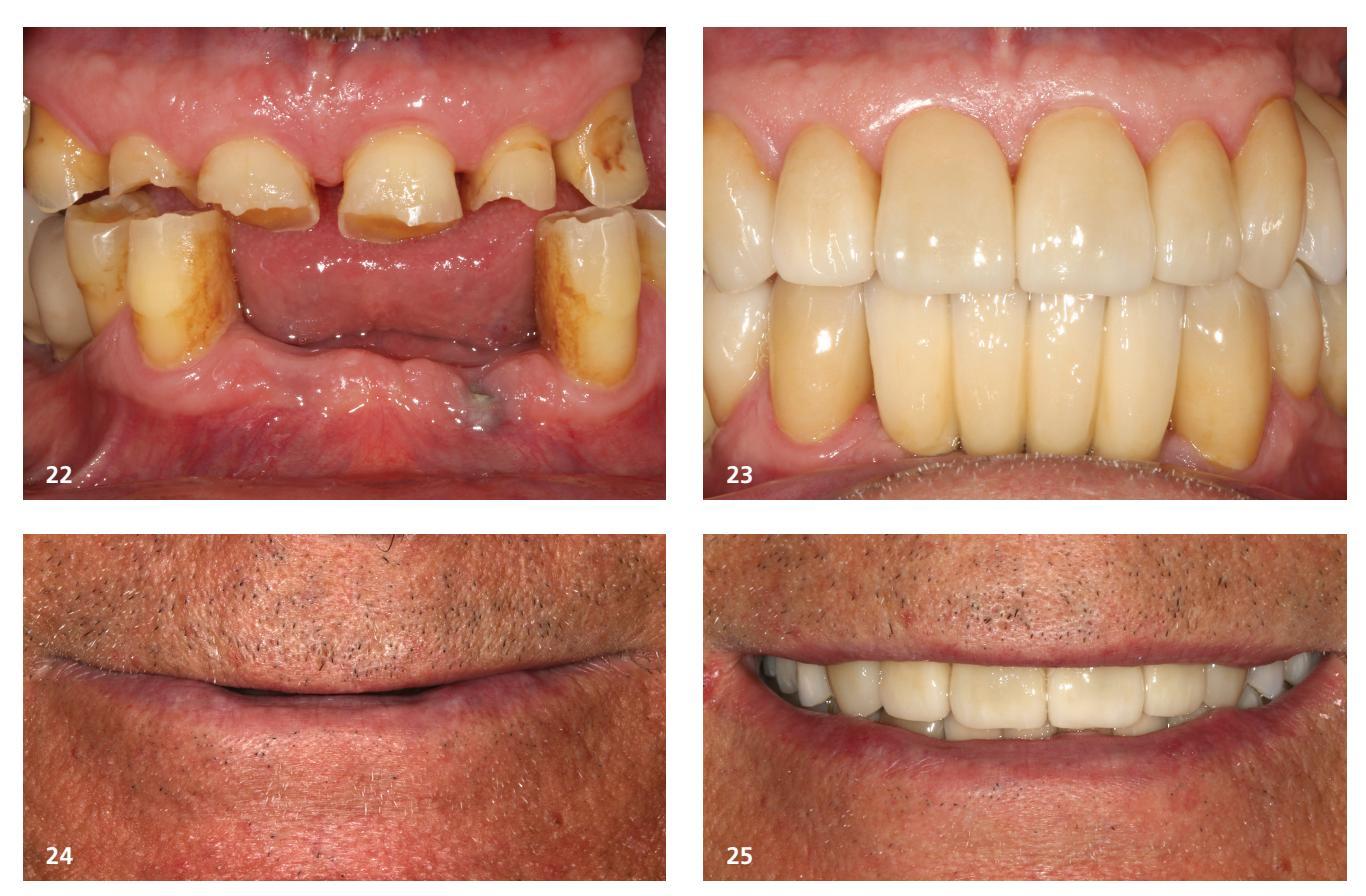
Figs. 22–25: Images before and after treatment at one year of follow-up showing the stability achieved and the preservation of the rehabilitation.
