Removal of a fractured instrument: Two case reports

Author_ Dr Rafaël Michiels, Belgium

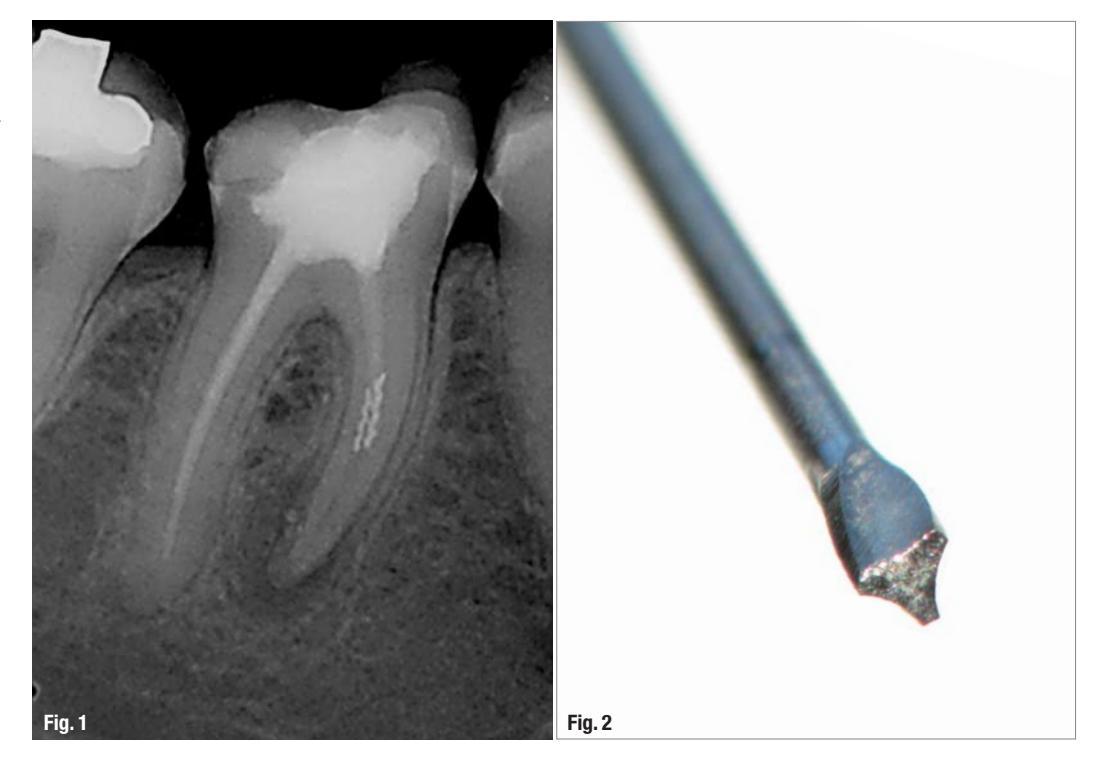
Fig. 1_Diagnostic radiograph, showing two separated instruments in the mesial root. Fig. 2_A modified Gates-Glidden bur used for creating a plateau above the instrument

nostic radiograph (Fig. 1) showed not one but two broken instruments in the mesial root, one in each mesial canal. Thereafter, the tooth was isolated with the rubber dam and the coronal filling was removed. Straight-line access was established, as this is imperative in order to be able to reach and see the fractured instruments. Gates-Glidden burs (DENTSPLY Maillefer) were used to enlarge the mesial orifices coronally.

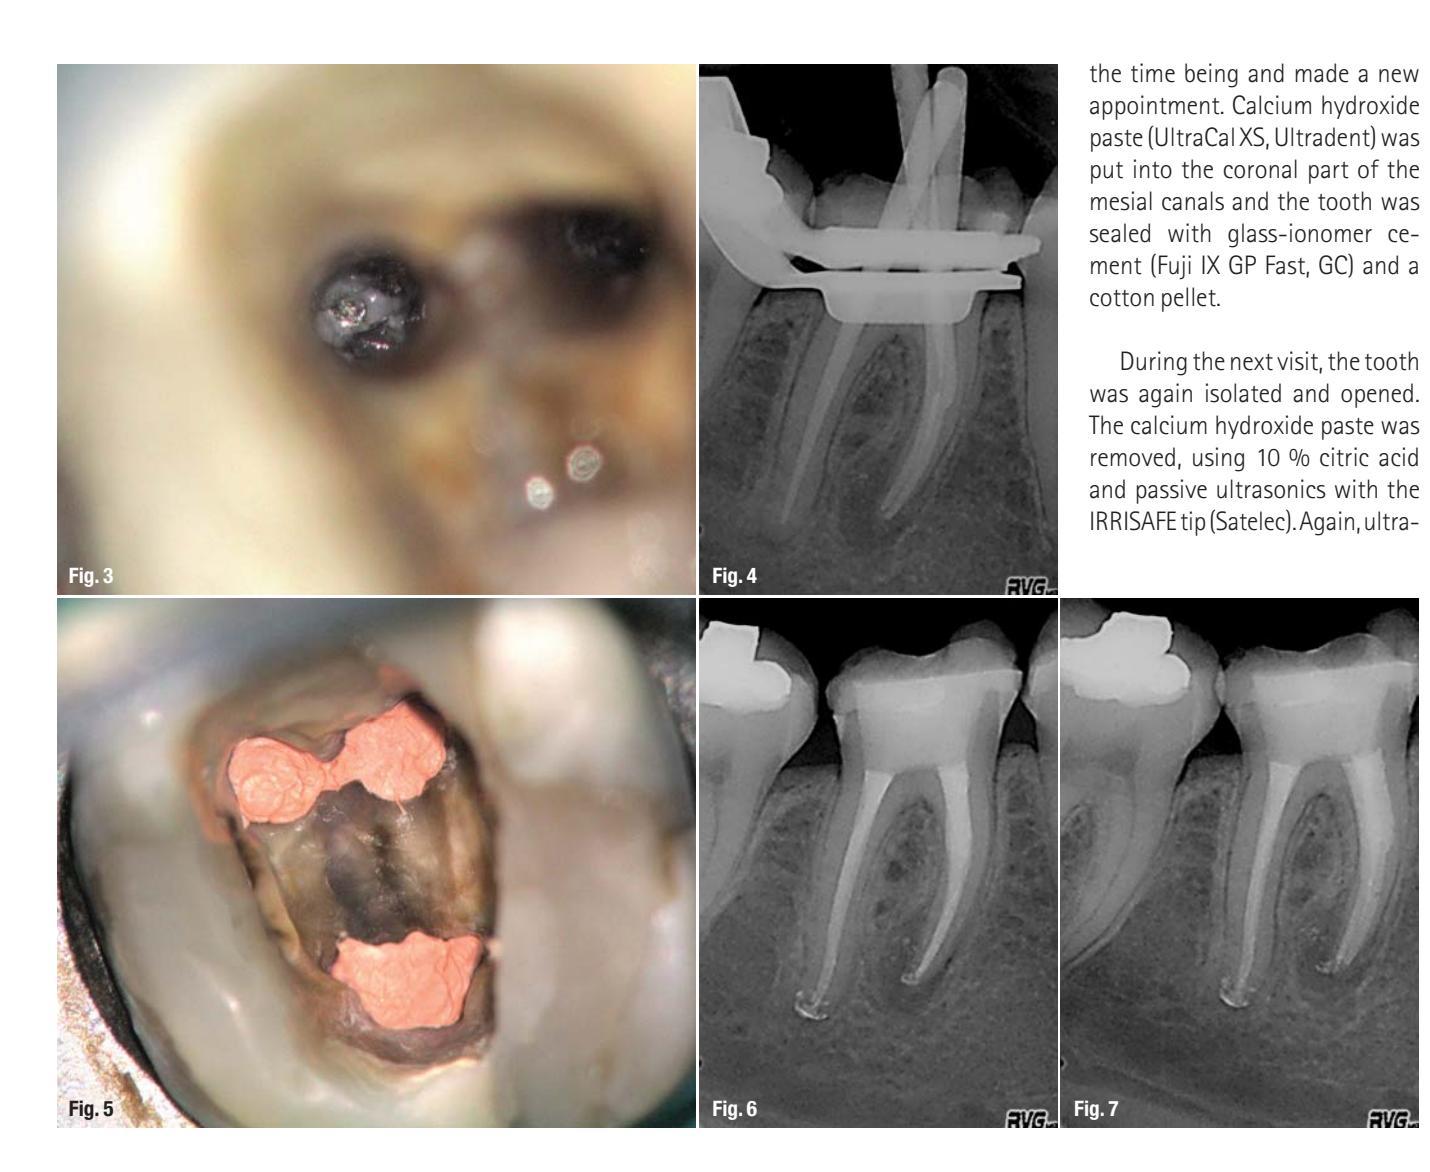
Fig. 3_One of the separated instruments.
Fig. 4_Gutta-percha cone fitting.
Fig. 5_The pulp chamber after obturation with gutta-percha.
Fig. 6_Final radiograph (parallel).
Fig. 7_Final radiograph (angled).

After reaching the instrument in the mesio-buccal canal, I modified a size 3 Gates-Glidden bur by removing the tip of the bur (Fig. 2). In this manner, one gains an aggressive bur that allows one to create a platform above the instrument. At this moment, the instrument could be clearly visualised (Fig. 3). Ultrasonics were then used to loosen the fragment. ProUltra tips (DENTSPLY Maillefer), both zirconium nitride and titanium, were used for this purpose.

One-and-a-half hours after starting the treatment, the fragment had been loosened but was still stuck in the canal. We decided to leave it in place for sonics were used to retrieve the instrument. After five minutes, the fragment in the mesio-buccal canal was removed. Another five minutes later, the instrument in the mesio-lingual canal was also removed. While removing the instrument in the mesio-buccal canal was very time-consuming, removing the instrument from the mesio-lingual canal was surprisingly easy. This clearly highlights the above-mentioned difficulty range of instrument retrieval.

After the removal of both instruments, working length was determined in both mesial canals with the electronic apex locator (Root ZX Mini, Morita). A glide path was established and the mesial canals were initially shaped with a ProTaper S1 (DENTSPLY Maillefer). Copious irrigation was performed using 3% sodium hypochlorite. Next, the gutta-percha in the distal canal was removed with a size 25.06 ProFile (DENTSPLY Maillefer), which was rotated at 500 rpm in an X-smart Easy endodontic motor (DENTSPLY Maillefer). No chemical was required for gutta-percha softening. The canals walls were scraped with Micro-Debriders (DENTSPLY Maillefer) in order to remove the last remnants of gutta-percha. All canals were shaped to a size 40.06 ProFile. Final apical shaping was performed with K-Flexofiles (DENTSPLY Maillefer). Smear-layer removal was carried out by irrigating the canal with 10% citric acid. A final wash of the canal was performed with sterile saline. Tapered gutta-percha cones were then fitted (Fig. 4) and tug-back was confirmed. Topseal (DENTSPLY Maillefer) was used as a rootcanal sealer.

obturation (Fig. 5), a temporary restoration of glassionomer cement was placed (Fuji IX GP Fast). Final radiographs (Figs. 6 & 7) were taken, both parallel and angled. The radiographs show two completely separated mesial canals; hence, instrument removal in both canals was favourable. The prognosis of this case was good and the patient was referred to her general dentist for a definitive coronal restoration.

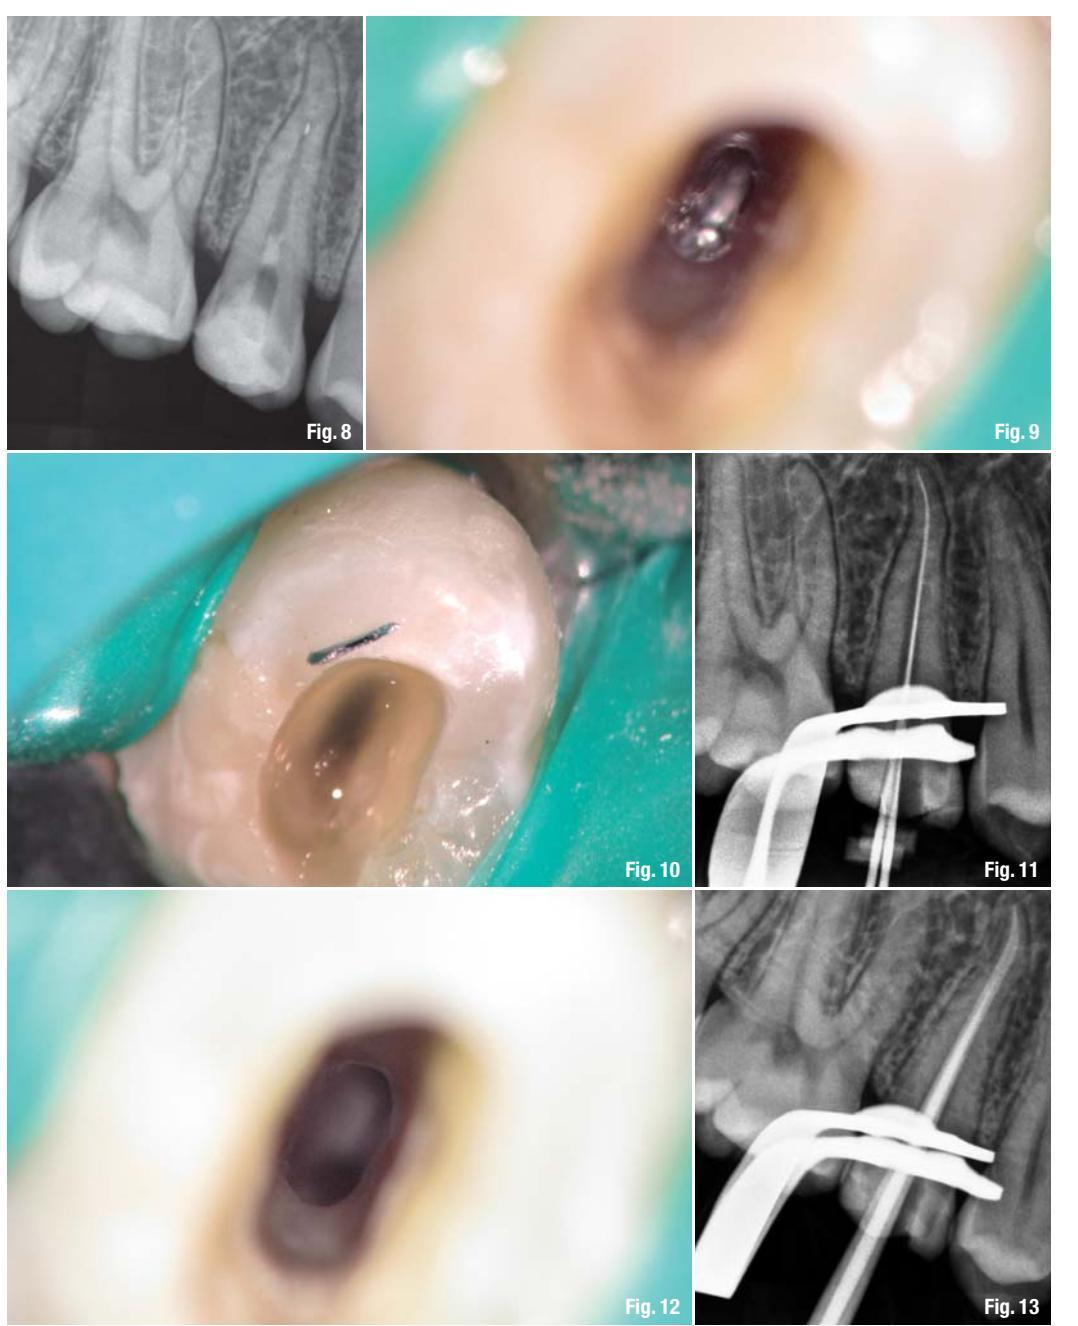
Fig. 8_Diagnostic radiograph, showing the separated instrument at approx. 5 mm from the apex. Fig. 9_The separated instrument. Fig. 10_The separated file after retrieval. Fig. 11_Working length determination. Fig. 12_Deep apical split. Fig. 13_Gutta-percha cone fitting.

A new diagnostic radiograph (Fig. 8) was taken, which showed the fragment approx. 5 mm from the apex. The tooth was isolated with a rubber dam and access was gained through the temporary restoration, which was placed by the referring dentist.

After opening, the remnants of calcium hydroxide paste were removed with 10% citric acid and passive ultrasonics. The fractured instrument could be visualised immediately (Fig. 9), because the canal was very large in the middle and coronal part. This allowed a very conservative and tissue-saving approach. Given the position in the canal and the shape of the canal, a deep apical split of the canal was suspected. After probing with small K-files, a patent palatal was confirmed.

The fractured instrument was retrieved (Fig. 10) and after determining working length (Fig. 11), shaping with rotary nickel-titanium instruments (Twisted Files, SybronEndo) was started. Both canals were shaped to a size 25.08 Twisted File. The master apical file was kept small due to the deep split (Fig. 12) and the tension felt while shaping, thus minimising new instrument fracture. Apical finishing was carried out with size 25 K-flexofiles. Smear-layer removal was performed with a rinse of 10 % citric acid. A final wash of the canal was carried out with sterile saline. Tapered gutta-percha cones were then fitted and tug-back was confirmed (Fig. 13). Topseal was used as a root-canal sealer. Both canals were obturated according to the continuous wave of condensation technique with the Elements Obturation Unit. After obturation (Figs. 14 & 15), a temporary restoration in glass-ionomer cement was placed together with a cotton pellet, which was soaked in an alcohol and chlorhexidine mixture first and then air-dried after it had been placed in the access cavity. Final radiographs (Figs. 16 & 17) were taken, both parallel and angled. The prognosis of this case was good and the patient was referred to his general dentist for a definitive coronal restoration.

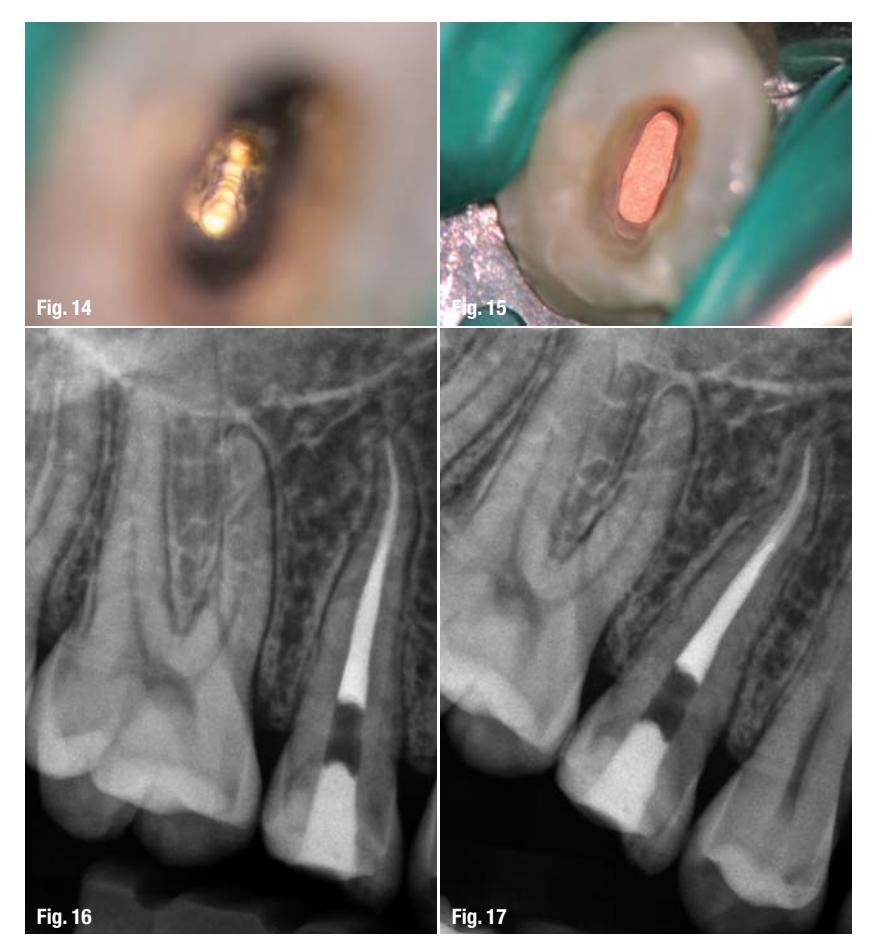
Fig. 14_Apical obturation with gutta-percha.
Fig. 15_The pulp chamber after complete obturation with gutta-percha.
Fig. 16_Final radiograph (parallel).
Fig. 17_Final radiograph (angled).
