## Room for improvement

Remarkable impurities found on randomly chosen ceramic implants

## Dr Dirk U. Duddeck, Germany

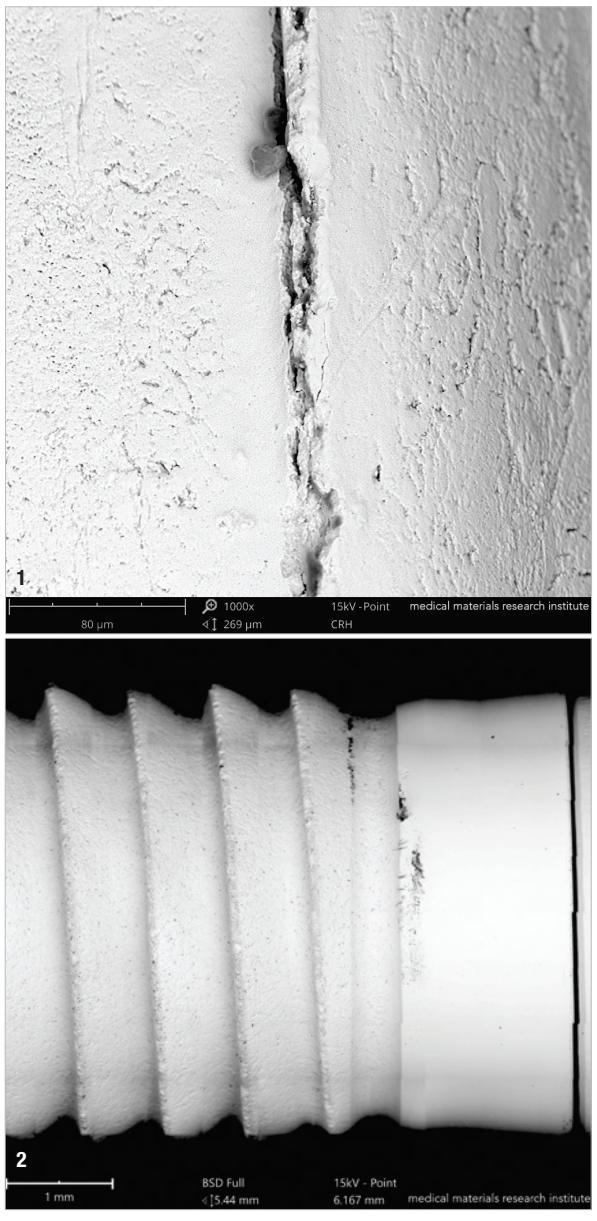
Fig.1: Organic contaminants in a crack at the implant shoulder. Fig.2: Plastic (polyoxymethylene) particles from the implant packaging on the first implant thread.

The Swedish-German research team from Charité Universitätsmedizin—Berlin (Duddeck and Florian Beuer), Sahlgrenska Academy at the University of Gothenburg (Tomas Albrektsson and Ann Wennerberg) and Malmö University (Christel Larsson), supported by the International University of Agadir (Jaafar Mouhyi), revealed some unexpected results. While the surfaces of two of the investigated implant systems were found to be largely free of particles, the other systems examined revealed significant carbon-containing organic impurities on their surfaces (Fig. 1). Subsequent time-of-flight secondary ion mass spectrometry analysis identified these contaminants as polysiloxanes, erucamide, aliphatic hydrocarbon compounds, fatty acid esters, talc and even polyacetal (polyoxymethylene; Fig. 2).

Remarkably, the study showed that in one system the sterile packaging itself was the cause of substantial plastic contamination on the sterile implant's surface some of the contaminants were millimetres in size. Dodecylbenzenesulphonic acid (DBSA) was also detected on samples of two implant systems, which suggests that the manufacturers' cleaning process of the ceramic implants examined was insufficient. DBSA is an aggressive surface-active cleaning agent classified as hazardous by the U.S. Environmental Protection Agency. Four of the ceramic implant systems examined had a moderately rough implant surface. Only one ceramic implant system showed minimal surface roughness. Clinical studies were documented for three ceramic implant designs, and these had a follow-up period of up to three years and results ranging from 82.5 to 100% survival. The two other implant systems did not provide properly conducted clinical records.
