# Development of a new **guided sleeve** made of **zirconia dioxide**

## Application for surgical guides in dental implantology

Leonard Vollmer, Dr Rainer Valentin, Dr Rolf Vollmer, Prof. Werner Götz, Germany

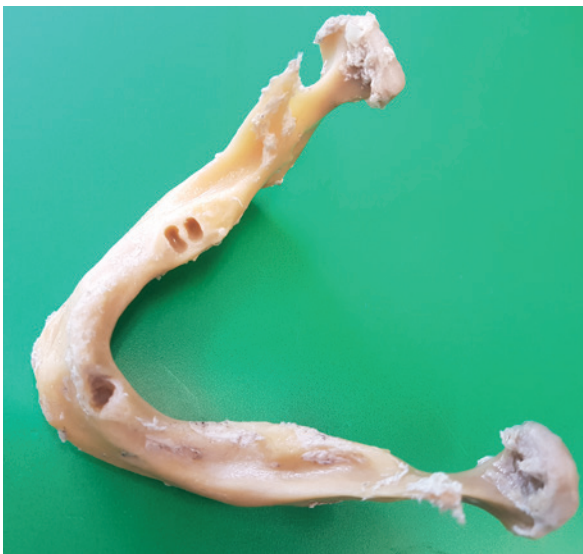
An anatomical edentulous macerated mandibular specimen fixed in paraformaldehyde was used for the experiment (Fig. 1). This preparation was chosen to simulate an *in vivo* situation. The portions of the cortical bone were broad and the cancellous structures dense. The

Fig. 1: Lower jaw preparation before drilling. (© Leonard Vollmer)
