# Screw-retained restoration of upper right first molar and second premolar

Dr Anthony Bendkowski, UK

In the following case report the intended screw-retained restorations was successfully achieved by using the DS OmniTaper Implant System to restore both the upper right first molar as well as the second premolar. This case report is published as an inspiration for clinicians or technicians, not necessarily as a recommendation from Dentsply Sirona.

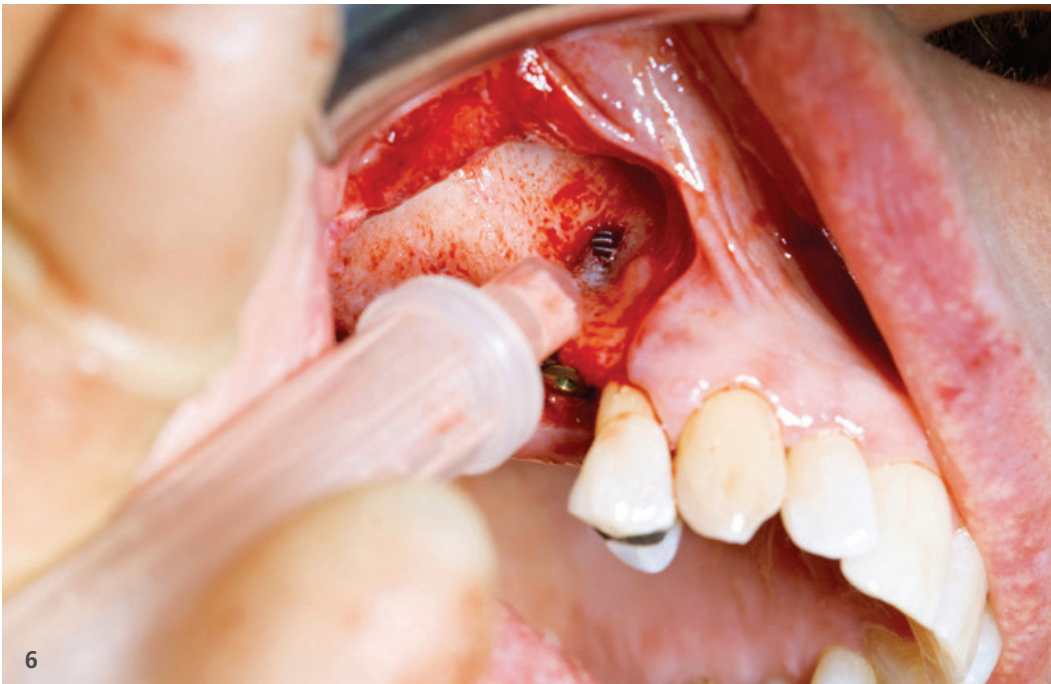
**Fig. 2:** Radiographic assessment: ample bone depth in posterior maxilla. **Fig. 3:** Full thickness envelope flap and Direction Indicators in situ. **Fig. 4:** Installation of an OmniTaper EV Ø 3.8 x 11 mm implant in tooth #4 (FDI 15) position using the TempBase Driver. **Fig. 5:** Both OmniTaper EV implants placed with the help of the pre-assembled TempBase abutments.

**Fig. 6:** Use of Dentsply Sirona disposable BoneTrap to augment the small bone fenestration.

implant was installed and nicely aligned in both tooth #4 (FDI 15) and #3 (FDI 16) positions using the TempBase Driver (Figs. 4 & 5) with the help of the pre-assembled TempBase abutments. The implant-abutment connection size was medium (M) as indicated by the yellow colour in Figure 5.

The small bone fenestration was then augmented by using the Dentsply Sirona disposable BoneTrap (Fig. 6) and a large quantity of autogenous bone collected (Fig. 7).

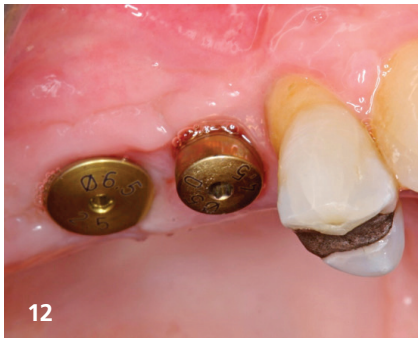
12

**Fig. 12:** Healing Abutment EV (M) placed after three months. **Fig. 13:** Atlantis IO FLO *in situ* ready for Primescan digital impression. **Fig. 14:** Design of Atlantis abutments and zirconia crowns. **Fig. 15:** Well-fitting screw-retained Atlantis CustomBase abutments and zirconia crowns. **Fig. 16:** Radiograph to verify correct seating of restorations. **Fig. 17:** Screw-access channels sealed and amalgam tooth position #5 (FDI 14) replaced with composite. **Fig. 18:** Final restorations completed.

Three months after the initial surgery healing abutments (M) were placed (Fig. 12). Next the Atlantis IO FLO were placed to complete the Primescan digital impression in order to achieve the planned
