# Immediately placed two-piece zirconia implant with customised healing abutment in the maxillary molar region

Drs Alexandre Marques Paes da Silva, Dennis de Carvalho Ferreira, Francisco Augusto Horta dos Santos, Mayla Kezy Silva Teixeira, Daniel Moraes Telles & Eduardo José Veras Lourenço, Brazil

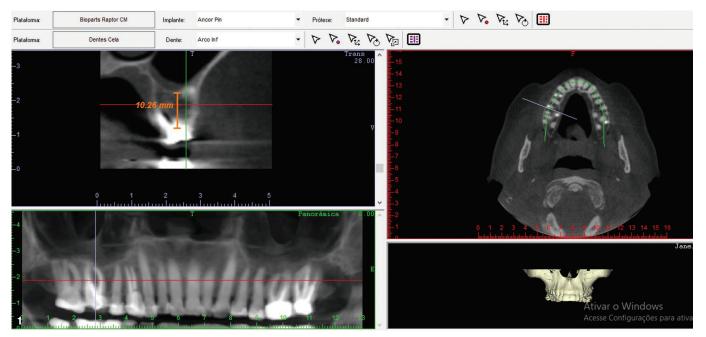
Fig. 1: Pre-op CBCT scan of the patient.

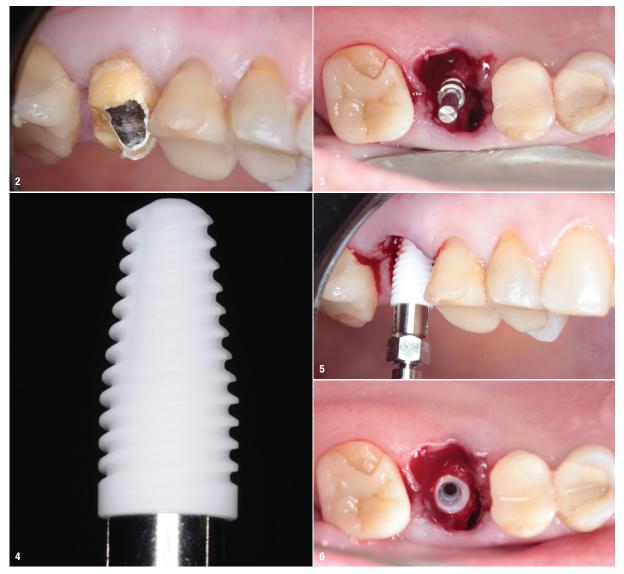
Fig. 2: Pre-op situation before sectioning of the roots. Fig. 3: Socket preparation. Fig. 4: GZi implant. Fig. 5: Placement of the implant Fig. 6: Final bone-level position of the implant.

After local anaesthesia (4% articaine with 1:100,000 adrenaline, DFL), tooth extraction was performed via a minimally invasive surgical approach. The roots of the first molar were sectioned and extracted separately using delicate periotomes to sever the periodontal ligament and lift the tooth pieces without flap raising (Fig. 2). After

extraction, the alveolus was thoroughly curetted to remove any inflammatory tissue and abundantly irrigated with saline solution. The recipient site preparation sequence was performed according to the manufacturer's recommendations (Zi ceramic implant, Neodent) as described in a previous study (Fig. 3).<sup>13</sup> A two-piece yttriastabilised zirconia implant (4.3 × 10.0 mm) was placed into the socket to a final insertion torque of 45 Ncm (Figs. 4–6).

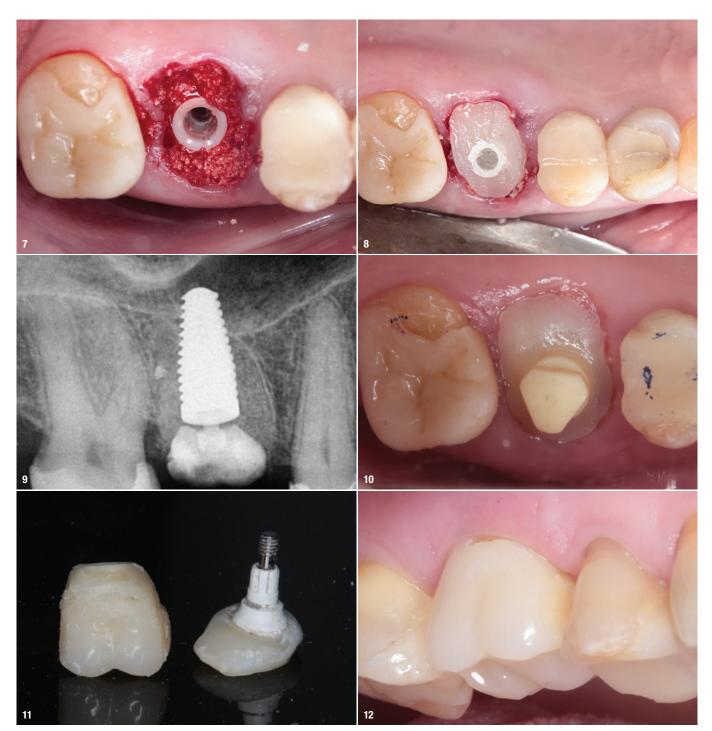
Fig. 7: After placement of the bone substitute material. Fig. 8: Customised healing abutment *in situ*. Fig. 9: Post-op radiograph with customised healing abutment. Fig. 10: Gingival emergence profile carefully copied using light-polymerised flowable resin. Fig. 11: Provisional crown and customised healing abutment. Fig. 12: Provisional crown *in situ*.

In addition, a bone substitute material (0.5 cm<sup>3</sup> of 0.5– 1.0 mm maxresorb granules, Straumann) was used to fill the gaps between the fresh socket walls and the external face of the implant (Fig. 7). A PEEK abutment was selected, and a customised healing abutment was made using light-polymerised flowable resin (Fig. 8). It was not necessary to use a suture to close the surgical wound. At the end of the surgery, a radiograph was taken (Fig. 9).

The three-month postoperative period was uneventful. The customised healing abutment was carefully removed, and conventional impressions were taken with a putty and medium-bodied addition-cured silicone using the closed-tray technique. A provisional crown was made with self-polymerising resin and seated. It remained in the patient's mouth until the day of cementation of the definitive crown. It is important to highlight that the gingival emergence profile was carefully copied using light-polymerised flowable resin (Figs. 10–12). A lithium disilicate crown was manufactured and cemented on to the prosthetic abutment with adhesive cement (Figs. 13–18).

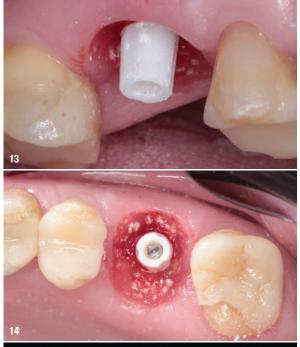
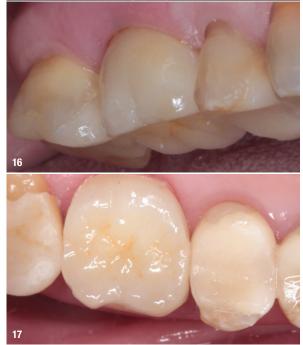
Figs. 13&14: Clinical views of the healthy peri-implant tissue free of inflammation. Fig. 15: Lithium disilicate crown. Figs. 16&17: Clinical views of the definitive crown.

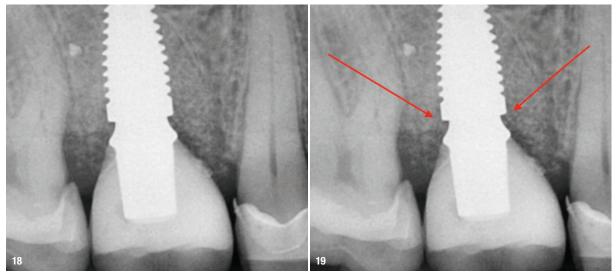
Fig. 18: Final radiograph with the definitive crown. Fig. 19: Radiograph at ten months showing marginal bone stability.

After cementation of the definitive crown, the stability of the marginal bone level was observed on the final radiograph in relation to the immediate postoperative radiograph. The patient has been followed up periodically for the last ten months, and there have been no complications to date. At the end of the treatment, she was asked to rate her degree of satisfaction with the aesthetic results of the treatment according a visual analogue scale and selected "very satisfied".
