# Single-tooth restoration with a two-piece Patent™ Implant

## Immediate implant placement and loading in the aesthetic zone

Dr Harald Fahrenholz, Austria

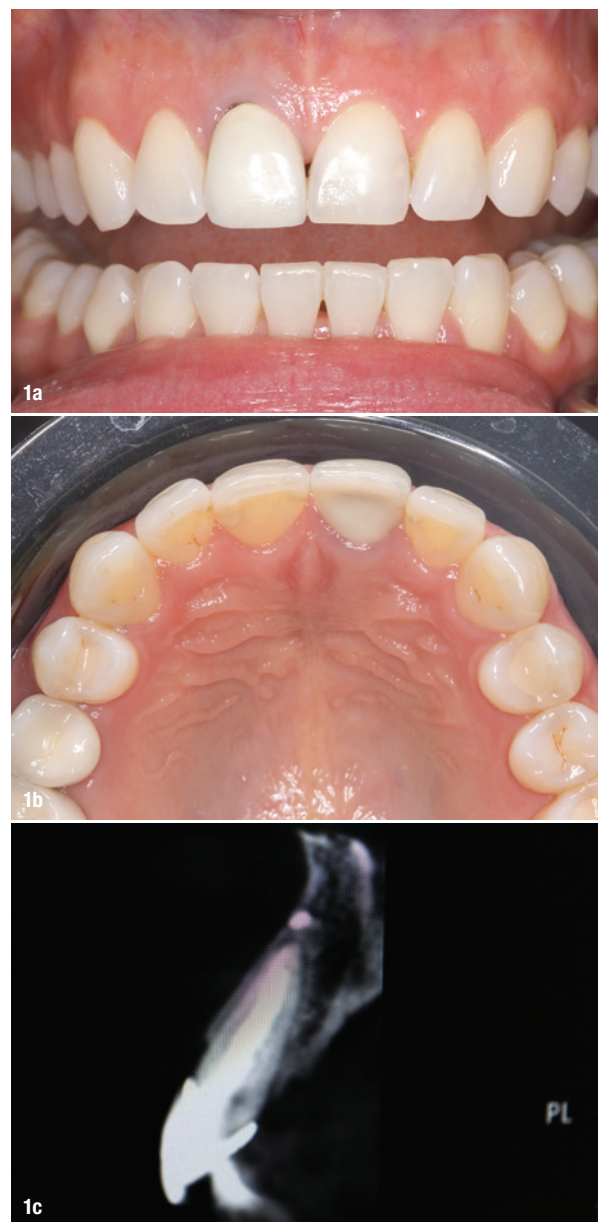
**Fig. 1:** Frontal (a), occlusal (b) and radiographic (c) views of the initial situation.

The 41-year-old female patient presented to the author's practice in October 2021. Owing to a failing post and core restoration of an endodontically treated tooth #11, she expressed the desire for a fixed tooth replacement solution (Figs. 1a & b). The radiographic evaluation by means of CBCT revealed that there was sufficient bone volume in the site for the planned implant placement (Fig. 1c).

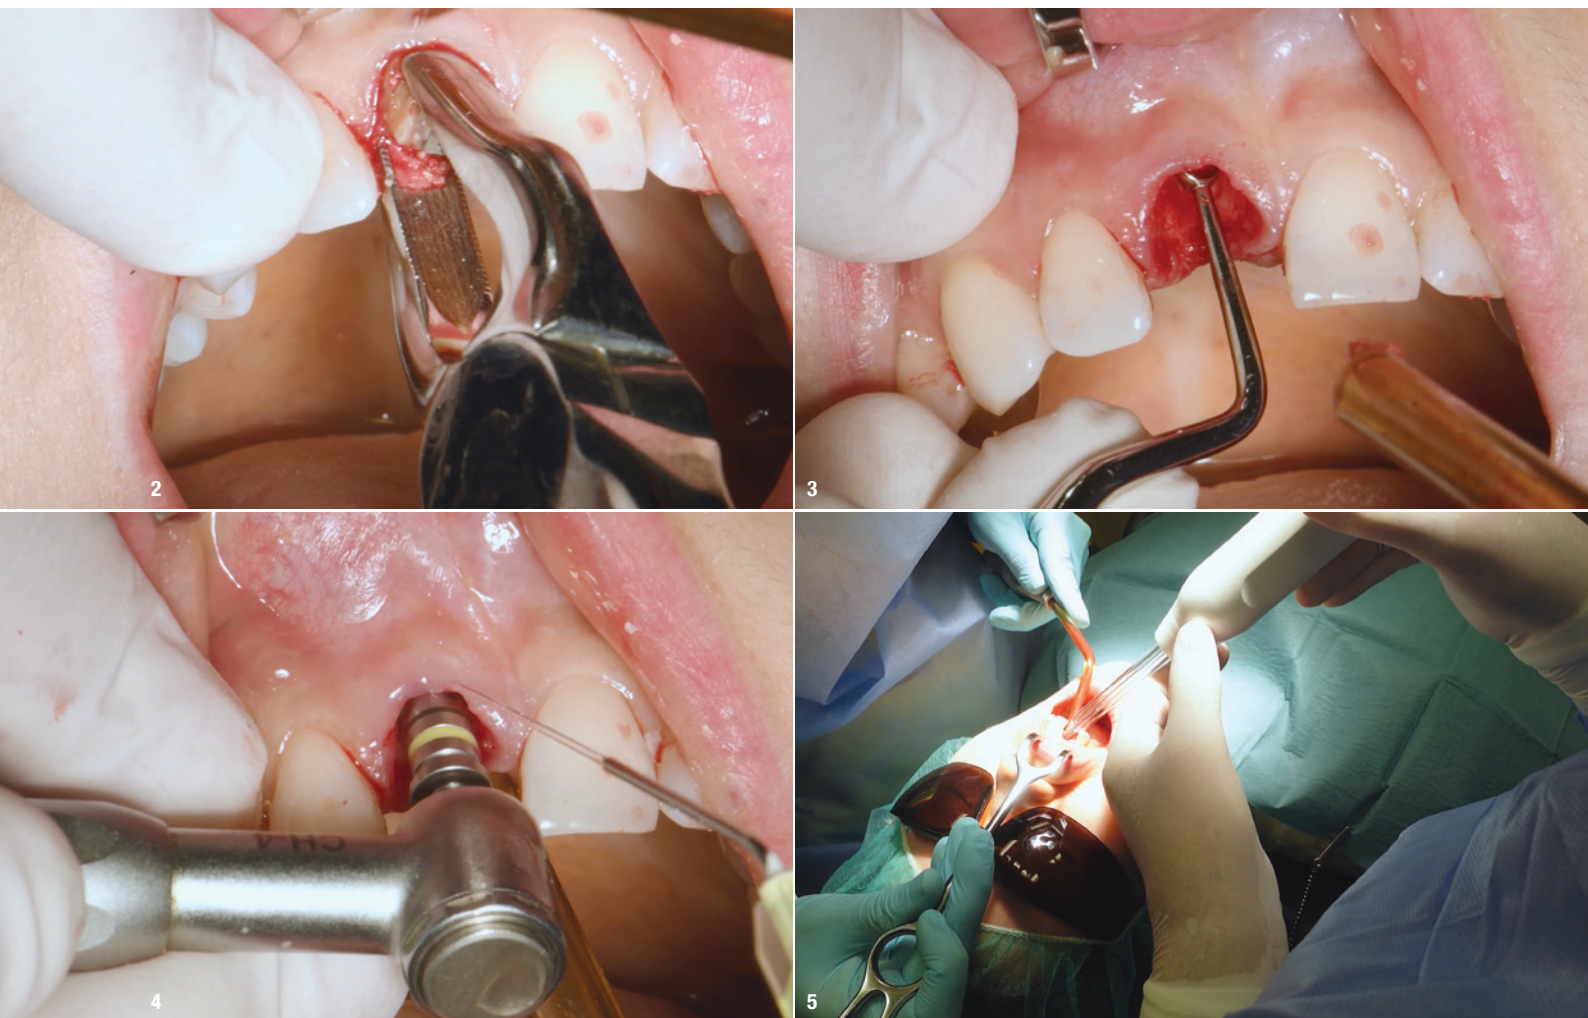
**Fig. 2:** Root extraction. **Fig. 3:** Thorough curettage of the extraction socket. **Fig. 4:** Osteotomy preparation according to the drilling protocol of the manufacturer. **Fig. 5:** Ozone therapy of the implant bed.

After local anaesthesia had been administered, a labial incision was made in the region of tooth #11 to facilitate the removal of the failing tooth. After the old restoration had been removed (Fig. 2), the underlying tooth root was extracted, and the extraction socket was carefully curetted to completely remove any fibrous tissue (Fig. 3). The osteotomy was prepared according to the drilling protocol of the implant manufacturer and under water cooling (Fig. 4). Once prepared, the osteotomy was treated with ozone to disinfect and sterilise the implant bed (Fig. 5). Thereafter, the two-piece zirconia implant with a diameter of 4.5 mm and a length of 13.0 mm was removed from the implant sleeve using an insertion tool and inserted into the osteotomy (Fig. 6). The implant was screwed into the bone using the torque wrench provided by the implant manu-

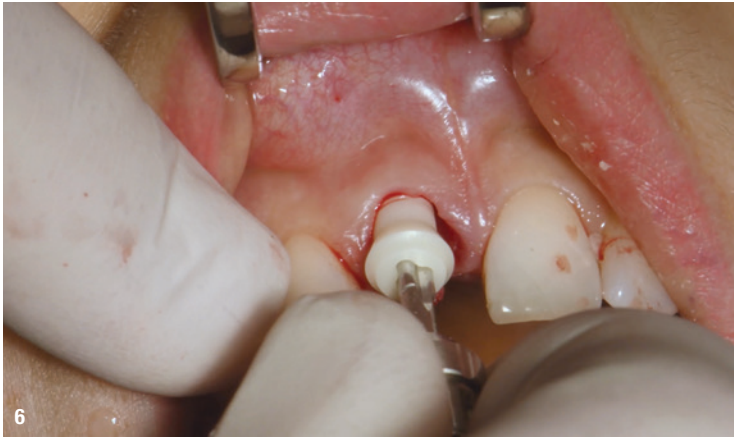
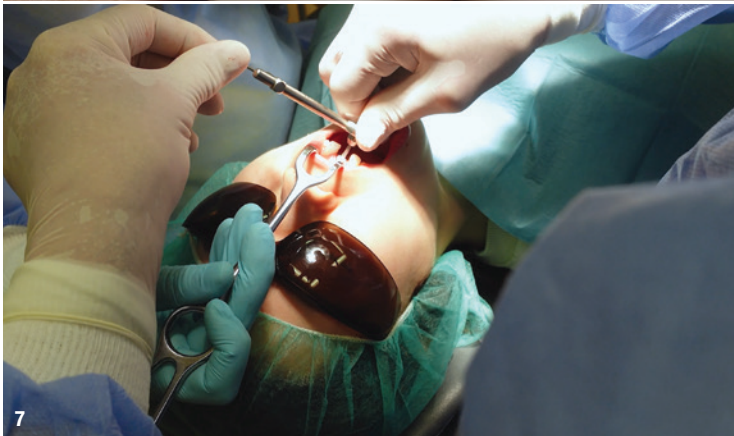
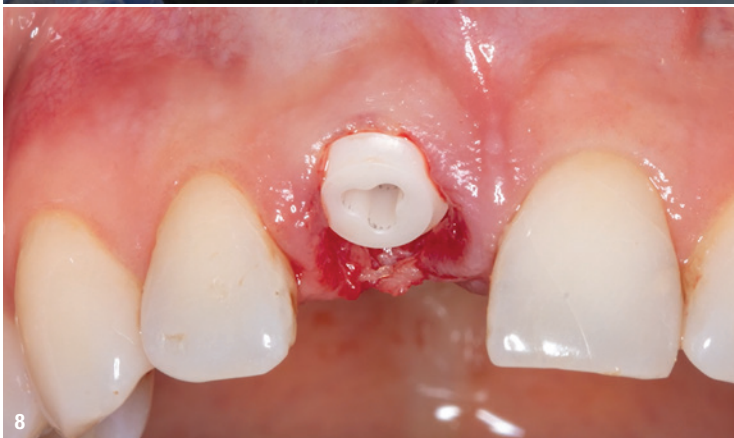
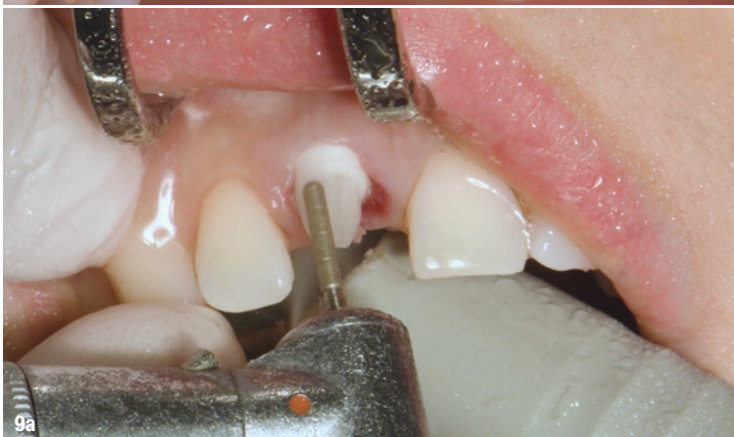
**Fig. 6:** Insertion of the implant into the osteotomy. **Fig. 7:** Insertion of the implant using the torque wrench of the manufacturer. **Fig. 8:** Inserted implant after achieving high primary stability. **Fig. 9:** Intra-oral preparation of the glass fiber post after try-in **(a)** and light polymerisation of the cement **(b)**.

facturer (Fig. 7), up to a maximum torque of 35 Ncm. High primary stability of the inserted implant was achieved (Fig. 8).

Immediately after implant insertion, the prefabricated glass fiber post was prepared extra-orally using a diamond bur and fitted into the 3C platform of the placed implant for try-in. The final preparation of the post was carried out intra-orally (Fig. 9a). After try-in of the provisional crown, which was fitted on to the prepared glass fiber post, both the post and provisional crown were removed again. The 3C platform of the implant was filled with a dual-polymerising cement (RelyX Unicem 2, 3M ESPE), and the prepared glass fiber post was inserted into it. Excess cement was removed and the glass fiber post was light-polymerised (Fig. 9b). The glass fiber post was isolated with Vaseline oil, and the provisional crown was subsequently cemented using a temporary cement mixture (Figs. 10a & b).
