Single-tooth restoration with a two-piece Patent™ Implant

Immediate implant placement and loading in the aesthetic zone

Dr Harald Fahrenholz, Austria

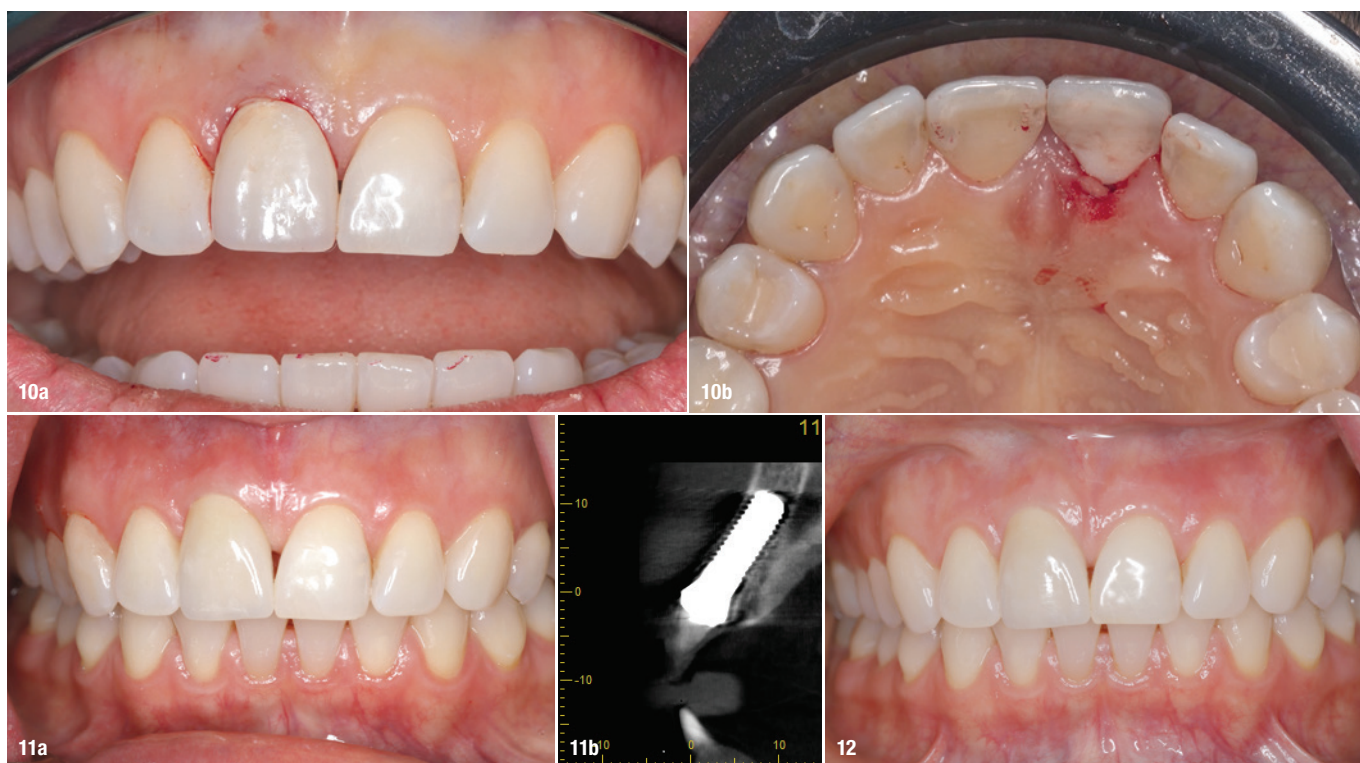
Fig. 10: Frontal (a) and occlusal (b) views of the clinical situation after delivery of the provisional restoration. **Fig. 11:** Frontal (a) and radiographic (b) views of the clinical situation after delivery of the definitive restoration after three months of healing. **Fig. 12:** Frontal clinical view of the final result after 12 months.

Immediately after implant insertion, the prefabricated glass fiber post was prepared extra-orally using a diamond bur and fitted into the 3C platform of the placed implant for try-in. The final preparation of the post was carried out intra-orally (Fig. 9a). After try-in of the provisional crown, which was fitted on to the prepared glass fiber post, both the post and provisional crown were removed again. The 3C platform of the implant was filled with a dual-polymerising cement (RelyX Unicem 2, 3M ESPE), and the prepared glass fiber post was inserted into it. Excess cement was removed and the glass fiber post was light-polymerised (Fig. 9b). The glass fiber post was isolated with Vaseline oil, and the provisional crown was subsequently cemented using a temporary cement mixture (Figs. 10a & b).

One week after surgery, the patient presented to the author's dental office for a follow-up appointment. Already at this time, an extremely beneficial and healthy soft-tissue reaction around the neck of the inserted implant was evident. After successful osseointegration and an uneventful healing period of three months, the definitive crown was delivered (Figs. 11a & b). At the 12-month follow-up, the soft-tissue conditions were considered healthy and stable, and the treatment result was deemed satisfactory from an aesthetic point of view (Fig. 12).
