Immediate placement and loading of ceramic implants in the aesthetic region: One-year follow-up—two case reports

Drs Alexandre Marques Paes da Silva, Dennis de Carvalho Ferreira, Thamires Alves Silva, Mayla Kezy Silva Teixeira, Daniel de Moraes Telles & Eduardo José Veras Lourenço, Brazil

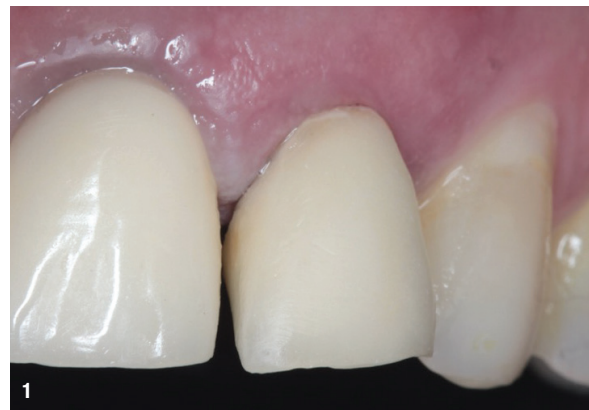
Fig. 1: Situation on initial clinical examination.

A 66-year-old female patient who was a smoker presented with the main complaint of a broken anterior tooth. On clinical examination, it was noted that the maxillary left lateral incisor had a metal-ceramic crown with a partially displaced cast metallic core (Fig. 1). The CBCT examination showed the presence of a vertical root fracture due to recurrent caries (Fig. 2). Given the clinical and radiographic situation, the proposed treatment was the extraction of the tooth in question, followed by immediate placement of a ceramic implant and immediate restoration with a crown.
