# Immediate placement and loading of ceramic implants in the aesthetic region: One-year follow-up—two case reports

Drs Alexandre Marques Paes da Silva, Dennis de Carvalho Ferreira, Thamires Alves Silva, Mayla Kezy Silva Teixeira, Daniel de Moraes Telles & Eduardo José Veras Lourenço, Brazil

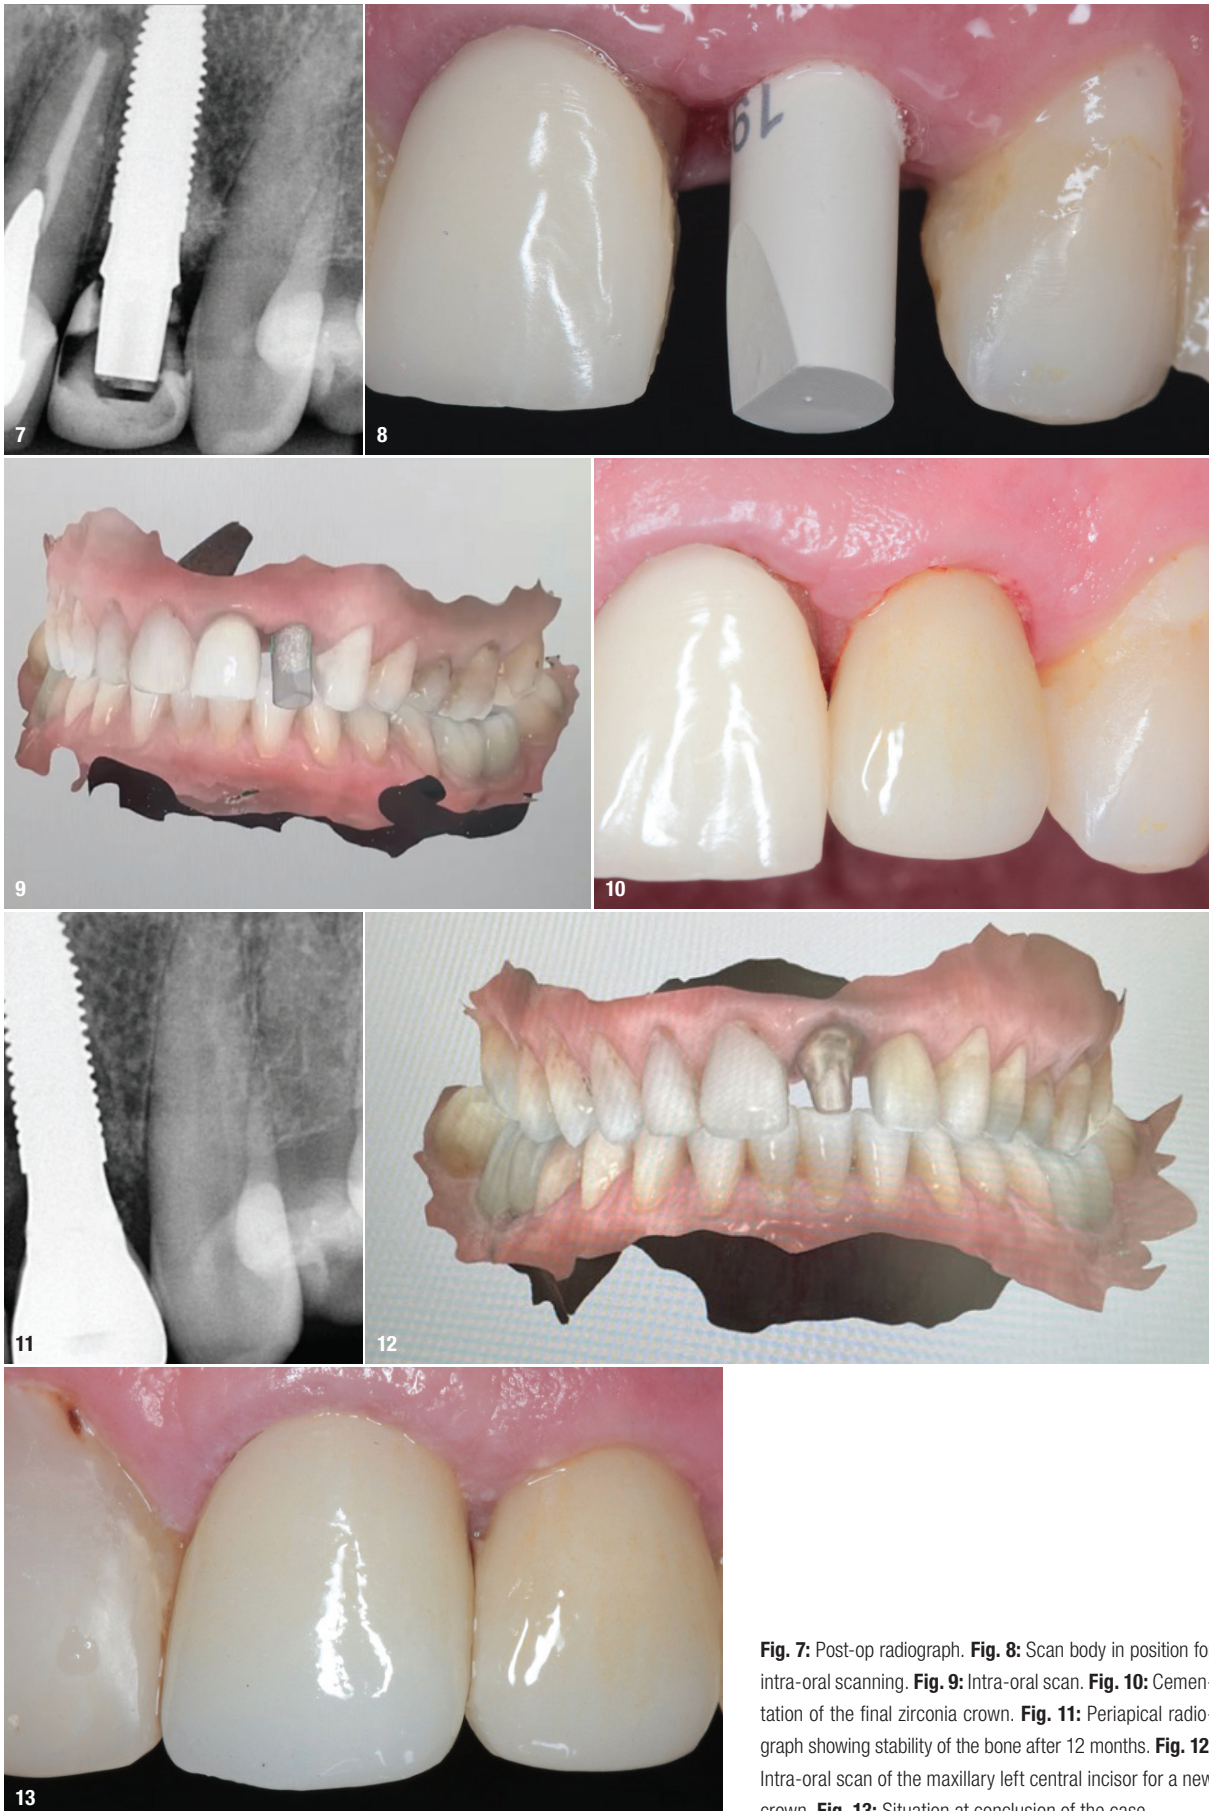
**Fig. 7:** Post-op radiograph. **Fig. 8:** Scan body in position for intra-oral scanning. **Fig. 9:** Intra-oral scan. **Fig. 10:** Cementation of the final zirconia crown. **Fig. 11:** Periapical radiograph showing stability of the bone after 12 months. **Fig. 12:** Intra-oral scan of the maxillary left central incisor for a new crown. **Fig. 13:** Situation at conclusion of the case.

The extraction was performed atraumatically with the aid of periostomes and forceps and a 3.75 × 13.0mm two-piece ceramic implant (Zi, Neodent) was placed in the fresh alveolus (Fig. 3). The insertion torque was 35Ncm, and this primary stability allowed for immediate loading. It should be noted that the implant was placed according to the manufacturer's recommendations at the level of the bone crest, and the gap was filled with bone substitute (maxresorb, botiss biomaterials; 0.5cm<sup>2</sup> of 0.5–1.0mm; Fig. 4). A 4.5 × 5.0 × 2.5mm (regular) zirconia abutment (Zi CR abutment) was seated (Fig. 5), and a provisional restoration was made with light-polymerising composite resin and cemented on the abutment (Fig. 6). At the end of the surgical procedure, a radiograph was taken (Fig. 7).

The three-month postoperative period was uneventful, and after this period, the patient returned to begin the final prosthetic phase. The final prosthesis was fabricated from monolithic zirconia using a digital workflow (Virtuo Vivo intra-oral scanner, Straumann; Figs. 8 & 9) and cemented on to the abutment with a dual adhesive cement (RelyX U200, 3M; Fig. 10). After 12 months of follow-up, the periapical radiograph showed the stability of the bone (Fig. 11).

After cementing the crown, it was observed that a new crown was needed for the adjacent tooth, the maxillary left central incisor, owing to the discrepancy in colour and dental anatomy. This prosthesis was also fabricated from monolithic zirconia using a digital workflow (Fig. 12) and cemented onto the prepared tooth with a dual adhesive cement (RelyX U200; Fig. 13).

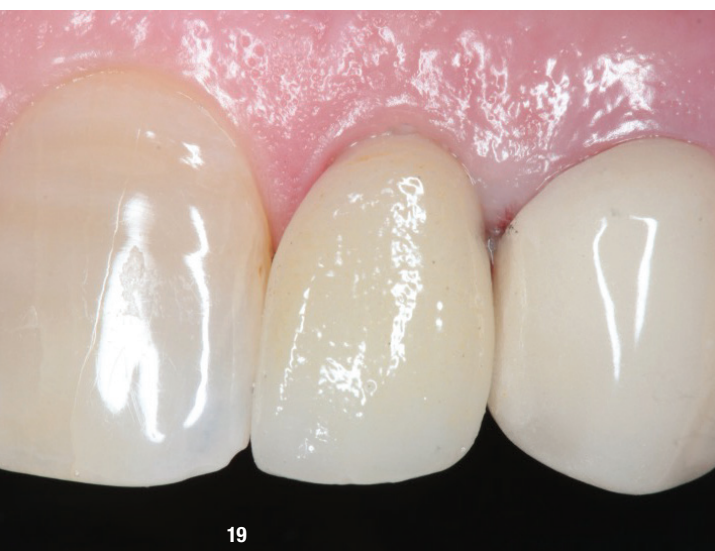
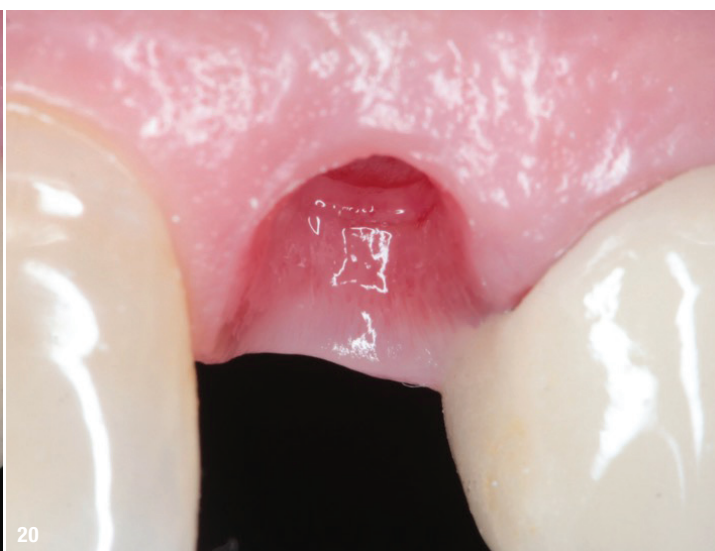
Fig. 19: Cementation of the final lithium disilicate crown. Fig. 20: Healthy soft tissue around the implant.

The three-month postoperative period was uneventful, and after this period, the patient returned to begin the final prosthetic phase. The final prosthesis was fabricated from lithium disilicate (IPS e.max, Ivoclar Vivadent) using an analogue workflow with impression material (addition-cured silicone, Yller) and cemented on to the abutment with a dual resin cement (RelyX U200; Fig. 19). Prior to cementation, the health of the peri-implant tissue around the ceramic implant was observed, as was the maintenance of the soft tissue, including the mesial and distal papillae (Fig. 20). After 12 months, the patient returned and a radiograph was taken, on which the maintenance of the bone around the implant was observed (Fig. 21).

tanium implants.<sup>12,13</sup> Furthermore, zirconia, like titanium, is a biocompatible material and favours the health of the peri-implant soft tissue,<sup>14</sup> as was observed after 12 months of follow-up in the two cases reported here. In Case 2, we observed the health of the soft tissue around the ceramic implant, particularly the collagen fibres present in the region.
