Oral rehabilitation in the aesthetic area—One-year follow-up

Immediate ceramic implant with immediate provisionalisation and connective tissue graft

This case report aimed to describe the step-by-step oral rehabilitation using immediate implant with immediate provisionalisation using ceramic implants and connective tissue grafts and its clinical and radiographic performance after a 12-month follow-up period in the aesthetic area (lateral upper incisor).

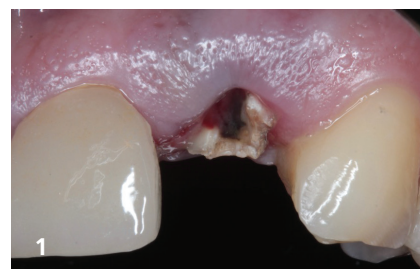
Fig. 1: Initial clinical situation.

The patient is male, 54 years old, healthy, and had suffered a fall from his own height in the past, in which the upper left lateral incisor was broken. On clinical examination (Fig. 1), a root fracture was found at the subgingival level and apparently infra-osseous, later confirmed through imaging tests (CBCT and peria-

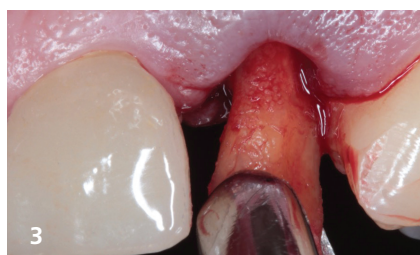
Fig. 3: Elevation of the tooth from inside the socket. **Fig. 4:** Neodent Zi implant 3.75x13 mm. **Fig. 5:** Occlusal view of the fresh socket—Zi-lock connection. **Fig. 6:** Removing the connective tissue graft with the double blade technique. **Fig. 7:** Connective tissue graft positioned on the vestibular side of the fresh socket. **Fig. 8:** CR abutment and connective tissue fixed with blue nylon suture. **Fig. 9:** Occlusal view of the CR abutment with gap filling with bone substitute.

The patient was instructed to perform antibiotic prophylaxis with four tablets of Amoxicillin 500 mg one hour beforehand and rinsed the mouth with 0.12% chlorhexidine for 30 seconds before receiving local anaesthesia with 4% Articaine (1:100,000 epinephrine). Then, the extraction was performed atraumatically with the aid of manual periostomes and forceps (Fig. 3) and a two-piece ceramic implant (Neodent Zi Ceramic Implant®, 3.75 x 13.0 mm) was placed in the fresh alveolus (Fig. 4). The Insertion torque was 35 Ncm. It should be noted that the in-

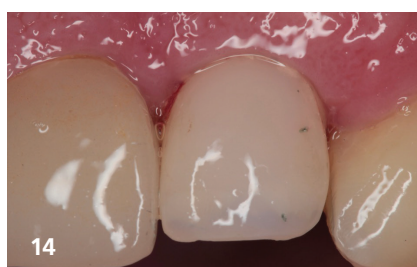
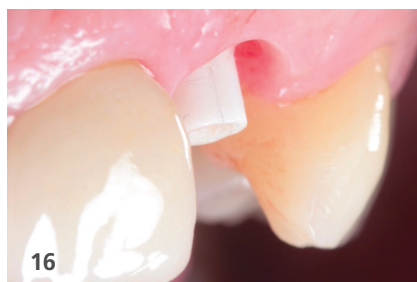
Fig. 14: Four months of follow-up. **Fig. 15:** Peri-implant tissue with a healthy appearance (occlusal view). **Fig. 16:** Peri-implant tissue with a healthy appearance (lateral view). **Fig. 17:** Closed impression technique with flow resin to copy the gingival emergence profile and addition silicone (Yllér).

After four months (Figs. 14–16), the patient returned to have the definitive crown made. This crown was fabricated using the analogic with a conventional impression that was taken with addition silicone with putty and regular body (Yllcr; Fig. 17), using the closed tray technique. One lithium disilicate crown (e.max®) was manufactured and cemented with adhesive cement (RelyX™ U200, 3M) onto the prosthetic abutments (Figs. 18 & 19). Occlusal adjustments were performed. At the end of the treatment, a final periapical X-ray was taken, and it was possible to observe the bone stability and the adaptation of the prosthetic work (Fig. 20).

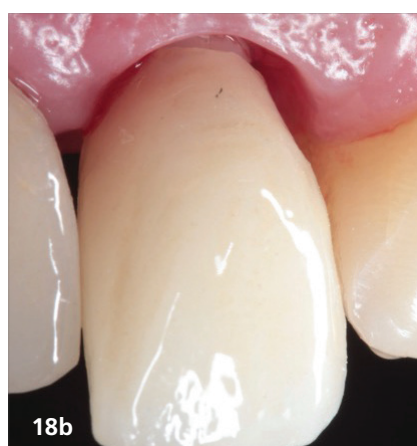
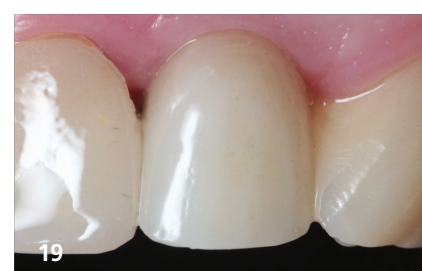
Figs. 18a & b: e.max crown being positioned over the CR abutment with maintenance of interdigital papillae and peri-implant volume. **Fig. 19:** e.max crown cemented. **Fig. 20:** 12-month follow-up X-ray. **Fig. 21:** Visual analogue scale.
