Oral rehabilitation in the aesthetic area—One-year follow-up

Immediate ceramic implant with immediate provisionalisation and connective tissue graft

This case report aimed to describe the step-by-step oral rehabilitation using immediate implant with immediate provisionalisation using ceramic implants and connective tissue grafts and its clinical and radiographic performance after a 12-month follow-up period in the aesthetic area (lateral upper incisor).

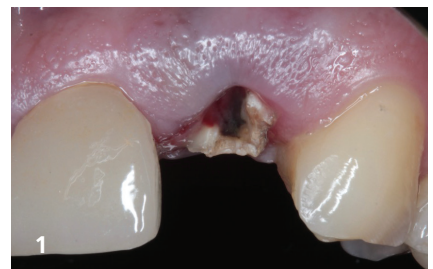
Fig. 1: Initial clinical situation.

The patient is male, 54 years old, healthy, and had suffered a fall from his own height in the past, in which the upper left lateral incisor was broken. On clinical examination (Fig. 1), a root fracture was found at the subgingival level and apparently infra-osseous, later confirmed through imaging tests (CBCT and peria-

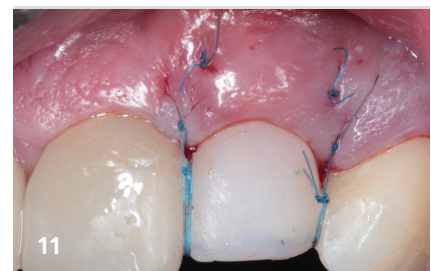
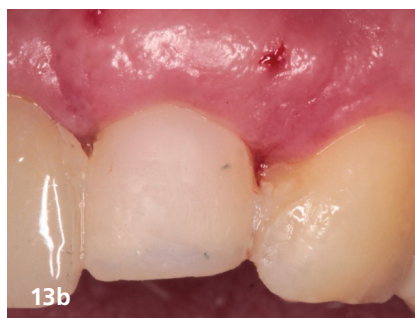
Figs. 10a & b: Temporary crown made of light-cured resin. **Fig. 11:** Temporary crown positioned and sutured. **Fig. 12:** Immediate postoperative radiographic image. **Figs. 13a & b:** 14 days postoperative—suture removal.

On the vestibular area, a CTG was removed from the patient's own palate using the DBT (Fig. 6) and fixed with Blue Nylon 6/0 suture (Techsuture; Figs. 7 & 8). To fill the "gap" between the external wall of the implant and the internal surface of the buccal wall of the alveoli, a bone substitute was used (Straumann® maxresorb® 0.5–1.0mm, 0.5cc; Fig. 9). A 4.5x5.0x1.5mm (regular) zirconia abutment (CR Zi Pillar®) was installed (Figs. 10a & b). Finally, a provisional restoration was made with light-cured composite resin and cemented on the ceramic abutment (Fig. 11).

At the end of the surgical procedure, a periapical X-ray was taken (Fig. 12). The Patient returned 14 days later for suture removal (Figs. 13a & b) and received the necessary instructions. The four-month postoperative period was uneventful, and after this period, the patient returned in order to begin the prosthetic rehabilitation phase.

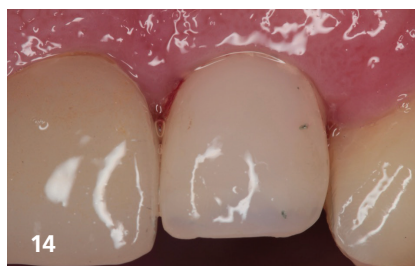
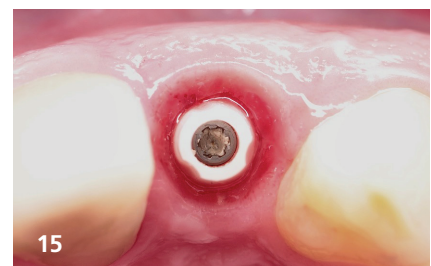
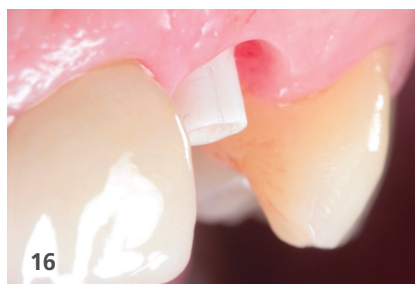
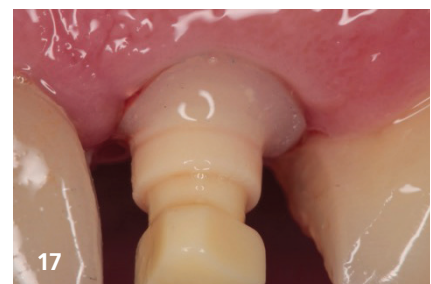
Fig. 14: Four months of follow-up. **Fig. 15:** Peri-implant tissue with a healthy appearance (occlusal view). **Fig. 16:** Peri-implant tissue with a healthy appearance (lateral view). **Fig. 17:** Closed impression technique with flow resin to copy the gingival emergence profile and addition silicone (Yllor).

After four months (Figs. 14–16), the patient returned to have the definitive crown made. This crown was fabricated using the analogic with a conventional impression that was taken with addition silicone with putty and regular body (Ylller; Fig. 17), using the closed tray technique. One lithium disilicate crown (e.max®) was manufactured and cemented with adhesive cement (RelyX™ U200, 3M) onto the prosthetic abutments (Figs. 18 & 19). Occlusal adjustments were performed. At the end of the treatment, a final periapical X-ray was taken, and it was possible to observe the bone stability and the adaptation of the prosthetic work (Fig. 20).

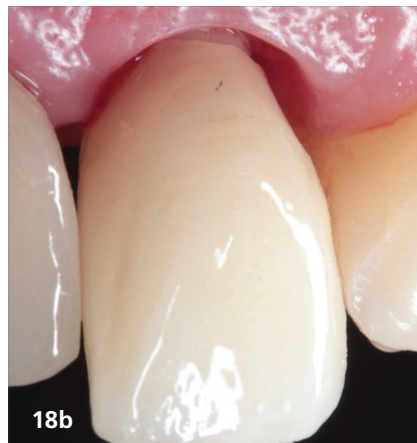
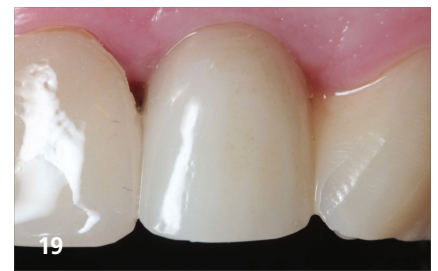
Figs. 18a & b: e.max crown being positioned over the CR abutment with maintenance of interdental papillae and peri-implant volume. **Fig. 19:** e.max crown cemented. **Fig. 20:** 12-month follow-up X-ray. **Fig. 21:** Visual analogue scale.

Then, the patient was questioned and instructed to respond about the degree of satisfaction with the treatment through a VAS (visual analogue scale) and answered that he was "very satisfied" (Fig. 21).

showing the stability of the alveolar bone crest without marginal bone loss (MBL).
