Oral rehabilitation in the aesthetic area—One-year follow-up

Immediate ceramic implant with immediate provisionalisation and connective tissue graft

This case report aimed to describe the step-by-step oral rehabilitation using immediate implant with immediate provisionalisation using ceramic implants and connective tissue grafts and its clinical and radiographic performance after a 12-month follow-up period in the aesthetic area (lateral upper incisor).

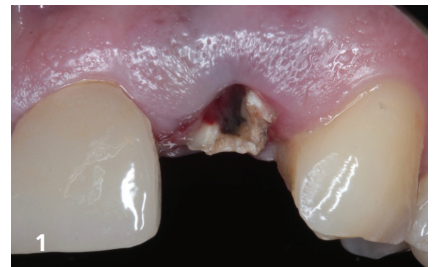
Fig. 1: Initial clinical situation.

The patient is male, 54 years old, healthy, and had suffered a fall from his own height in the past, in which the upper left lateral incisor was broken. On clinical examination (Fig. 1), a root fracture was found at the subgingival level and apparently infra-osseous, later confirmed through imaging tests (CBCT and peria-

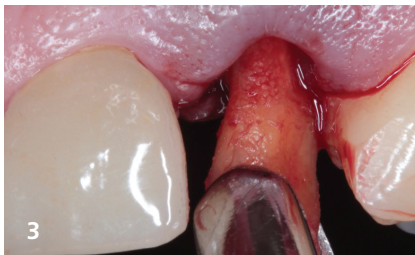
Fig. 3: Elevation of the tooth from inside the socket. **Fig. 4:** Neodent Zi implant 3.75x13 mm. **Fig. 5:** Occlusal view of the fresh socket—Zi-lock connection. **Fig. 6:** Removing the connective tissue graft with the double blade technique. **Fig. 7:** Connective tissue graft positioned on the vestibular side of the fresh socket. **Fig. 8:** CR abutment and connective tissue fixed with blue nylon suture. **Fig. 9:** Occlusal view of the CR abutment with gap filling with bone substitute.

The patient was instructed to perform antibiotic prophylaxis with four tablets of Amoxicillin 500 mg one hour beforehand and rinsed the mouth with 0.12% chlorhexidine for 30 seconds before receiving local anaesthesia with 4% Articaine (1:100,000 epinephrine). Then, the extraction was performed atraumatically with the aid of manual periostomes and forceps (Fig. 3) and a two-piece ceramic implant (Neodent Zi Ceramic Implant®, 3.75 x 13.0 mm) was placed in the fresh alveolus (Fig. 4). The Insertion torque was 35 Ncm. It should be noted that the in-
