# Long-term success of implant-supported rehabilitation in the aesthetic zone: A nine-year follow-up case report

Drs Léon Pariente & Karim Dada, France

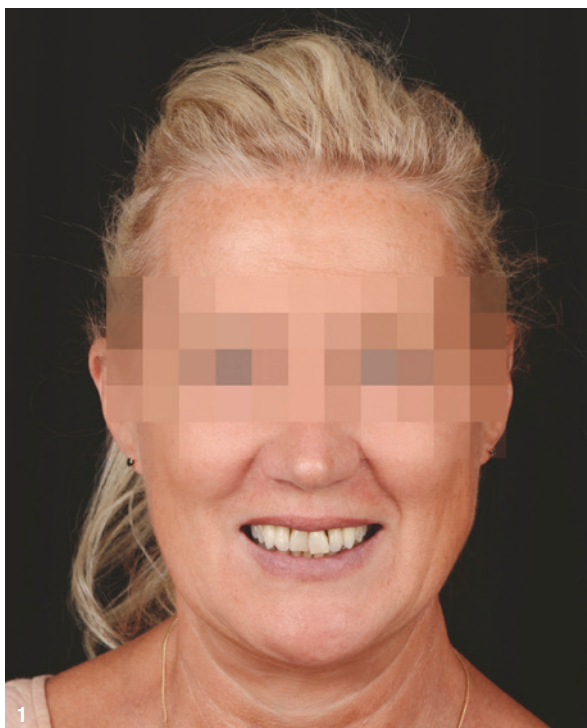
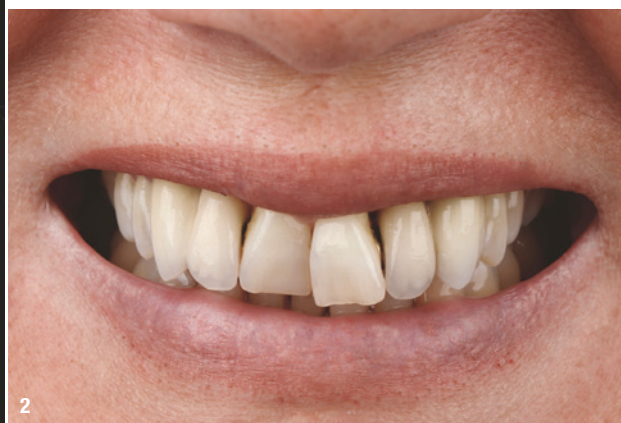
**Fig. 1:** The patient's extra-oral examination revealed a medium smile line. **Fig. 2:** Misalignment observed in the maxillary front teeth.

The patient’s extra-oral examination revealed a medium smile line and misalignment of the front teeth (Figs. 1 & 2). During the intra-oral examination, advanced periodontal attachment loss and mobility were noted in teeth #12, #21, and #22 (Fig. 3). Cone-beam computed tomography (CBCT) imaging indicated the absence of buccal bone on tooth #21 (Fig. 4).

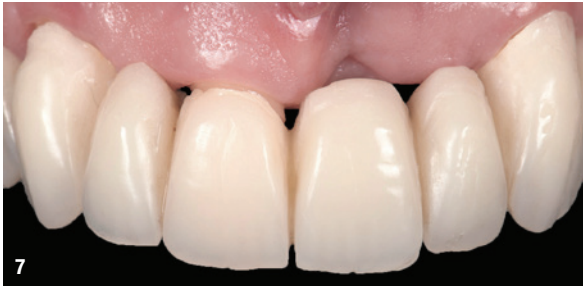
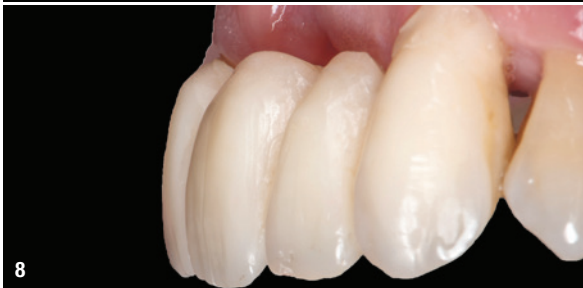
**Fig. 6:** Extraction of the upper left central incisor and lateral incisors, followed by the preparation of upper right central incisor and canines. **Fig. 7:** Placement of a temporary resin-based bridge. **Fig. 8:** Post-healing, horizontal and vertical ridge deficiencies observed at the site of #21. **Fig. 9:** Six weeks after dental extractions, the patient exhibited uneventful wound healing. **Fig. 10:** Placement of Straumann® Roxolid® SLActive® BLT 3.3 mm implant at site #12, and a BLT 4.1 mm implant at site #21. **Fig. 11:** At five months post-surgery, the radiographic control of implant #21 confirmed proper positioning and implant integrity.

Local anaesthesia with lidocaine 2% with epinephrine 1:100,000, was administered. This was followed by atraumatic extractions of teeth #12, #21, and #22, with alveolar curettage. Additionally, dental preparations on teeth #13, #11, and #23 were carried out (Fig. 6).

A temporary resin-based bridge was placed in the second sextant (Fig. 7). Following wound healing, horizontal and vertical deficiencies were observed at ridge position #21 (Fig. 8).

At the six-week follow-up post dental extractions, the patient presented with uneventful wound healing (Fig. 9). A mucoperiosteal flap, with a crestal incision, was raised to facilitate implant placement. The Straumann® Surgical Cassette was employed to prepare the implant bed. Subsequently, a Straumann® Roxolid® SLActive® BLT ø3.3 mm implant was positioned at site #12, and a Straumann® Roxolid® SLActive® BLT ø4.1 mm implant was placed at position #21 (Fig. 10). The implants were

A radiographic control was conducted on implant #21, five months post implant surgery, to assess the progress and ensure the integrity of the implant in its position (Fig. 11).

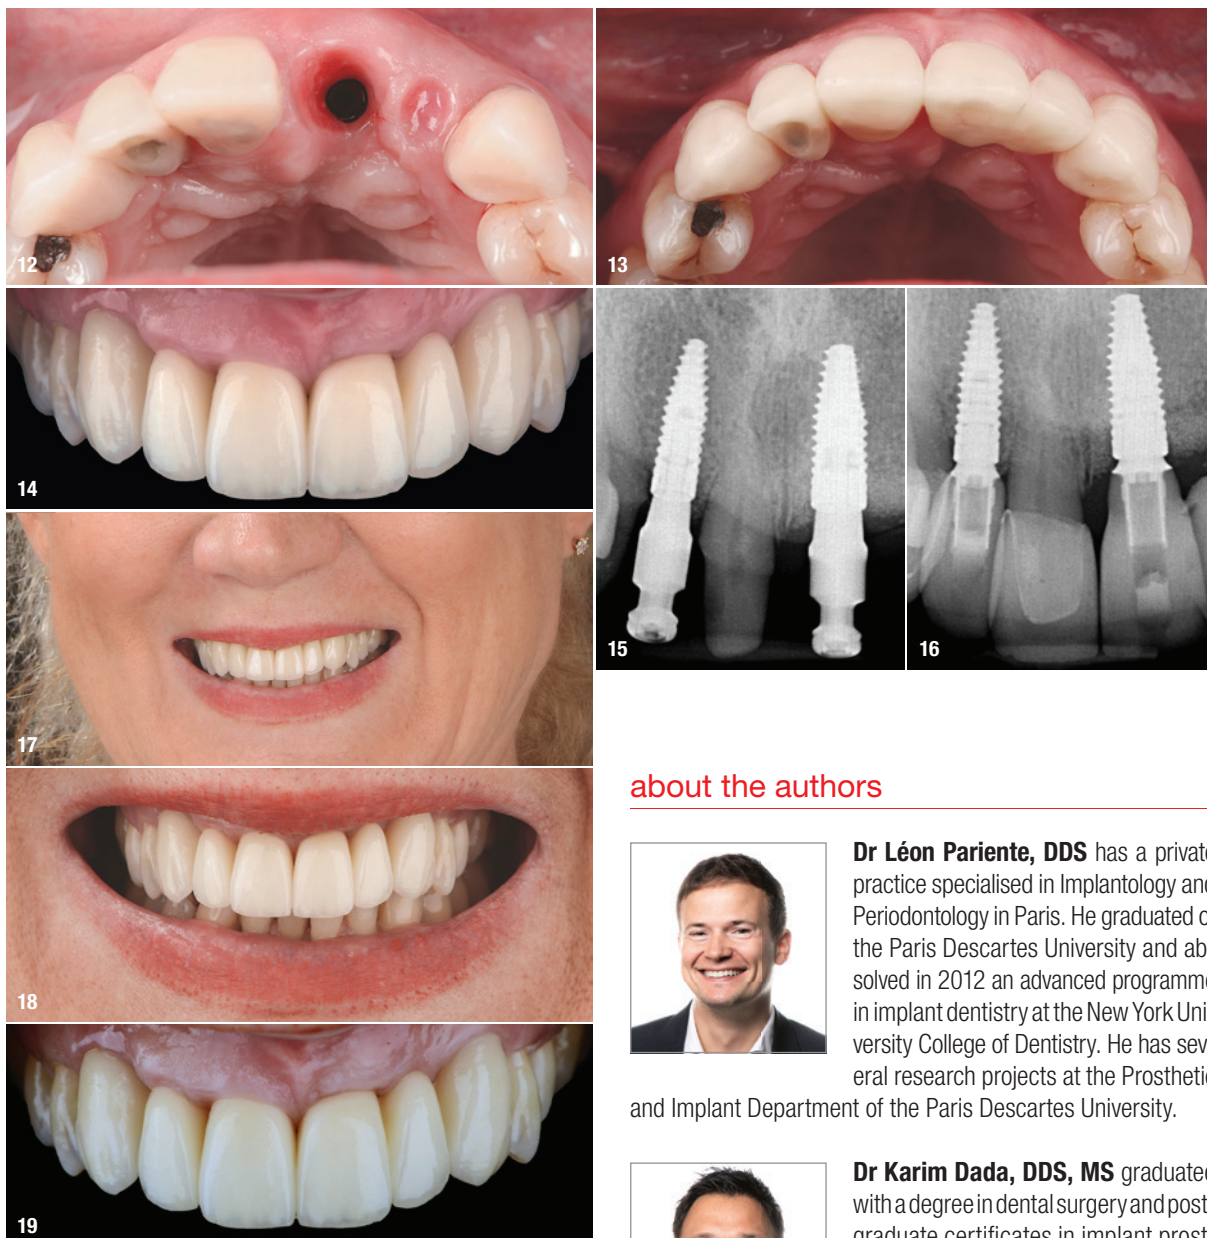
**Fig. 12:** Successful soft-tissue healing observed at the seven-month follow-up. **Fig. 13:** Placement of the final restorations. **Fig. 14:** The aesthetically pleasing appearance of the final crowns. **Fig. 15:** Radiographic assessment at the time of final impression confirmed precise implant placement and verified bone structure integrity. **Fig. 16:** A follow-up radiographic evaluation assessed the long-term stability and health of the implant sites. **Fig. 17:** Six-year follow-up showing favourable aesthetic results. **Fig. 18:** Six-year follow-up demonstrating a satisfactory clinical outcome. **Fig. 19:** Nine-year follow-up revealing successful results, with healthy soft and hard tissues maintained.

Soft-tissue conformation was evaluated seven months after the delayed loading of implant #21, with the aim to assess the maturation and adaptation of the surrounding soft tissues to the implant site (Fig. 12).

After the successful healing and osseointegration of both implants, the final restorations were placed on the implants, and the screws were tightened within the range of 15 to 35 Ncm revealing a natural and aesthetically pleasing appearance of the final crowns (Figs. 13 & 14).

Radiographic control was conducted at the time of the final impression to ensure an accurate assessment of the implant placement and surrounding structures (Fig. 15). Additionally, a follow-up radiographic evaluation was performed six years after the completion of the treatment to monitor the long-term stability and health of the treated area (Fig. 16).

At the six-year (Figs. 17 & 18) and nine-year (Fig. 19) follow-ups, comprehensive clinical and radiographic assessments underscored favourable outcomes, including osseointegration, the maintenance of bone density around the implants, and pleasing aesthetics. These findings collectively indicated the success of the long-term treatment.
