Full-arch dentistry with dynamic navigation and photogrammetry

Dr Emilien Tronc, France

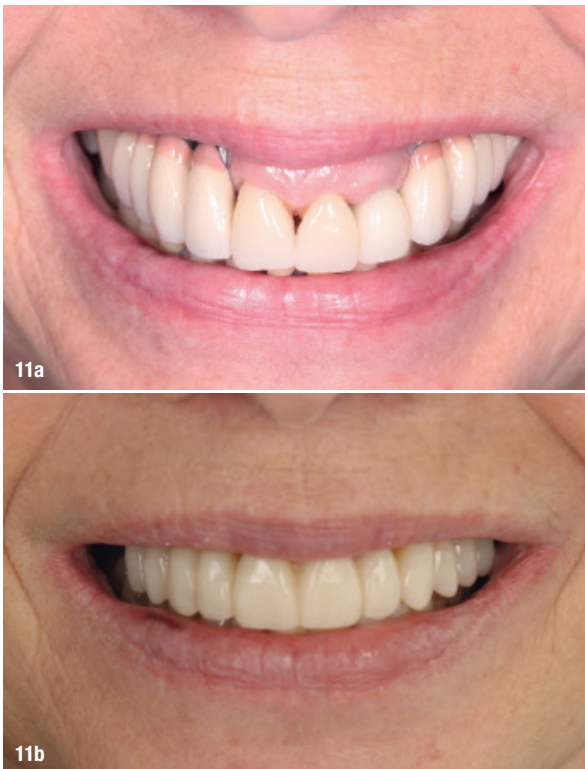
Fig. 11a: Pre-treatment image of patient with full confident smile, and un-aesthetic implants. **Fig. 11b:** Post-treatment final result of restored implants and bridge.

The functional bridge will be kept in place for a minimum of six months to give the patient sufficient time to plan and complete her mandibular treatment (posterior sectors) before proceeding with the construction of the definitive bridge with the referring practitioner (Figs. 11a & b).
