# Full-arch dentistry with **dynamic navigation** and **photogrammetry**

Dr Emilien Tronc, France

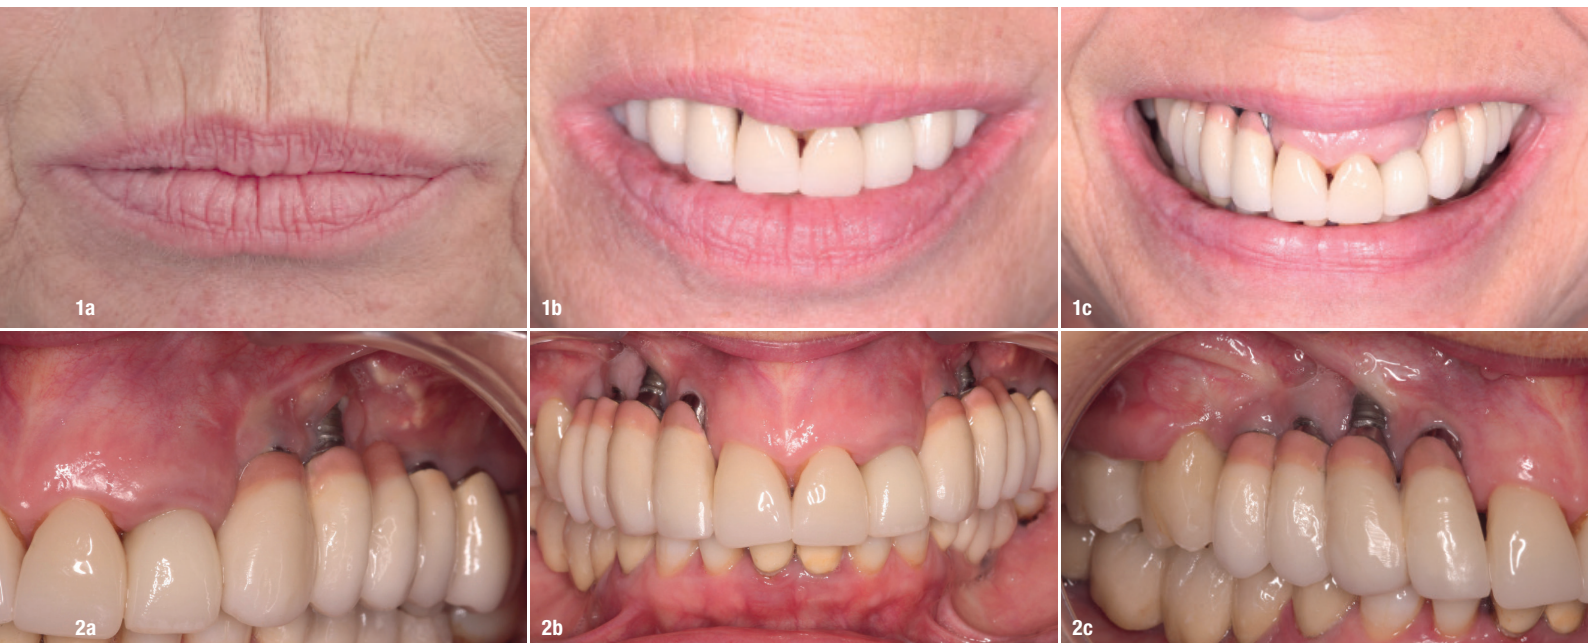
**Fig. 1a:** Initial expression with a closed, natural smile. **Fig. 1b:** Relaxed open mouth smile. **Fig. 1c:** Full, confident smile showcasing unaesthetic implants. **Fig. 2a:** Left quadrant—side view of dental implants and restorations. **Fig. 2b:** Front view of dental work. **Fig. 2c:** Right quadrant—opposite side view of dental implants and restorations.

The clinical examination reveals a marked loss of vertical dimension and a collapse of soft tissues and lips, although the upper lip remains intact (Figs. 1a–c). A high smile line is evident, exposing substantial crown height and showing noticeable offsets at the necks of teeth #11 to #22 in comparison to adjacent teeth.

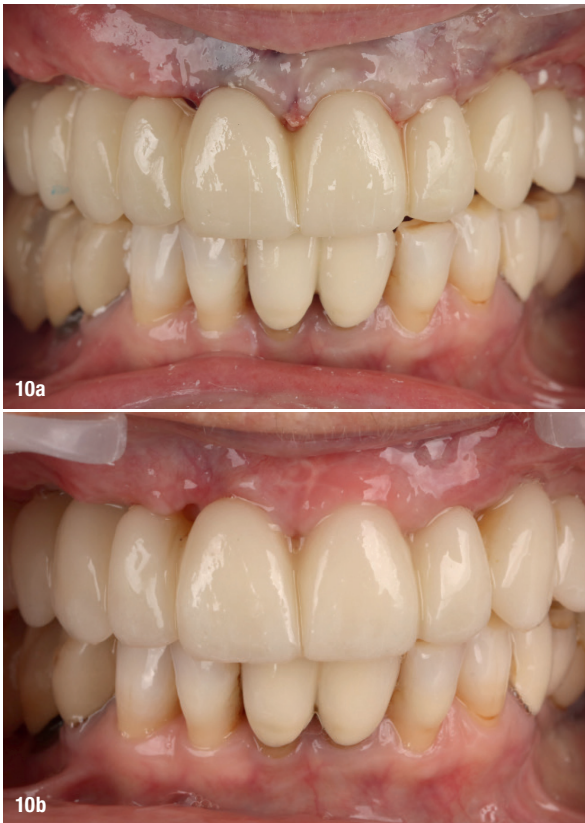
**Fig. 10a:** Passive fitting prosthesis after new bridge and implants are placed (one month). **Fig. 10b:** Passive fitting prosthesis after new bridge and implants are placed (three months).

This immediate passive fit not only improves comfort but also saves time, reduces the risk of complications, and minimises the need for rework, facilitating better integration with the underlying structures (Figs. 10a & b). The patient is scheduled to return for postoperative follow-up appointment at 15 days, one month, and again at three months.

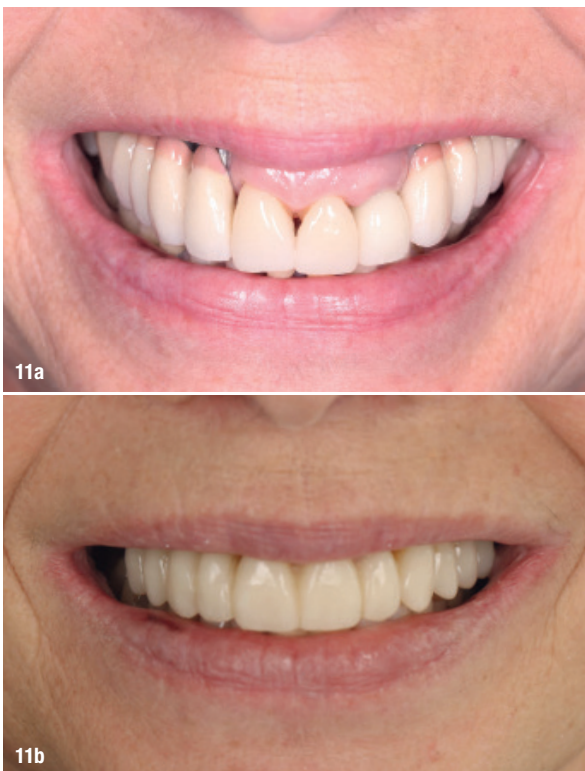
**Fig. 11a:** Pre-treatment image of patient with full confident smile, and un-aesthetic implants. **Fig. 11b:** Post-treatment final result of restored implants and bridge.

The functional bridge will be kept in place for a minimum of six months to give the patient sufficient time to plan and complete her mandibular treatment (posterior sectors) before proceeding with the construction of the definitive bridge with the referring practitioner (Figs. 11a & b).
