# One-piece AWI G-Line ceramic implants in the premolar region

## Clinical use of the AWI single-unit implant system following delayed implantation

Bozhidar Hristov Savev, Germany

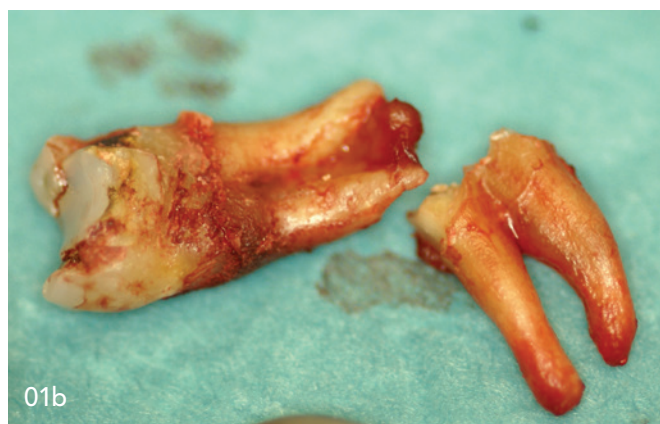
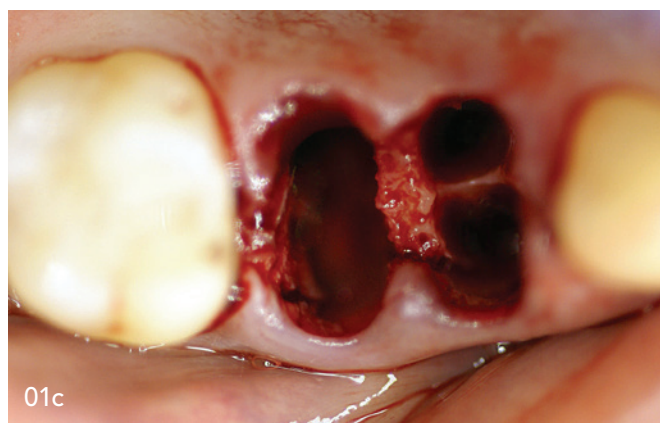
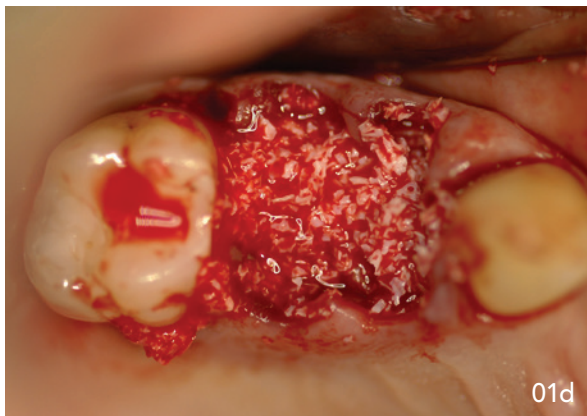
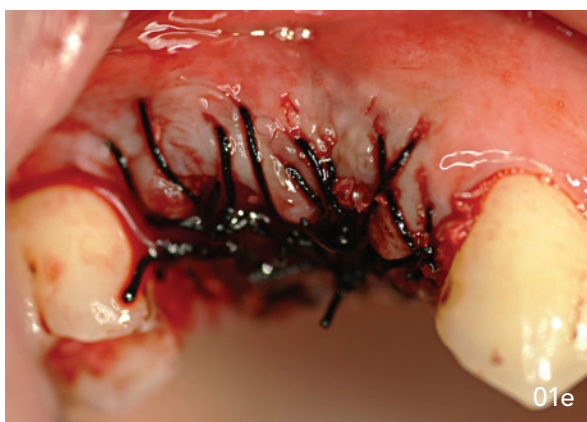
Figure 1a shows the pre-extraction clinical status of teeth 14 and 15. Due to ankylosed roots, osteotomy was required for removal. During luxation with Bein elevators, the buccal plate fractured (Fig. 1c). Following extraction, the sockets were filled with a mixture of autologous bone chips and bovine xenograft. To ensure volume preservation and favourable soft-tissue healing, the sites were covered with a resorbable collagen membrane before suturing (Figs. 1d+e).

This calcium loss accelerates bone resorption and increases the risk of both osteoporosis and periodontal disease. To mitigate these effects, stable periodontal conditions, control of systemic and lifestyle-related risk factors, and excellent oral hygiene must be ensured (Figs. 1a–c).

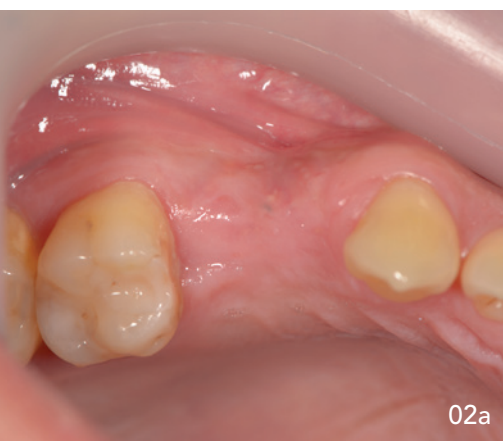
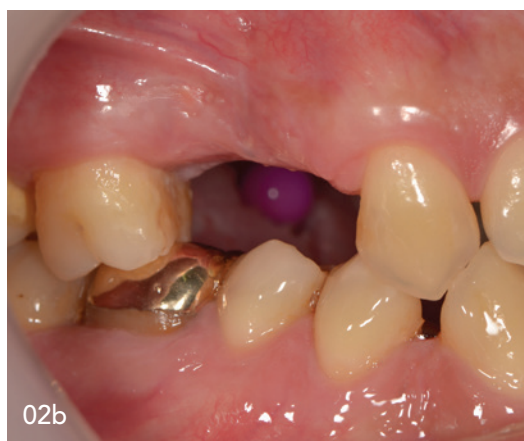
The patient requested a fully metal-free solution, including the prosthetic restoration. Six months later, the alveolar ridge was assessed as suitable for implant placement (CBCT and clinical pre-op: Figs. 2a+b). A crestal incision with a releasing cut at tooth 13 was made, and a mucoperiosteal flap was elevated (Fig. 2c). Two one-piece AWI G-Line zirconia implants (AWI 394010R, gingiva-coloured) were inserted (Figs. 3a–h).

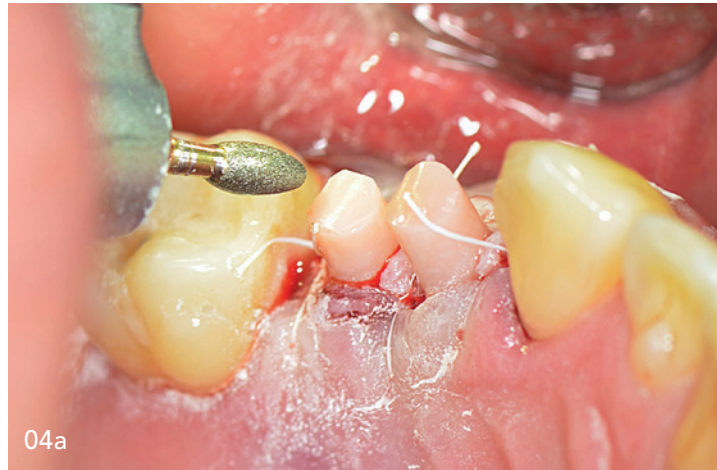
Simultaneous lateral augmentation was carried out using  $\beta$ -TCP Easy Graft and PRGF membranes to cover both the graft and the implants, enhancing wound healing. A post-operative radiograph confirmed correct implant placement (Fig. 4c).

Therefore, ceramic implants must be inserted at a slower rotational speed to avoid excessive interface temperatures. Post-insertion, the implants were shortened and shaped using a red contra-angle handpiece and ceramic polishing instruments (Figs. 4a+b). Healing was performed transgingivally over four to six months.

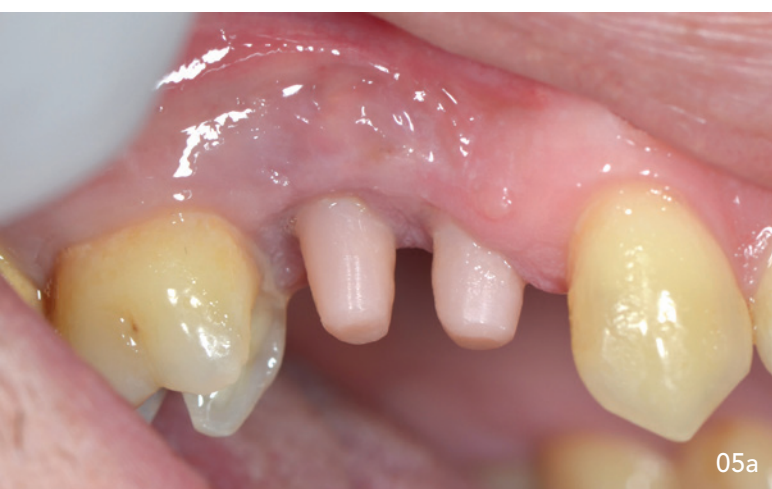
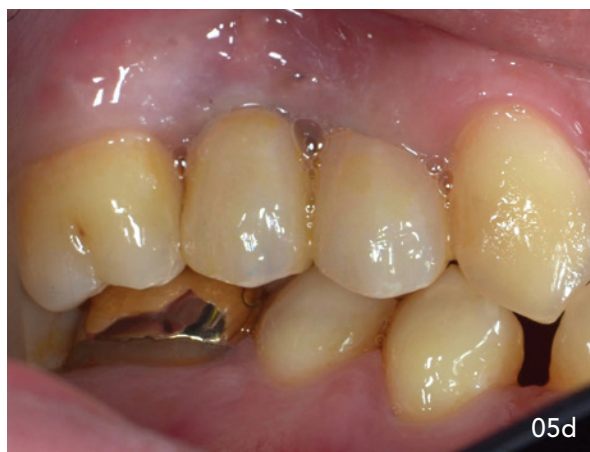
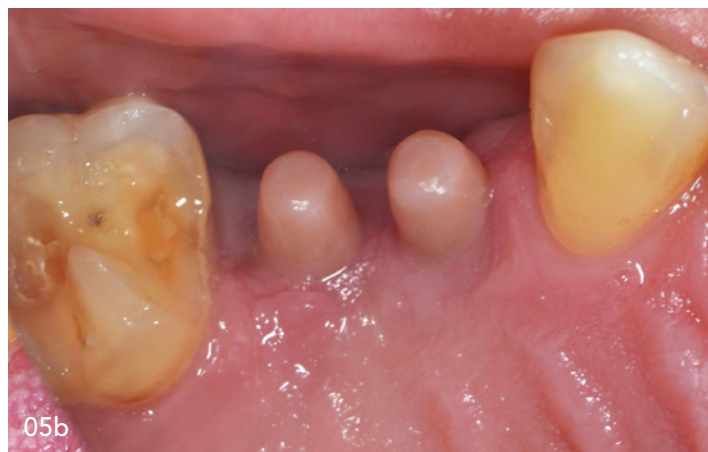
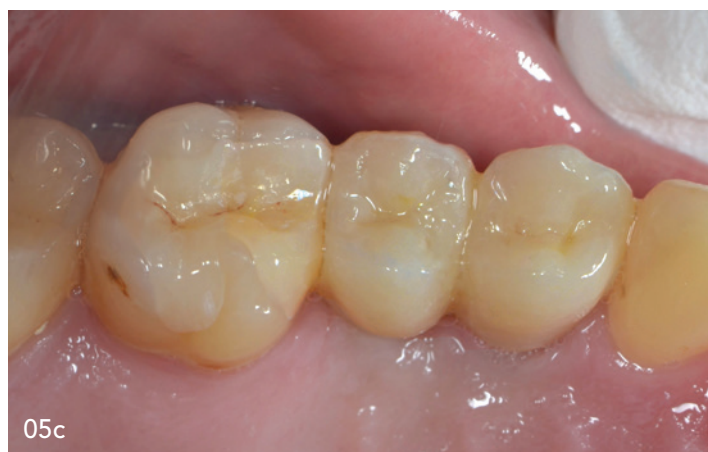
Figures 5b and c show well-healed soft tissue around the implant sites. If necessary, the implant shoulder can be positioned 1.5–2 mm subgingivally in a scalloped fashion to match the natural gingival architecture.

In the same appointment, tooth 16 was prepared for a partial crown. A conventional impression was taken using Honigum Heavy and Light materials (DMG). Final restoration was performed using pressed monolithic e.max crowns. The final result in the upper jaw is shown in Figures 5c and d.

Tobacco use is a known risk factor for complications associated with dental implants. Although smokers have a higher risk of implant loss, successful treatment is achievable with appropriate prophylaxis management (Figs. 5c+d). Due to nicotine-induced calcium depletion, bone quality in smokers is often reduced.
