Immediate anterior maxilla restoration

Integrating guided bone regeneration and digital planning for aesthetic results

Dr Dalton Marques, Brazil

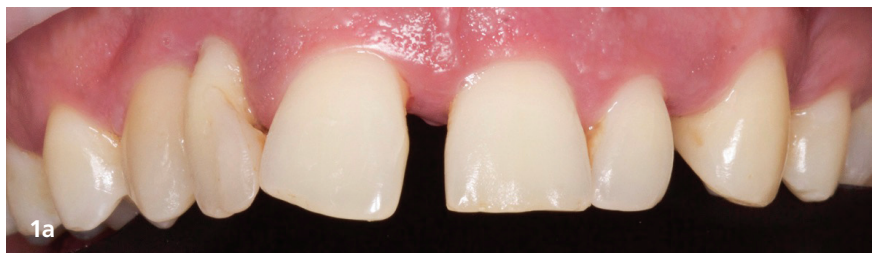
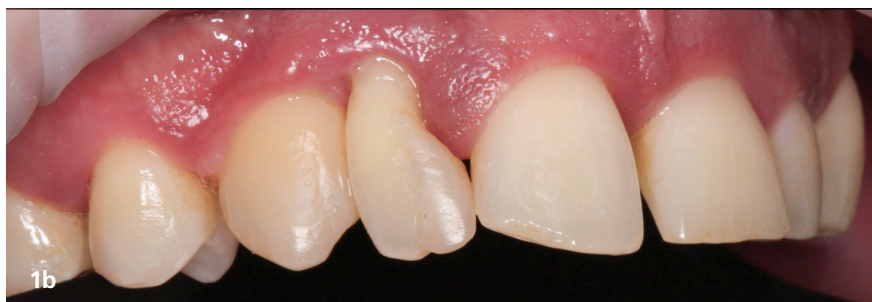
Figs. 1a+b: Hopeless maxillary central and lateral incisors.

The patient presented a low smile line with no signs of local inflammation. There was mobility grade II in the front teeth and a diastema centralis, which, according to the patient, has progressively widened over time (Fig. 1).

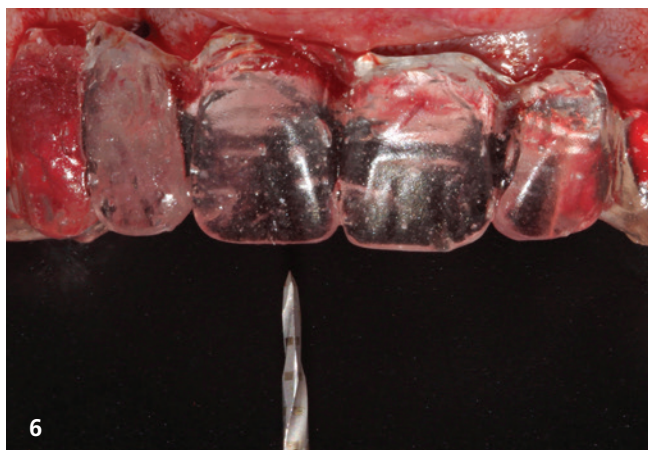
sion was made, and a surgical stent was positioned to guide implant-site preparation following the extractions. The implant beds were prepared using the Straumann® BLX Surgical Cassette following the manufacturer's instructions (Fig. 6).

Fig. 6: Implant bed preparation following extraction of hopeless teeth. – **Fig. 7:** Immediate Straumann® BLX implants placed at #13 (5.0 × 10 mm), #11 (3.75 × 10 mm), and #22 (4.5 × 10 mm). – **Fig. 8:** Gaps and sockets filled with cerabone® granules. – **Fig. 9:** The flap is closed with sutures.

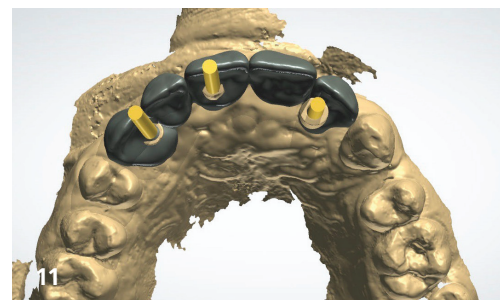
Digital impressions were taken using the Straumann® Virtuo Vivo™ intra-oral scanner and a five-unit bridge was digitally planned (Fig. 10). Additionally, an occlusal view of the virtually planned five-unit bridge was generated to ensure precise alignment and aesthetics (Fig. 11).

Fig. 10: Digital impressions with Straumann® Virtuo Vivo™ and five-unit bridge digitally planned. – **Fig. 11:** Occlusal view of digitally planned five-unit bridge.

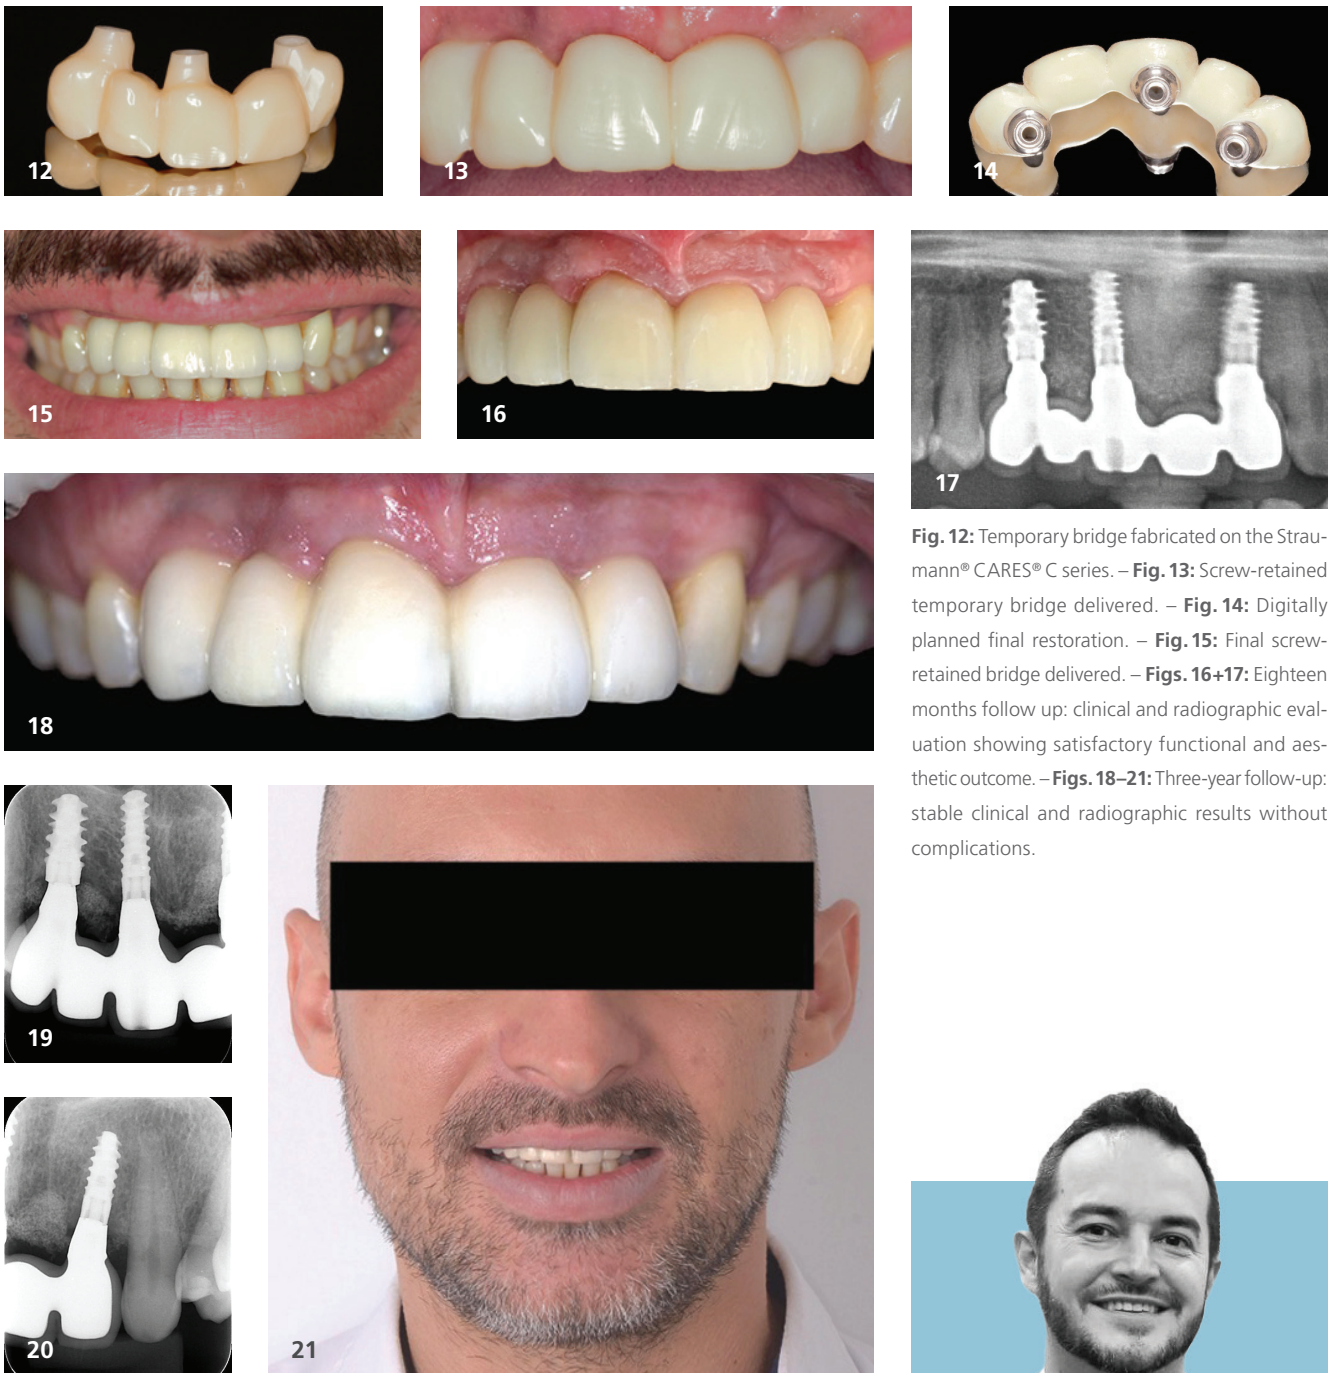
A temporary bridge was then fabricated using a milled resinous material on the Straumann® CARES® C series milling machine (Fig. 12). The screw-retained temporary bridge was then delivered to the

patient, providing functional and aesthetic restoration while supporting tissue healing and adaptation (Fig. 13).

At the six-month follow-up, healing was uneventful. The final restoration was also digitally planned (Fig. 14). The final screw-retained bridge was delivered, occlusion was checked, and instructions were given. The patient was very satisfied with the results (Fig. 15).

Eighteen months after delivery of the definitive prosthesis, clinical and radiographic evaluation demonstrated stable implants, healthy peri-implant bone, and satisfactory prosthesis integration (Figs. 16+17). At the three-year follow-up, these results remained stable, with no complications observed (Figs. 18–21).

Fig. 12: Temporary bridge fabricated on the Straumann® CARES® C series. – **Fig. 13:** Screw-retained temporary bridge delivered. – **Fig. 14:** Digitally planned final restoration. – **Fig. 15:** Final screw-retained bridge delivered. – **Figs. 16+17:** Eighteen months follow up: clinical and radiographic evaluation showing satisfactory functional and aesthetic outcome. – **Figs. 18–21:** Three-year follow-up: stable clinical and radiographic results without complications.
