Immediate implantation with two-piece ceramic implants in the mandibular premolar region

Dr Nalat Wongwatjana, Thailand

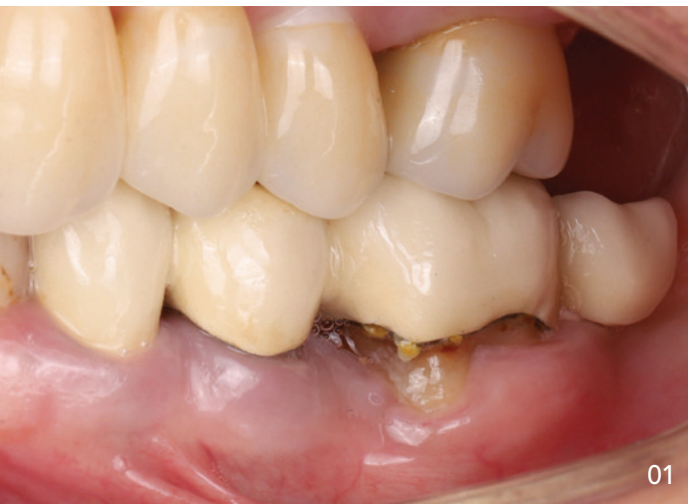
01
Preoperative clinical view showing secondary caries beneath existing crowns on teeth #34–36.

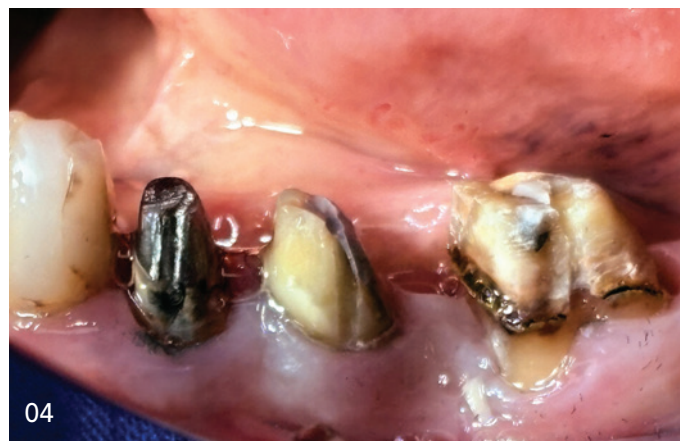
04 Clinical view after crown removal on teeth #34–36 before extraction.

On the day of surgery, the existing crowns on teeth #34–36 were removed. Teeth #33, #34, and #35 were extracted atraumatically, with particular care taken to preserve the alveolar socket walls. The extraction sockets were thoroughly curetted and degranulated using a round diamond degranulation bur and curettes to eliminate granulation tissue and residual infection.

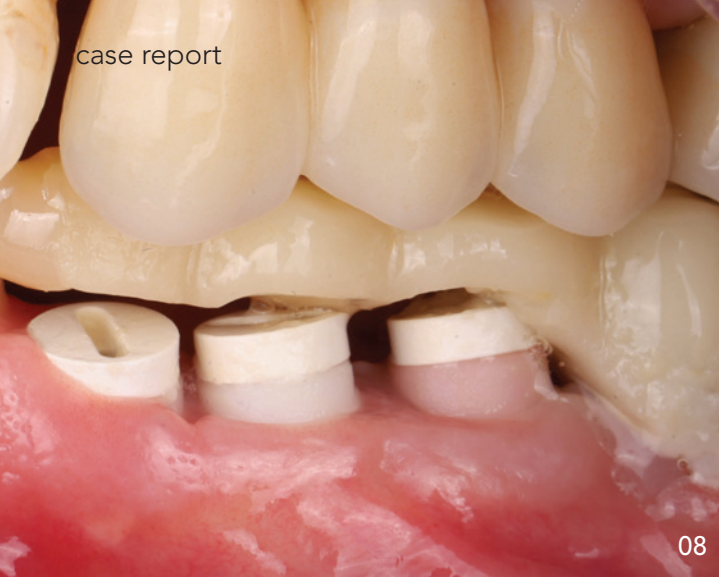
08
Three-month follow-up demonstrating healthy soft-tissue maturation and contour development.

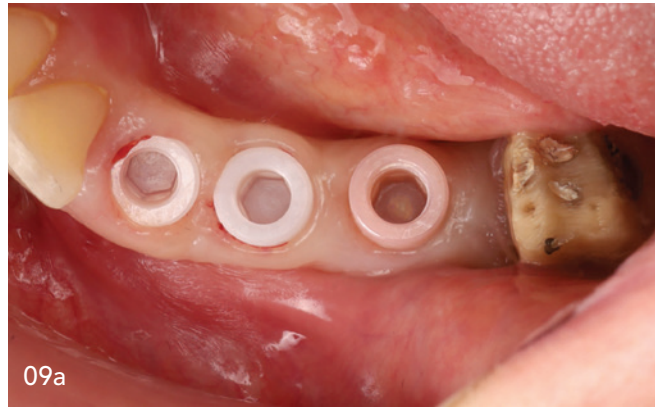
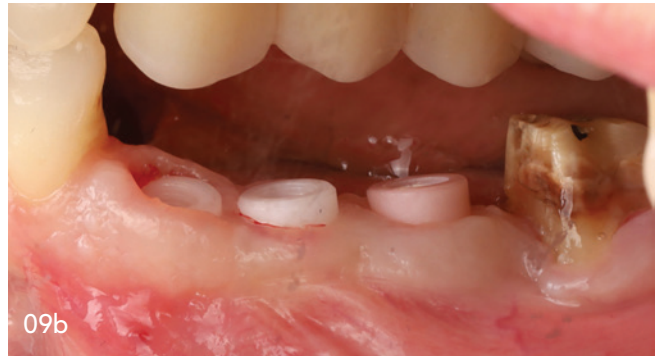
09a

09a+b
Six-month follow-up after cover-screw removal, showing excellent peri-implant tissue health.

After six months, clinical and radiographic evaluation confirmed uneventful healing, stable bone levels, and healthy peri-implant soft tissue. The temporary bridge was removed, and the definitive abutments were cemented using 3M Ketac Glass Ionomer Cement, torqued to 15Ncm as per manufacturer guidelines.

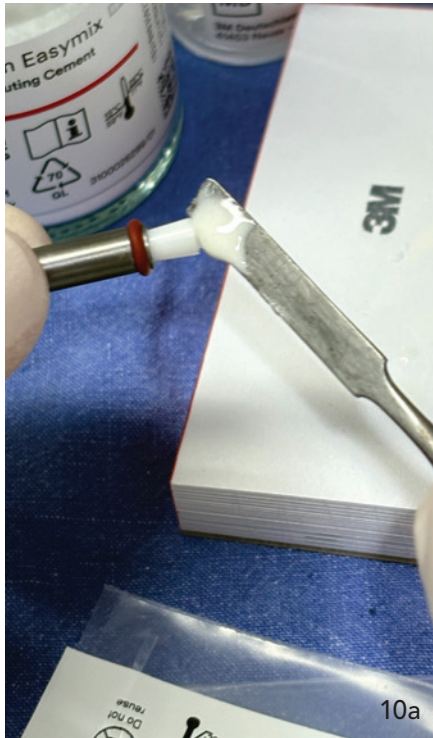
10a

10a+b
Application of mixed 3M Ketac GI cement on abutments prior to final fixation.

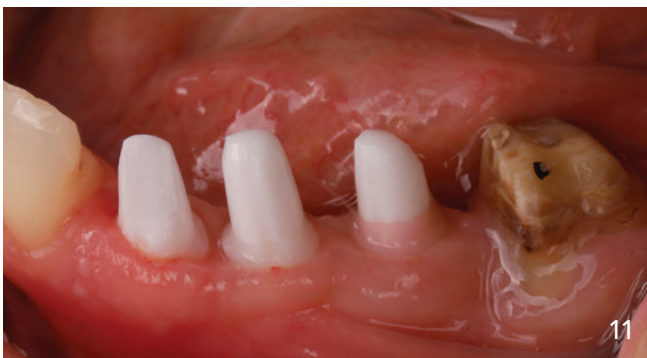
11
Prepared abutments before digital scanning, showing precise margins and emergence profile.

The abutments were prepared using a fine red diamond bur, and a digital impression was recorded with the 3Shape intra-oral scanner. Final monolithic zirconia crowns were fabricated and cemented with GI cement. The final prosthetic phase included zirconia crowns on implants #33–35 and a new zirconia crown on the natural tooth #36, restoring function and aesthetics while maintaining a fully metal-free workflow.

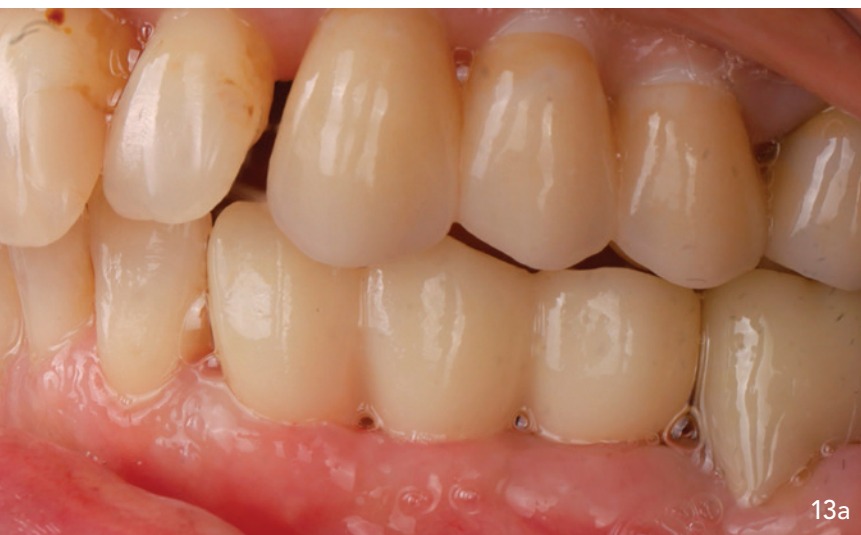
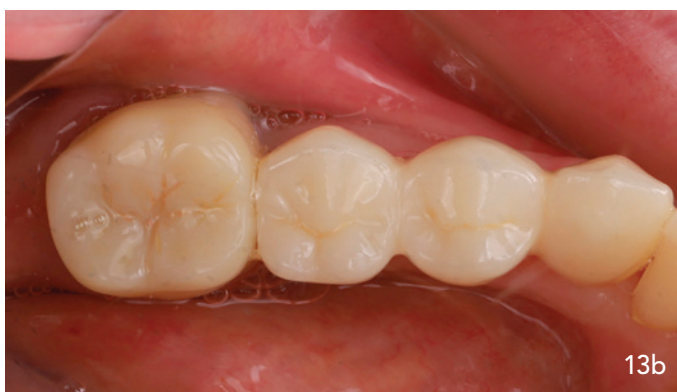
13a

13a+b
Final zirconia crowns on implants #33–35 and tooth #36, demonstrating natural colour harmony and healthy gingiva.
