Bypassing a fractured instrument

Author_ Dr Rafaël Michiels, Belgium

_Case report

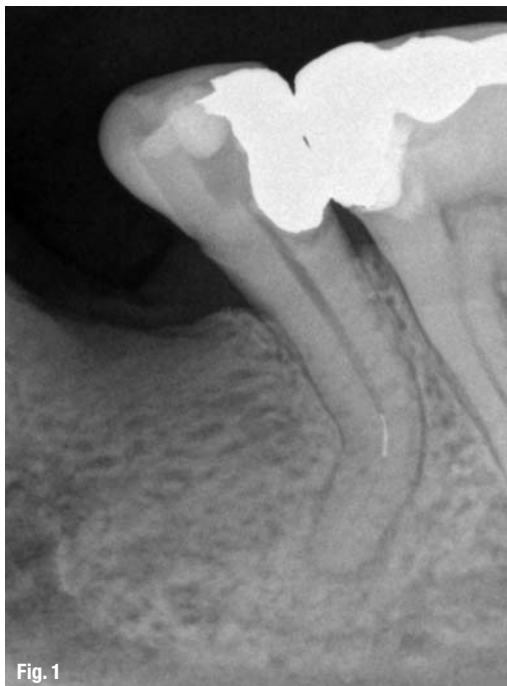
Fig. 1 _Diagnostic radiograph showing a separated instrument in the canal at the curvature.

Before starting the treatment, a new diagnostic radiograph was taken (Fig. 1). It showed a fractured instrument in the curvature of the root. The tooth was isolated with a rubber dam and the coronal filling was removed. Straight-line access was established, as this is imperative to be able to reach and see the fractured instrument. In this case, the fractured instrument could not be visualised (Fig. 2). The decision was made to try to bypass the instrument rather than try to retrieve it. The key factors for this decision were the impossibility of visualising the instrument, the location of the instrument, the

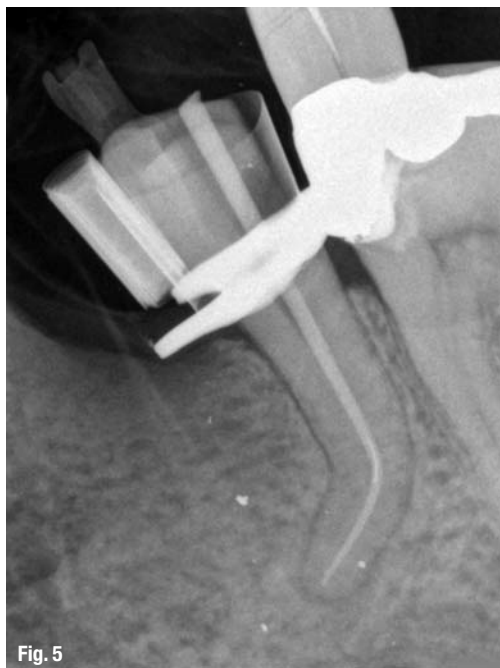
Fig. 5

Fig. 5_ Gutta-percha cone-fitting.

Topseal (DENTSPLY Maillefer) was used as a root-canal sealer. After radiographical confirmation (Fig. 5), additional gutta-percha cones, ISO size 20, were placed into the canal, according to the cold lateral condensation technique. Next, the gutta-percha was removed to about 5 mm from the apex with the System B Elements Obturation Unit (SybronEndo). Owing to the curvature, it was not possible to go any deeper. Hence, I decided to create

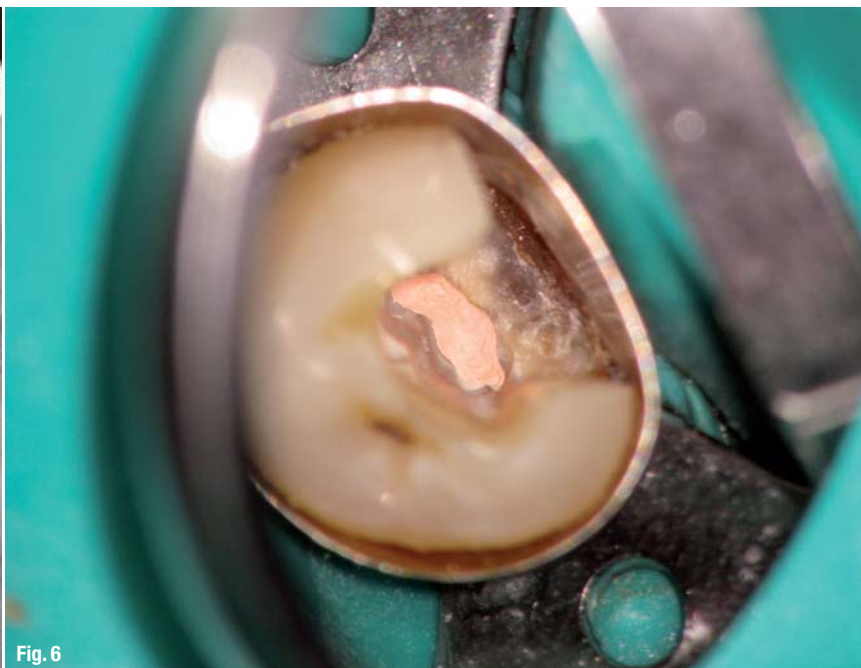
Fig. 6

Fig. 6_ The pulp chamber after obturation with gutta-percha.

a hybrid technique with cold lateral condensation. Finally, the backfill was done with the Elements Obturation Unit. After obturation (Fig. 6), a temporary restoration in glass-ionomer cement (Fuji IX FAST A1, GC) was placed. Final radiographs were taken, both parallel and angled (Figs. 7 & 8). The prognosis of this case was excellent and the patient was referred to his general dentist for a definitive coronal restoration.

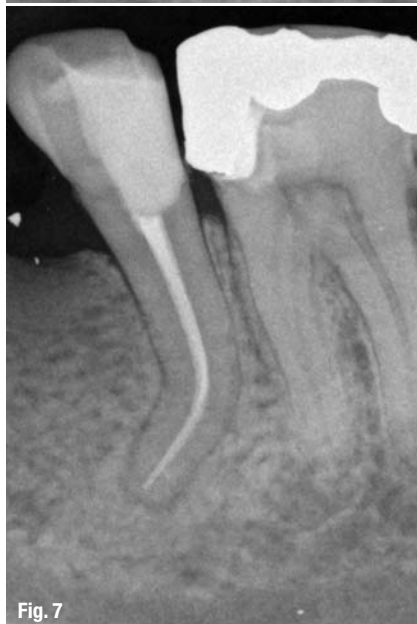
Fig. 7

Fig. 7_ Final radiograph (parallel).

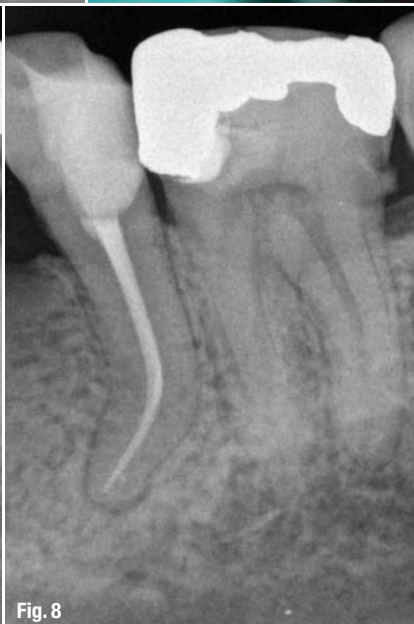
Fig. 8

Fig. 8_ Final radiograph (angled).
