Bypassing a fractured instrument

Author_ Dr Rafaël Michiels, Belgium

_Case report

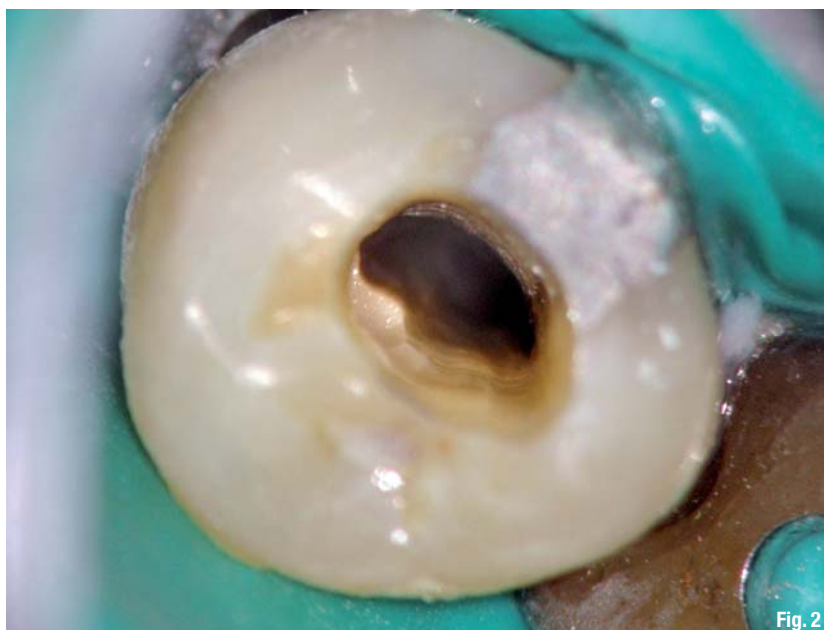
Fig. 2

Fig. 2_ The instrument was not visible through the microscope.

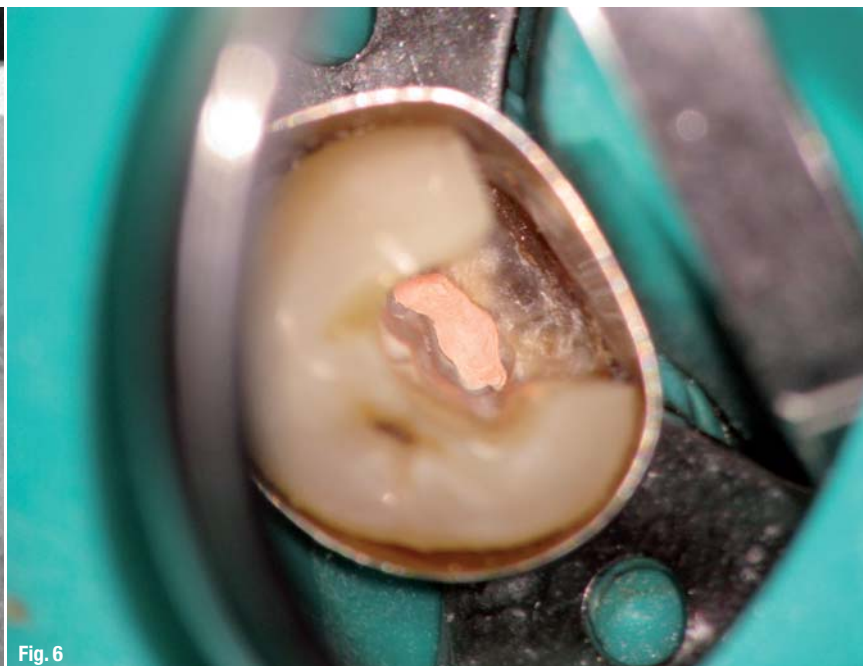
Fig. 6

Fig. 6_ The pulp chamber after obturation with gutta-percha.

a hybrid technique with cold lateral condensation. Finally, the backfill was done with the Elements Obturation Unit. After obturation (Fig. 6), a temporary restoration in glass-ionomer cement (Fuji IX FAST A1, GC) was placed. Final radiographs were taken, both parallel and angled (Figs. 7 & 8). The prognosis of this case was excellent and the patient was referred to his general dentist for a definitive coronal restoration.

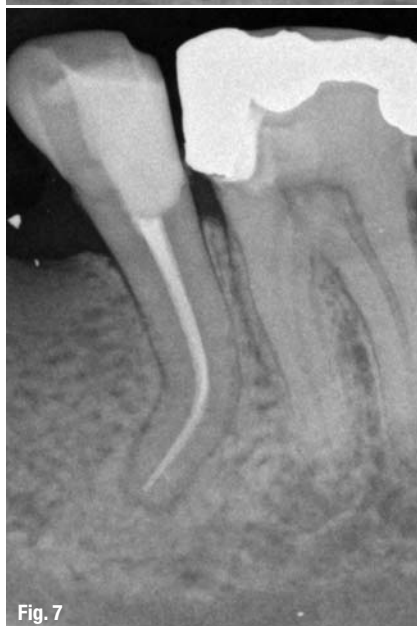
Fig. 7

Fig. 7_ Final radiograph (parallel).

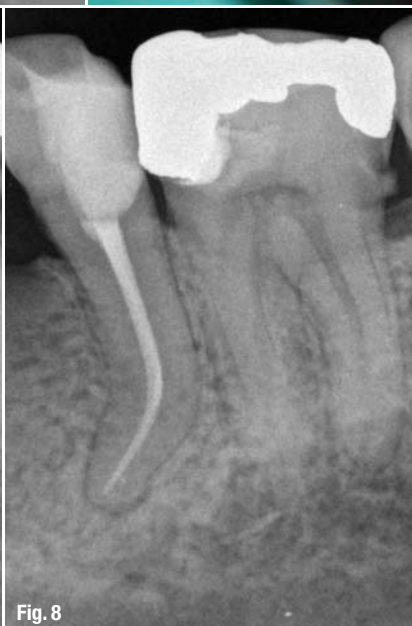
Fig. 8

Fig. 8_ Final radiograph (angled).
