Enamel alterations

Author_Dr Prof Giuseppe Iaria, Italy

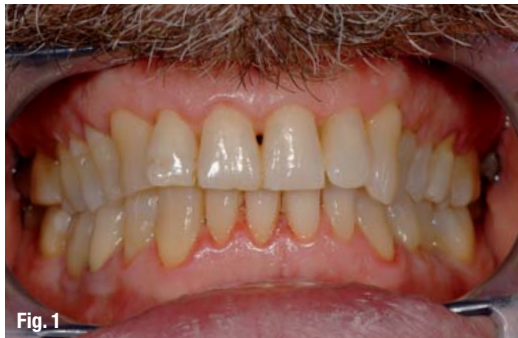
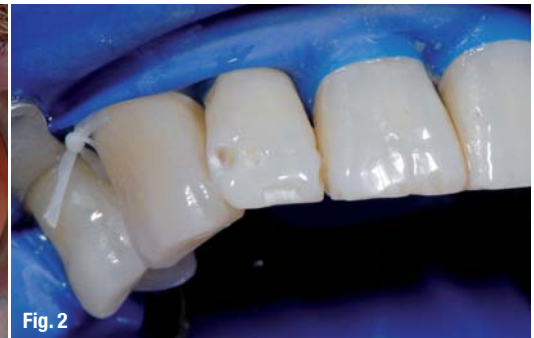
A healthy 56-year-old male patient presented with enamel alteration of tooth #7. The oral examination showed a healthy periodontium and temporomandibular joint, and the teeth were in a Class I occlusion (Figs. 1–4). The radiographic examination showed no other radicular lesions. The soft-tissue status indicated good periodontal health. For the hard-tissue test, percussion was normal, and there was no mobility or tenderness to touch or air spray. The tooth tested vital with the electric pulp tester and cold testing.

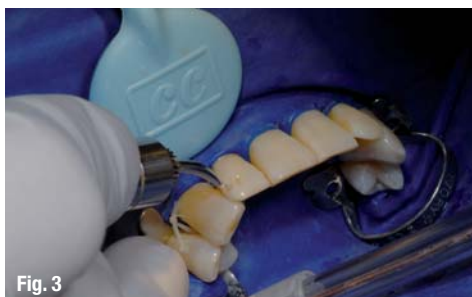
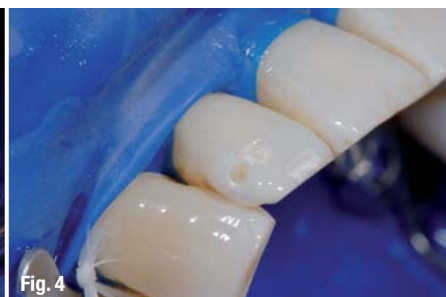
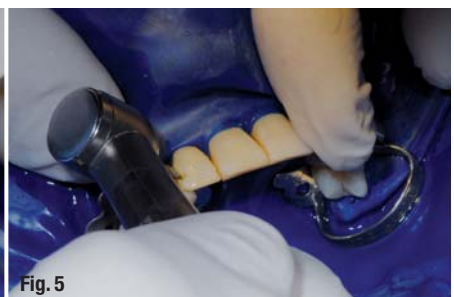
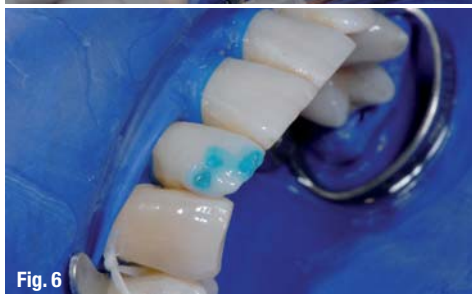
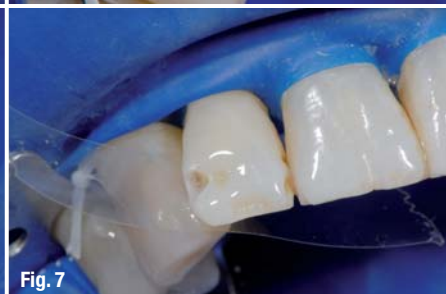
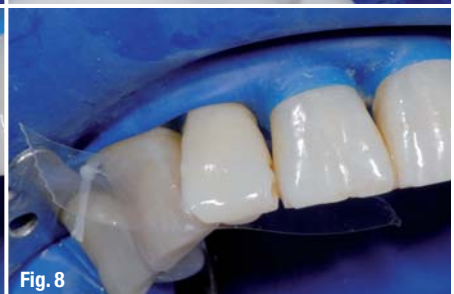
Adequate water spray must be maintained as the procedure is performed. Good visibility and low power are necessary for careful preparation in order to avoid both thermal damage and excessive removal of tooth structure.

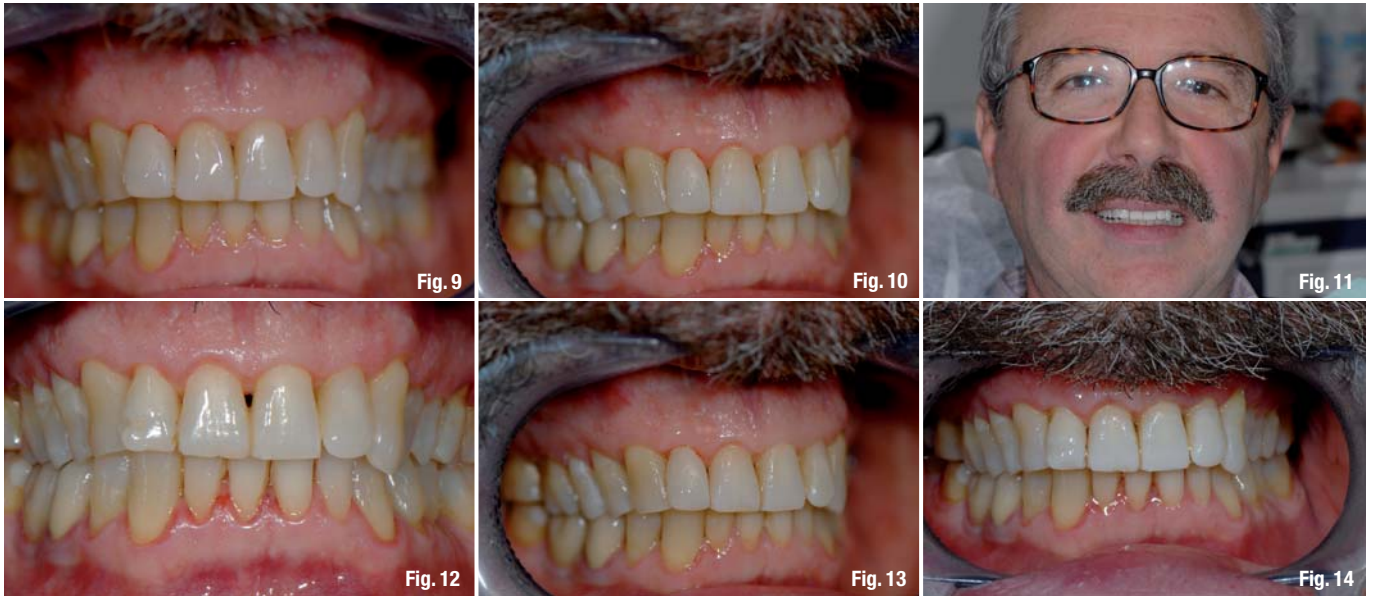
Treatment alternatives
